Reconnaissance Report
ON THE 21 AUGUST 1988 EARTHQUAKE
IN THE NEPAL-INDIA BORDER REGION

**Research Report on Natural Disasters,
Supported by the Japanese Ministry
of Education, Science and Culture
(Grant No.63115047)
Japanese Group for the study of
Natural Disaster Science**

Teizo FUJIWARA	Professor, Disaster Prevention Research Institute, Kyoto University
Tadanobu SATO	Associate Professor, Disaster Prevention Research Institute, Kyoto University
Tetsuo KUBO	Associate Professor, Faculty of Engineering, Nagoya Institute of Technology
Hitomi Ohashi MURAKAMI	Instructor, Faculty of Engineering, Hokkaido University

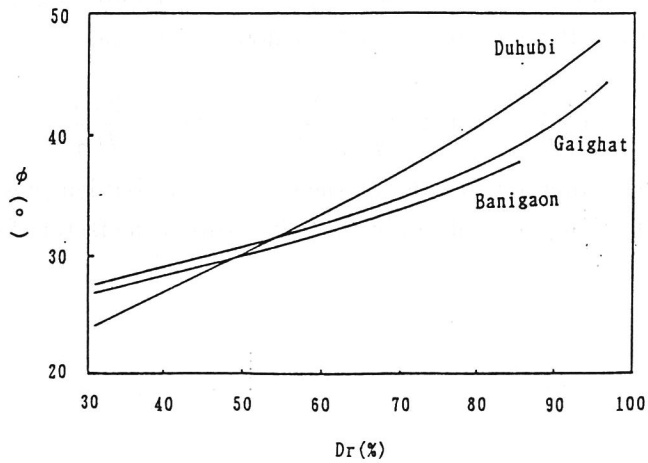
Fig. 2.20 Internal friction angle of the sand samples in Fig. 2.19 in terms of relative density

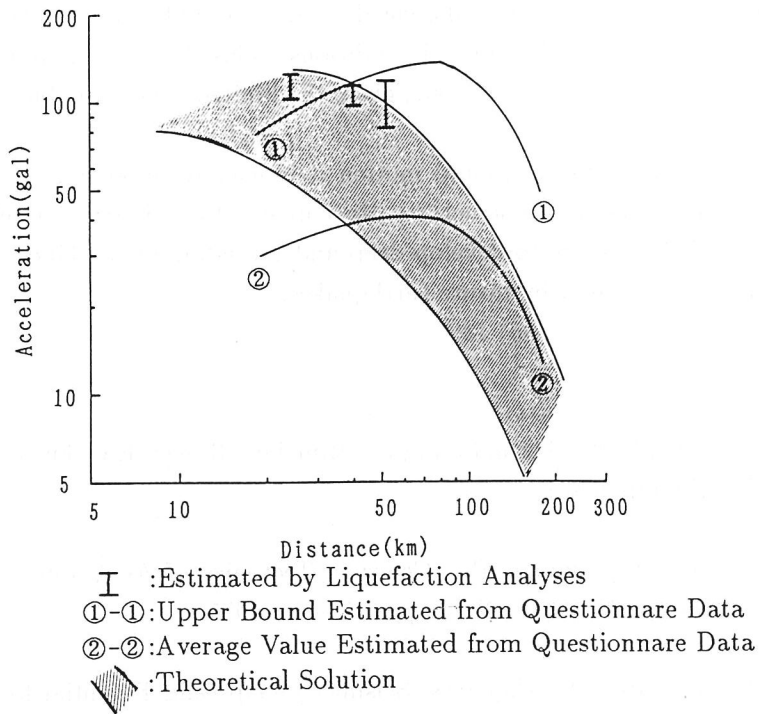
Fig. 2.23 Comparison of maximum ground intensities obtained by several methods

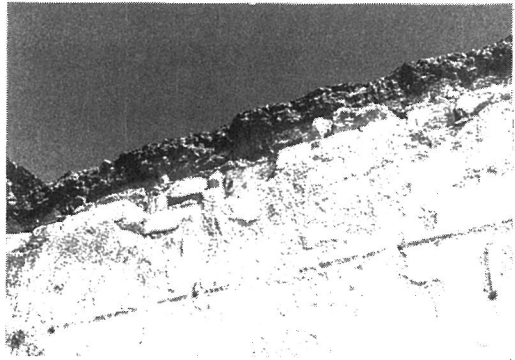
Photo. 3.2 Cross-sectional view of the floor slab system of the same damaged brick masonry house

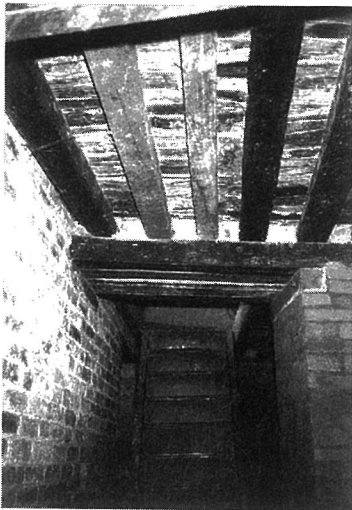
Photo. 3.3 Interior view of the floor slab system of a brick masonry building

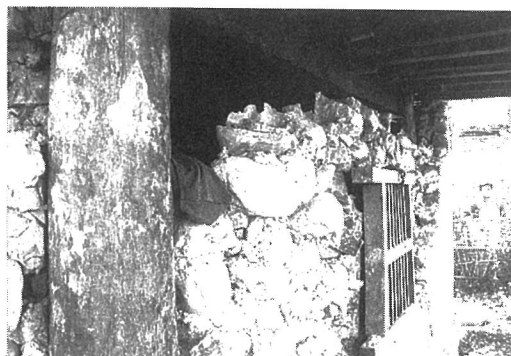
Photo. 3.9 A mud-stone, rural house at Gaighat, Nepal partly damaged during the earthquake

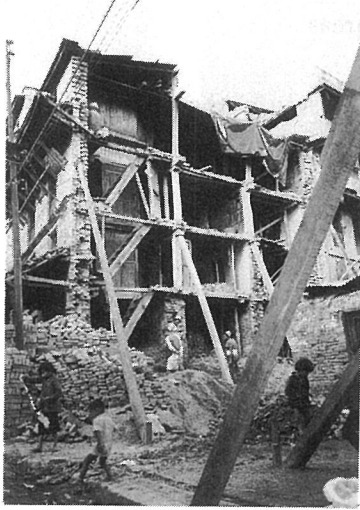
Photo. 3.10 Typical pattern of damage to a brick masonry building produced by the earthquake; example 1

The typical damage pattern for brick masonry structures was seen in buildings of two or more stories, possibly because the gable walls of such buildings are exclusively self-supporting, there being no connecting seismic component. As shown, the wooden beams run transversely, and no specific seismic structural components are positioned to strengthen the gable wall. Therefore when out-of-plane lateral forces are applied in the longitudinal direction, the gable wall sloughs off (*Photos. 3.10* and *3.11*). Lack of stiffness in the floor slab system, in particular longitudinally, might cause major deformation during excitation and thrust the gable wall into an out-of-plane position.

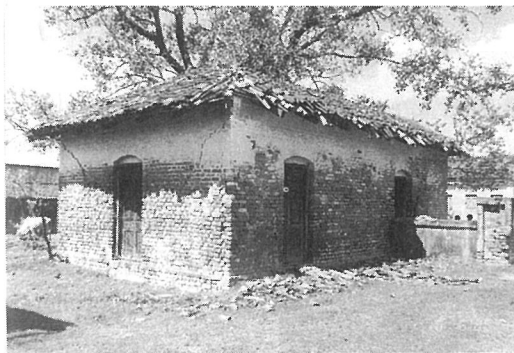
Photo. 3.14 A damaged kiosk in the backyard of the Darbhanga District Headquarters Office, Darbhanga, India

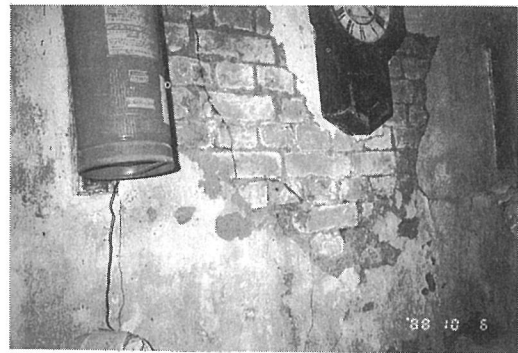
Photo. 3.15 Cracks on the brick masonry wall in the Darbhanga District Headquarters Office, Darbhanga

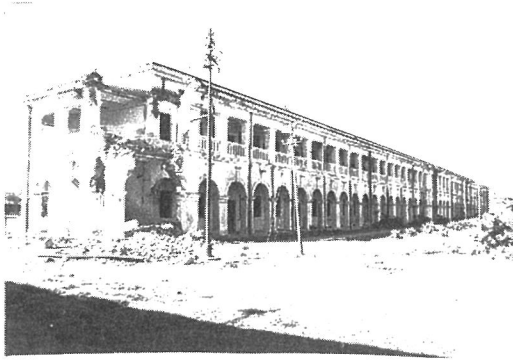
Photo. 3.17 The damaged Medical College Hospital, Darbhanga

Damage to an entrance of the dormitory at the Medical College Hospital is shown in *Photo. 3.17*. *Photo. 3.18* gives a close-up view. There are no reinforcing bars for the girders and beams, nor for the floor system composed of layers of bricks and mud. The building consequently is extremely heavy and has poor ductility for deformation. Numerous cracks have appeared within the dormitory in its transverse walls and in its longitudinal walls around the windows and doors. Note that the one-story buildings located less than 20m from the damaged dormitory show no exterior seismic damage, not even small cracks around their window frames (*Photo. 3.19*).

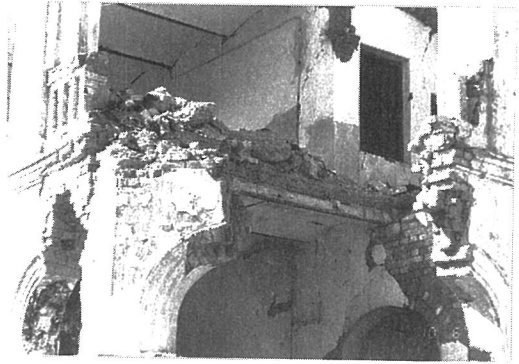
Photo. 3.18 Close-up of a cross-sectional view of the damaged Medical College Hospital, Darbhanga

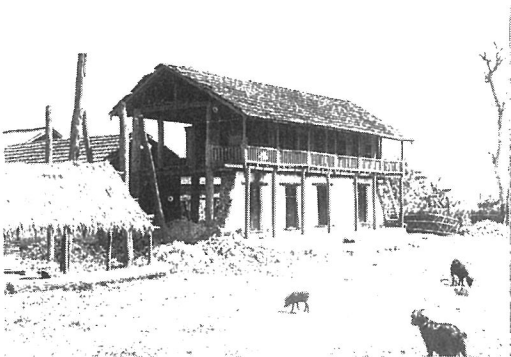
Photo. 3.26 A damaged brick masonry farm house, Gaighat, Nepal

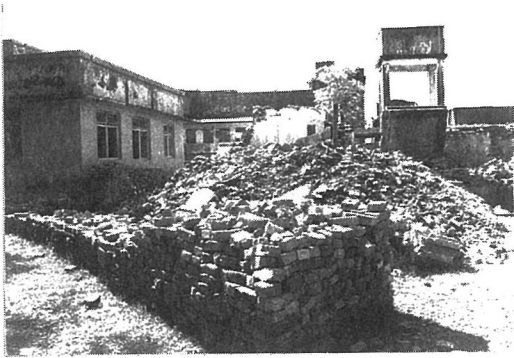
Photo. 3.28 Collapse of a brick masonry building: the nurses' headquarters, Dharan Hospital, Dharan Bazaar, Nepal

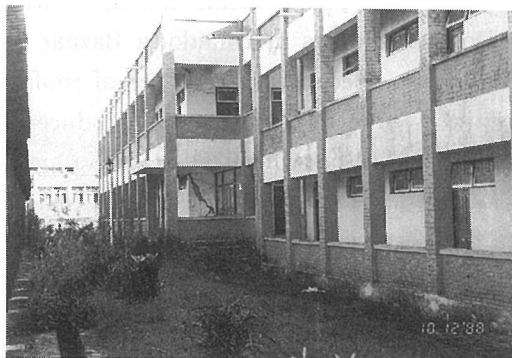
Photo. 3.34 Seriously and slightly damaged classroom buildings, the Engineering College Campus, Tribhuvan University, Dharan Bazaar, Nepal

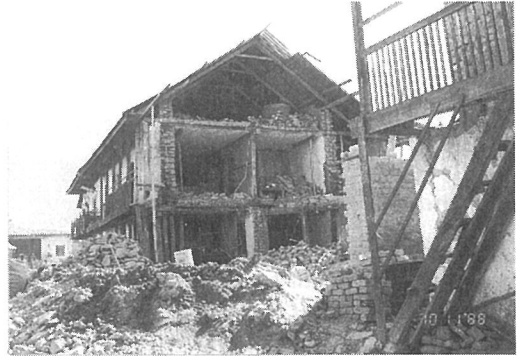
Photo. 3.37 Damage to the gable wall of a brick masonry building; example 2, Dhankuta Bazaar, Nepal

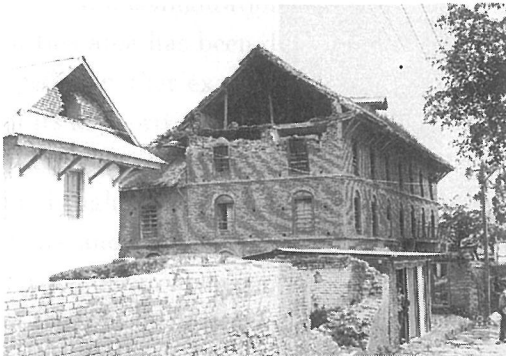
Photo. 3.38 Damage to the gable wall of a brick masonry building; example 3, Dhankuta Bazaar, Nepal

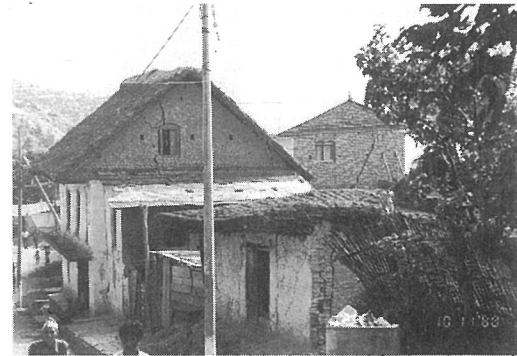
Photo. 3.39 Damage to the gable wall of a brick masonry building; example 4, Dhankuta Bazaar, Nepal

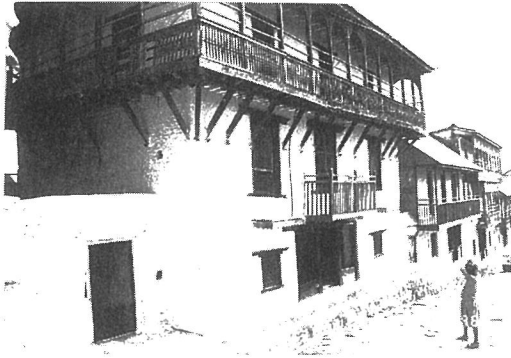
Photo. 3.40 Exterior view of a rural brick masonry house, Dhankuta Bazaar, Nepal

Almost every building in Dhankuta Bazaar appears to have been harmed by the 1988 earthquake. The house shown in *Photo. 3.40* does not look seriously damaged. Its exterior facade may have been reconditioned; the interior, however, shows large cracks in the walls (*Photo. 3.41*). The inhabitants told us that blocks of wall fell during the earthquake.

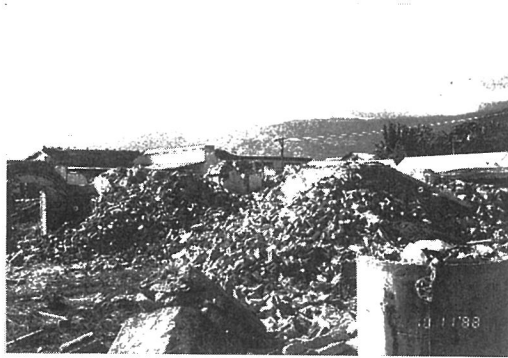
Photo. 3.42 The completely collapsed Dhankuta Hospital, Dhankuta Bazaar, Nepal

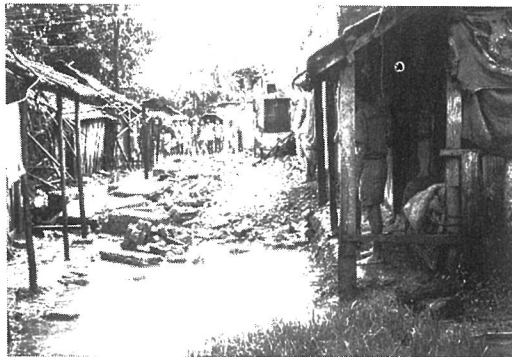
Photo. 3.43 A collapsed single-story brick masonry house in Biratnagar, Nepal (photo taken by a resident just after the shock)

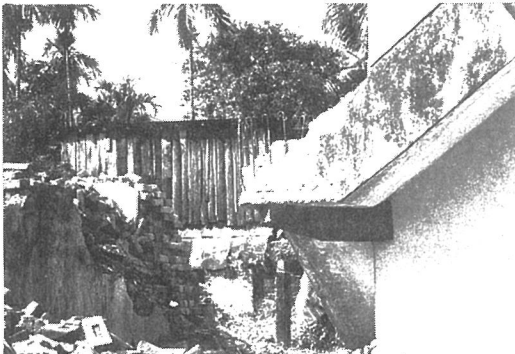
Photo. 3.55 The damaged two-story reinforced concrete medical office at Dharan Hospital, Dharan Bazaar, Nepal

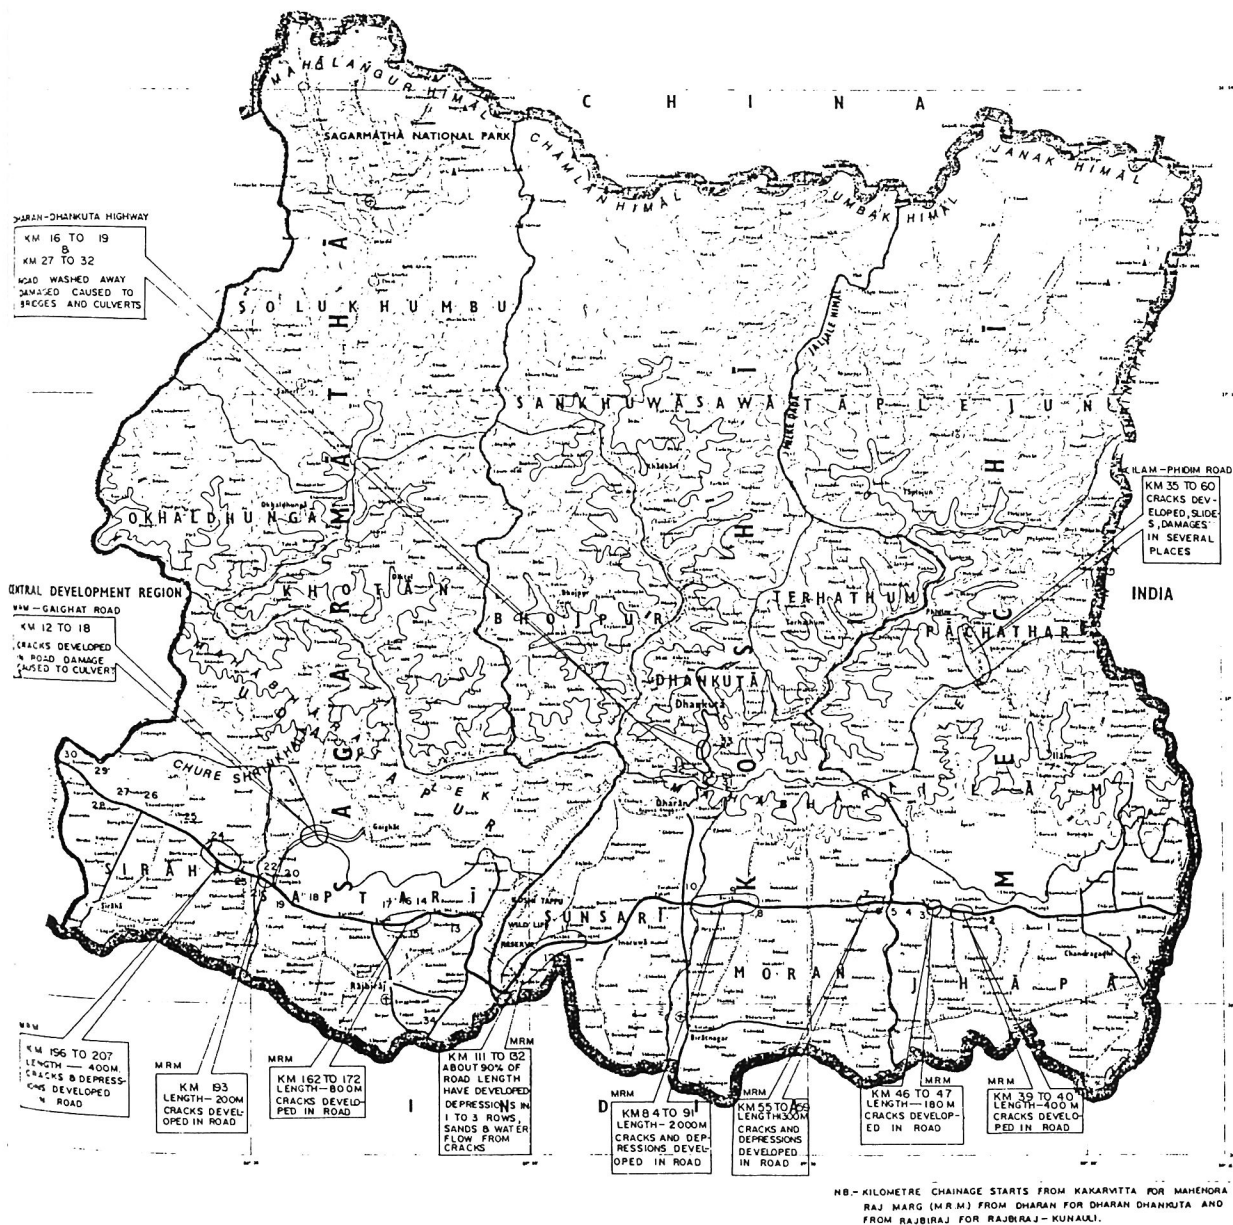
Fig. 3.7 Damage to roads in the eastern development region of Nepal

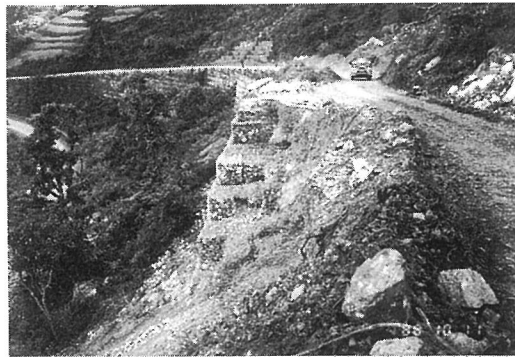
Photo. 3.70 Road damaged by a landslide

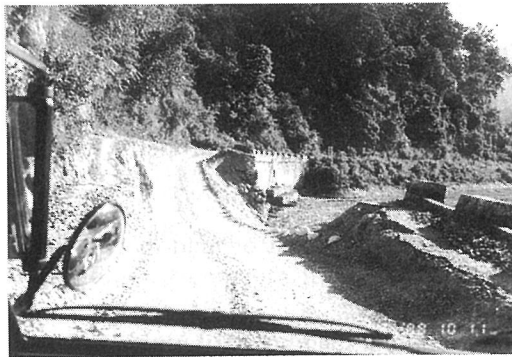
Photo. 3.71 Retaining wall failure
