**Doctoral Dissertation**

**DEVELOPMENT OF A METHOD OF  
REMAINING LIFE PREDICTION FOR AN AGED BRIDGE BASED ON  
CONCRETE CORES AND CROSS-SECTION  
CUTTING-OFF GIRDERS**

**RATNA WIDYAWATI**

**Department of Environmental Science and Engineering  
Graduate School of Science and Engineering  
Yamaguchi University, Japan  
March, 2015**

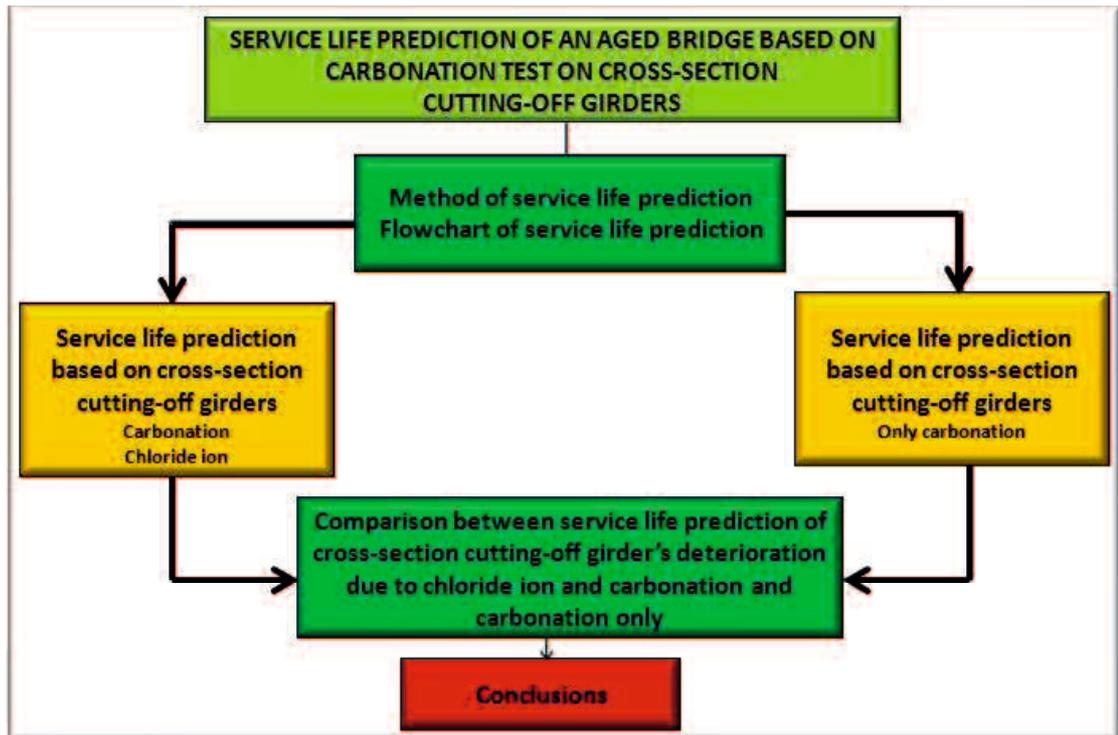
Fig. 1.1 The flow of the study of remaining life prediction

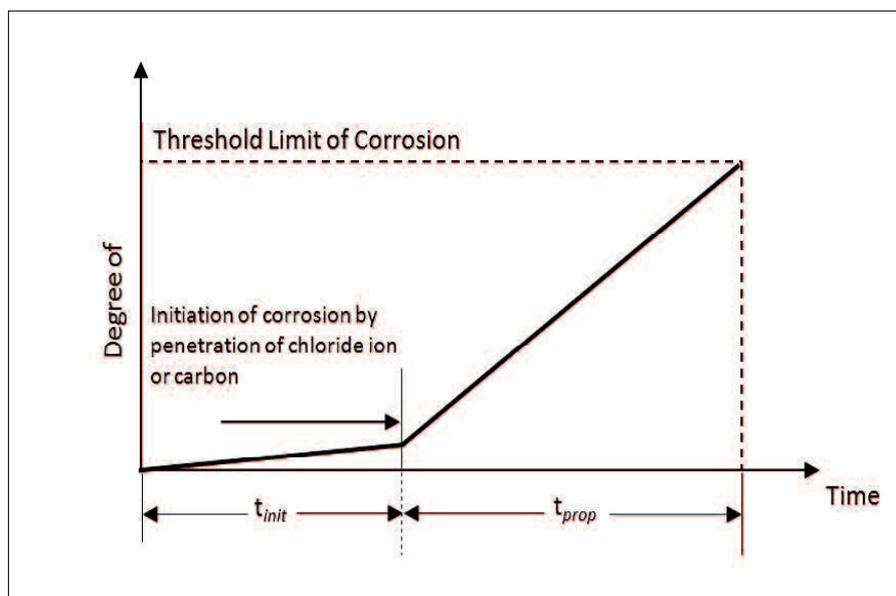
Fig. 2.1 Service life model by Tutti (1982)

Service life of RC structures has been divided into several stages by previous researchers. Fig. 2.1 shows the Tutti's model for predicting deterioration. This model divided the service life of RC structures into two stages, i.e., initiation and propagation stages [12]. Initiation stage is the time required for carbon dioxide or chloride ion to reach the reinforcing bar and start the initiation corrosion. Propagation stage is the time between the initiation corrosion and the initiation cracking has occurred.

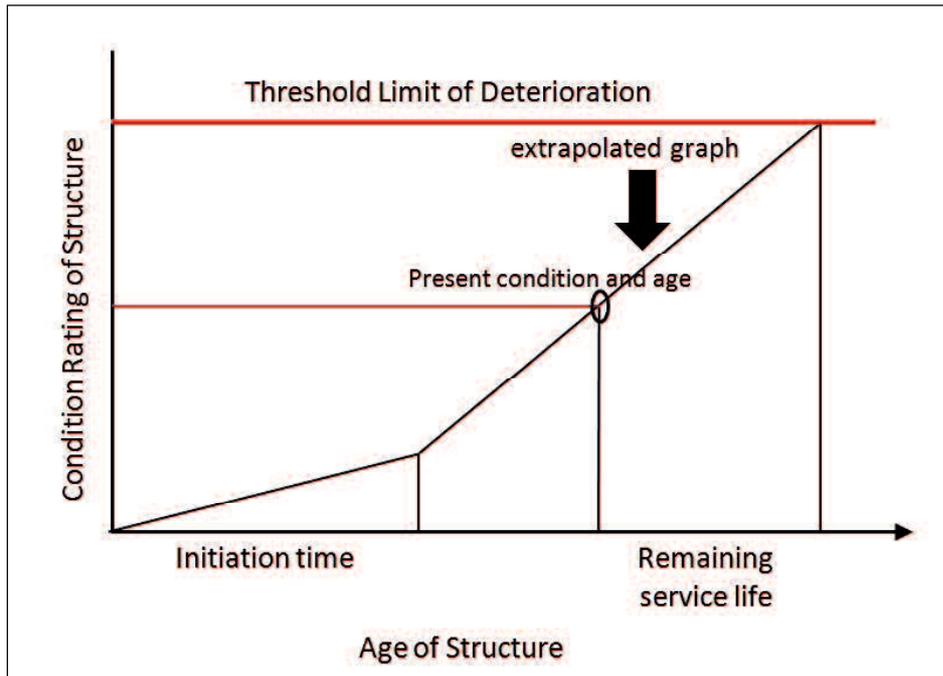
Fig. 2.2 Service life model by Verma (2013)

Fig. 2.2 shows the model of service life prediction by Verma. In this model, service life prediction of RC structures is also divided into two stages, initiation and propagation stages, similar to Tutti's model. Initiation stage is the time period required for the initiation corrosion either when the carbonation depth is reached in the concrete cover or the chloride ion has reached the threshold value. Propagation stage is the time period between initiation and failure of the structures [13].

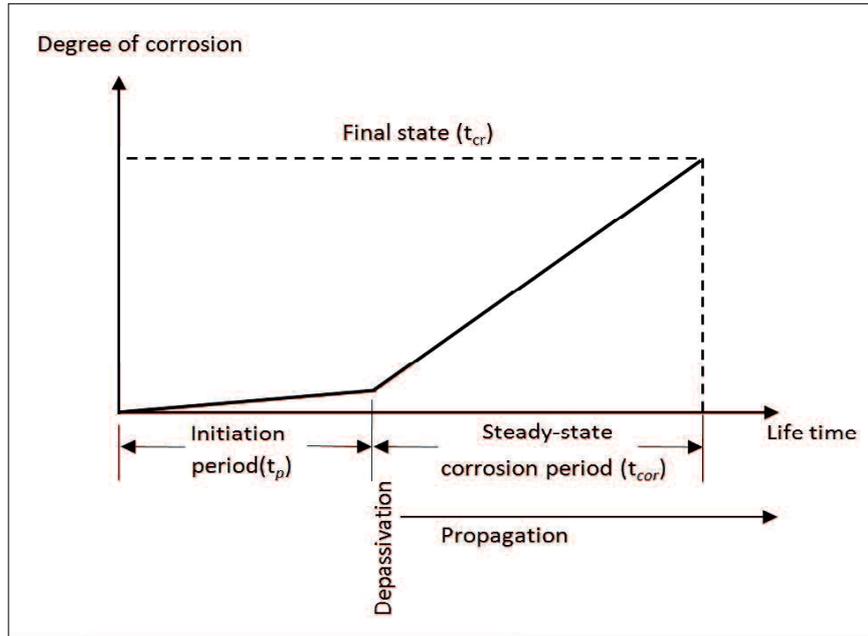
Fig. 2.3 Stages of reinforcing bar corrosion model by Ahmad (2002)

According to Ahmad's model, the state of corrosion process has three stages, depassivation, propagation and final state, as shown in Fig. 2.3. Depassivation is the loss of oxide (passive layer) on the reinforcing bar which protects the reinforcing bar from corrosion. Depassivation was initially formed when the concrete became acidic due to the carbon dioxide or chloride penetration. The process of depassivation takes an initiation period, which is the time from initial condition (construction) to the time due to initiation of corrosion (depassivation). The propagation phase starts from the time of depassivation to the final stage. During the final stage, the corrosion will lead to cracking and spalling of concrete cover [11]. The critical time,  $t_{cr}$ , can be define as follows:

Where  $t_{cr}$  is critical time in years,  $t_p$  is time from construction to the time of initial corrosion (depassivation) in years and  $t_{cor}$  is time from the depassivation to the final stage in years, when it has reached the critical time. Therefore, the service life can be estimated to the critical time as given by Eq. 2.1.

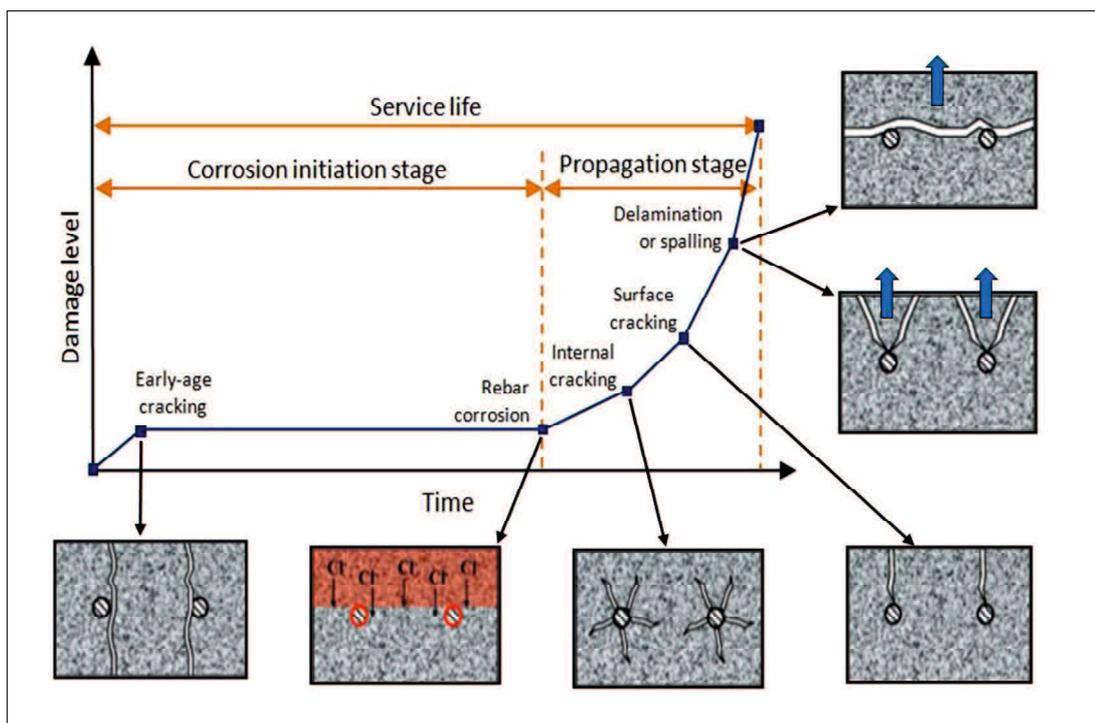
Fig. 2.4 Schematic description of the service life model

Based a conceptual model illustrated in Fig. 2.4 which shows a two-stage service life model. The service life ( $t_s$ ) can be defined as the total time to reach a given corrosion induced damage level, which is the sum of the corrosion-initiation time ( $t_i$ ) and the propagation time ( $t_p$ ) corresponding to a given level of damage, as follows:

Several different estimates of service life can be obtained using this conceptual model. In Ref. [14] the end of service life is defined as the time to onset of spalling.

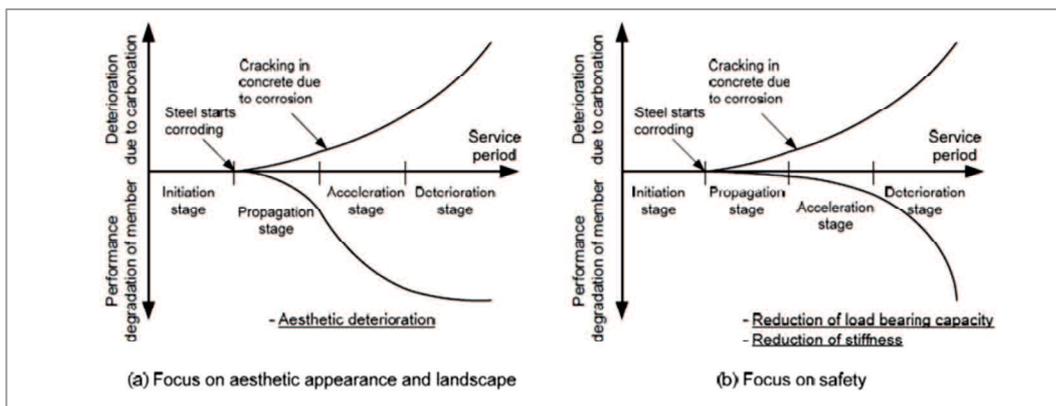
Figure 2.5 Conceptual view of deterioration progress due to carbonation

Deterioration due to carbonation and steel corrosion during the incubation stage, propagation stage, acceleration stage and deterioration stage is shown in Fig. 2.5 and Table 2.1 as follow:

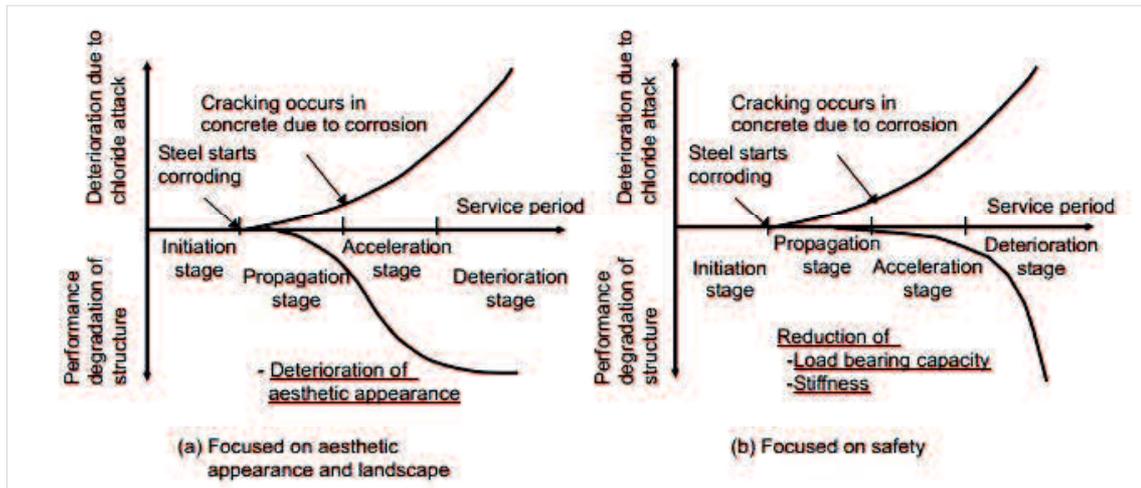
Fig. 2.6 Conceptual view of deterioration progress due to chloride ion

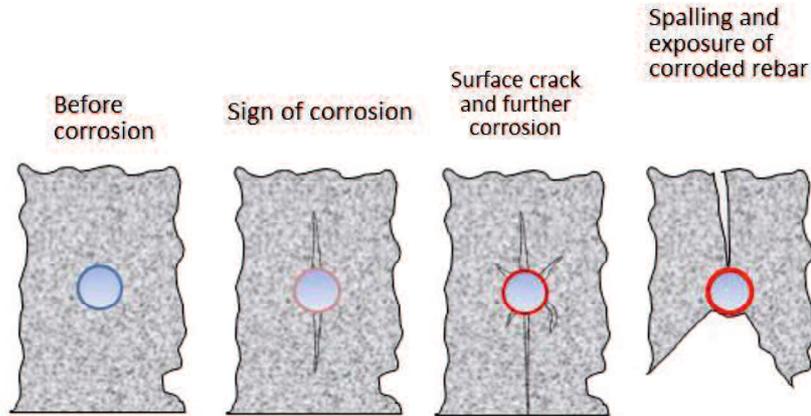
Fig. 2.7 Corrosion process

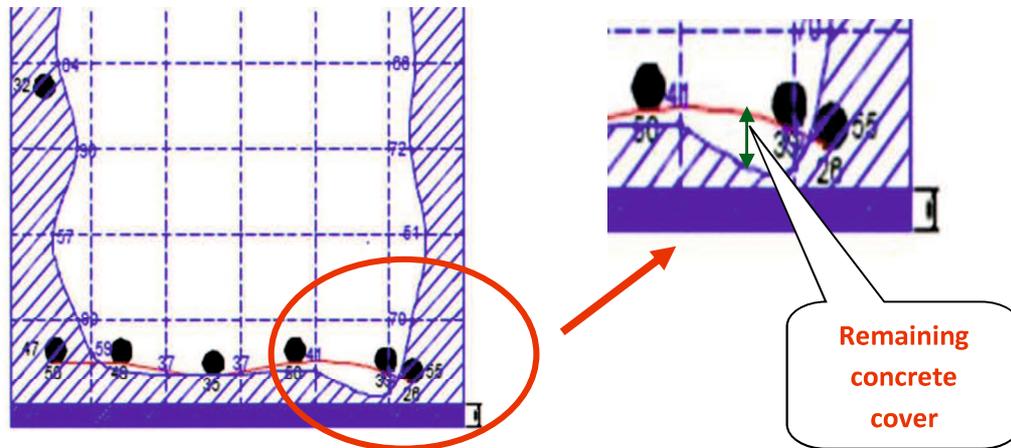
Fig. 2.8 Remaining concrete cover

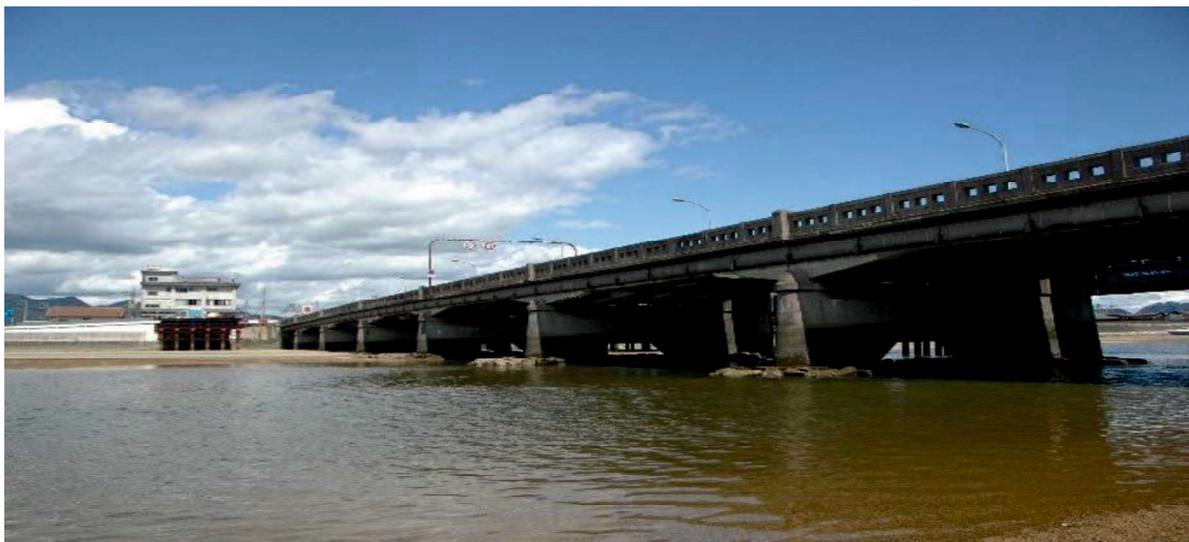
Fig. 3.2 General view of SK Bridge

SK Bridge is a T-girder concrete bridge. It has eight spans, and each span consists of five girders. Table 3.1 shows the geographical location of SK-Bridge. The bridge has a total length of 168 m and a width of 11 m. SK Bridge had been completed in 1942. After approximately 70 years in service, the bridge had been demolished in 2013. The general view of SK Bridge can be seen in Fig. 3.2.

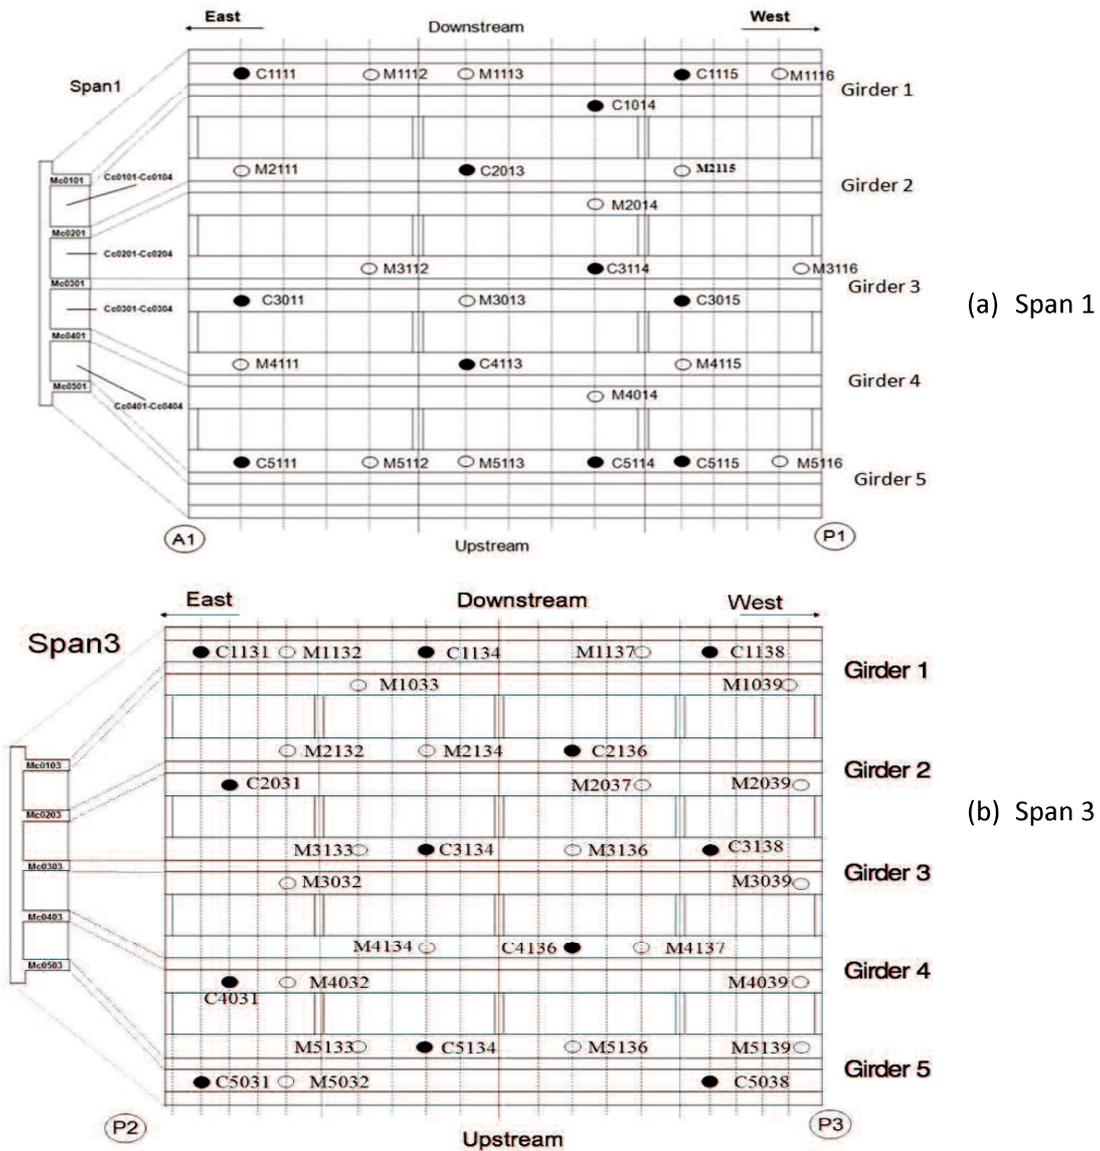
Fig. 3.4 Concrete cores locations

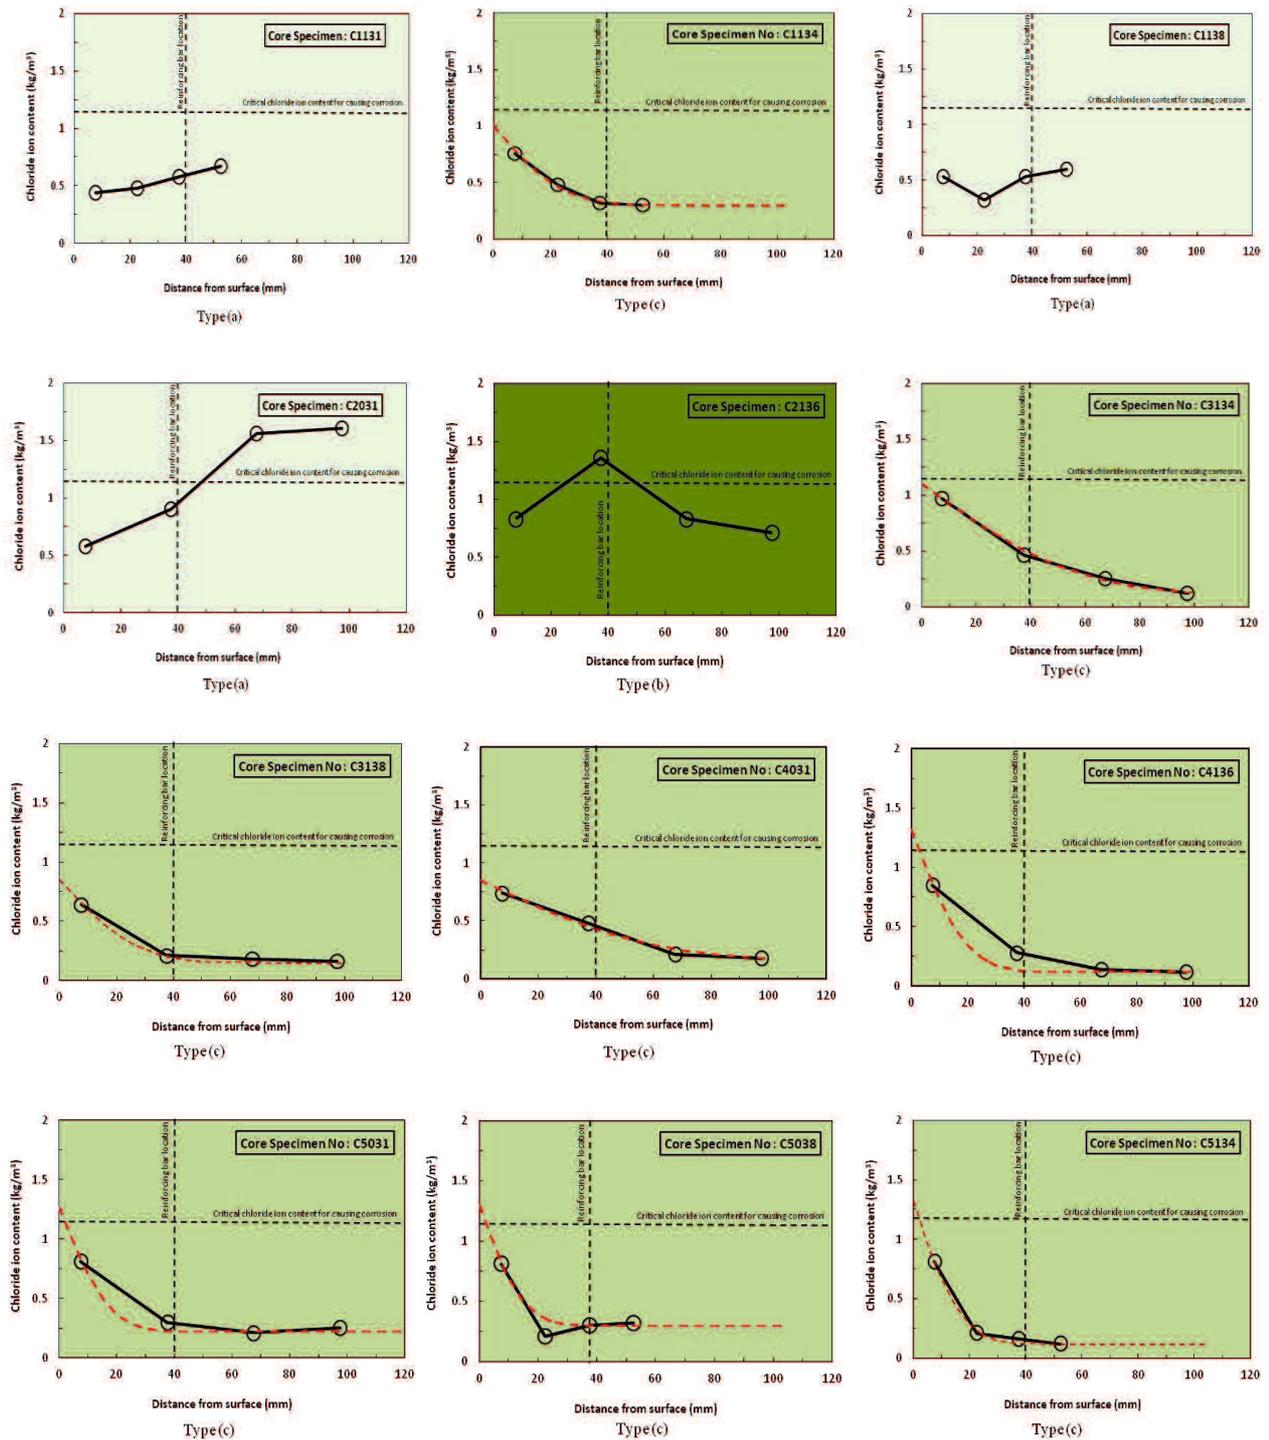
Fig. 3.9 Types of chloride ion content distribution in Span 3

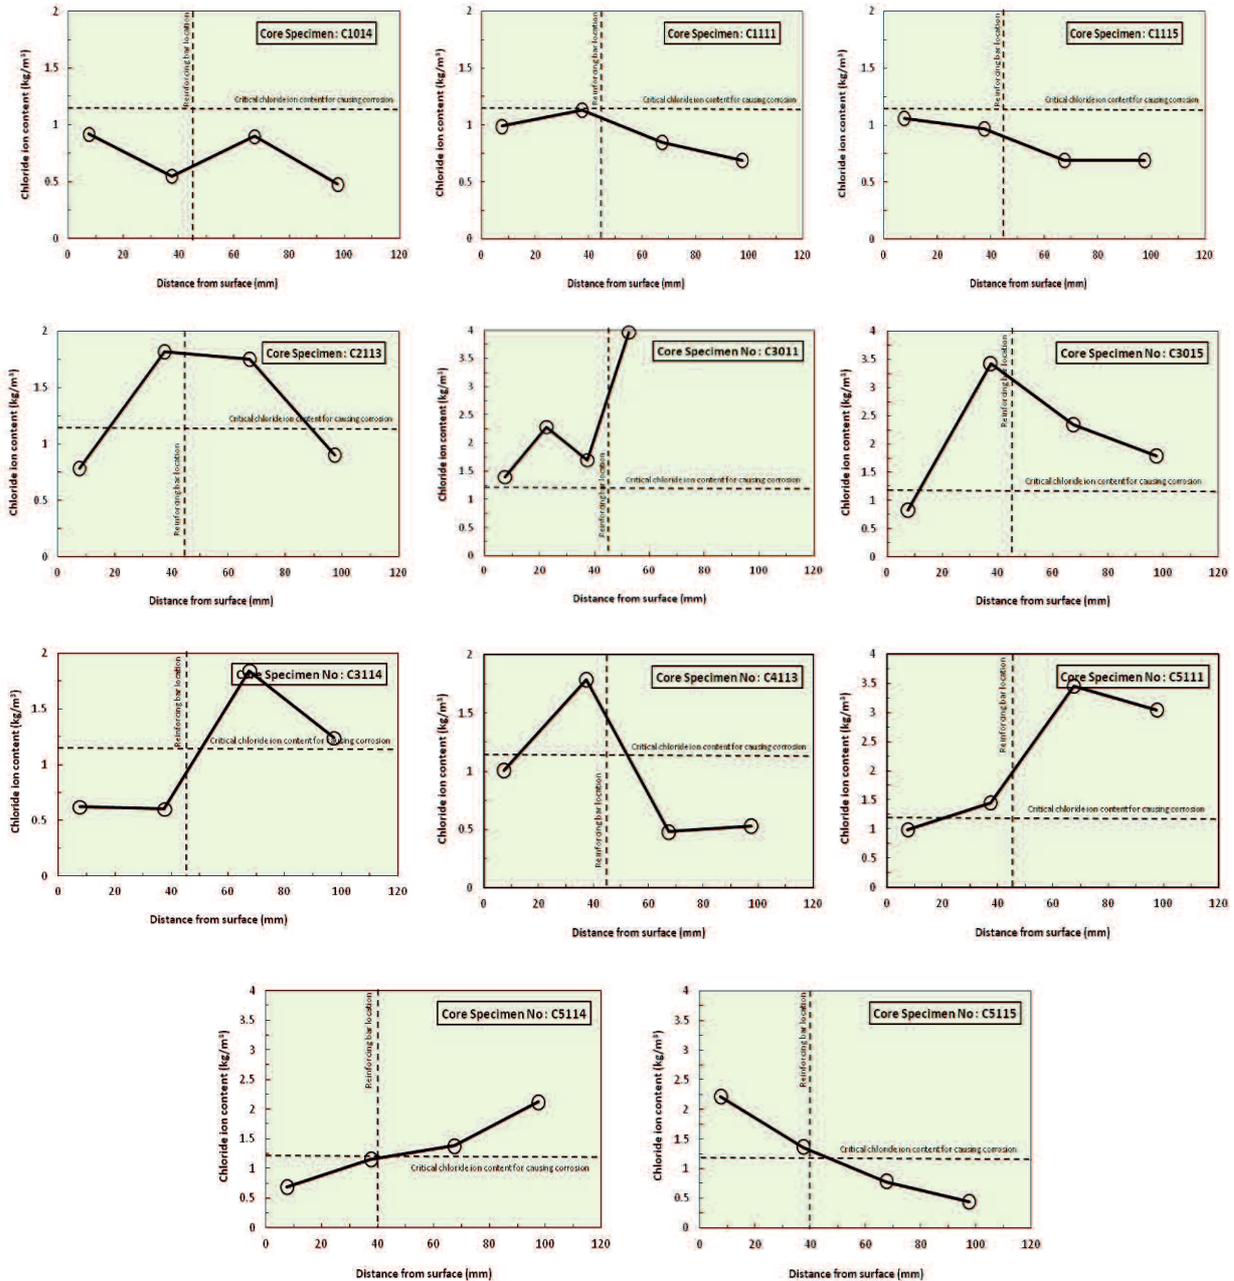
Fig. 3.10 Chloride ion content distributions in Span 1

The results of the chloride ion content analysis in the investigated main girders (2<sup>nd</sup> case) almost half of the number is relatively higher than the requirement of the critical chloride ion content for steel corrosion is assigned by 1.2 kg/m<sup>3</sup>. The chloride ion test results reveal some specimens which are affected by large chloride ion content and also carbonation.

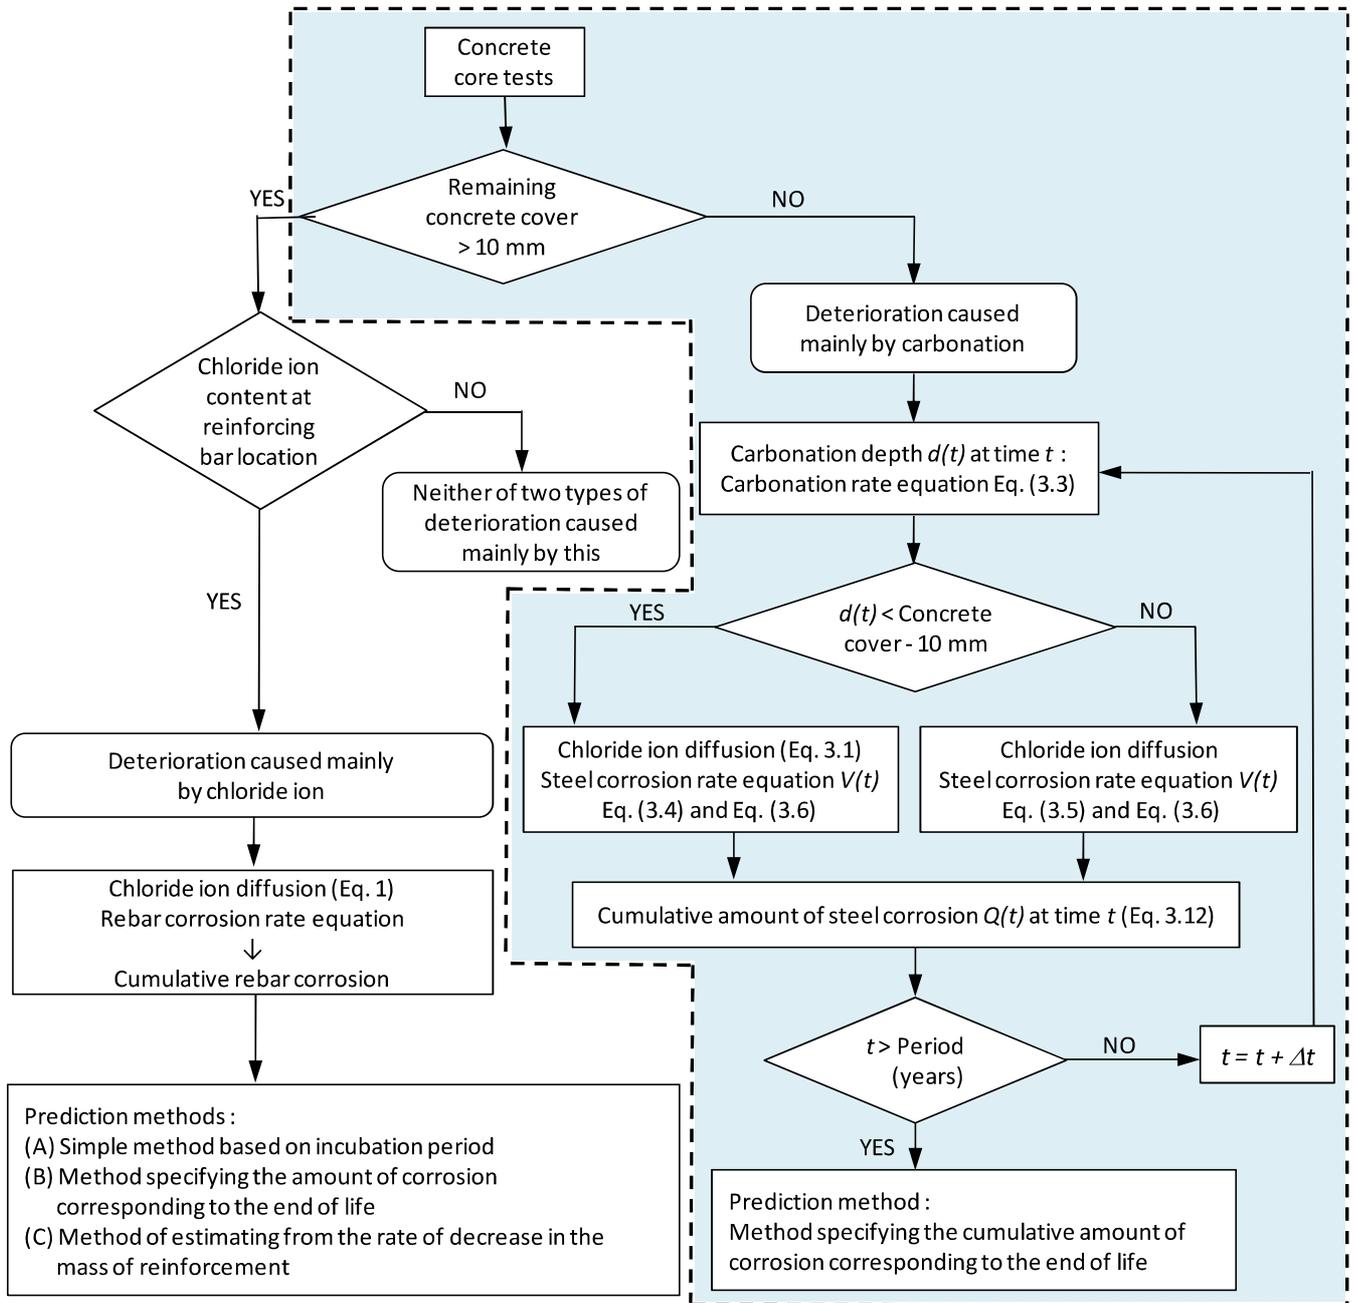
Fig. 3.11 Flowchart of remaining life prediction

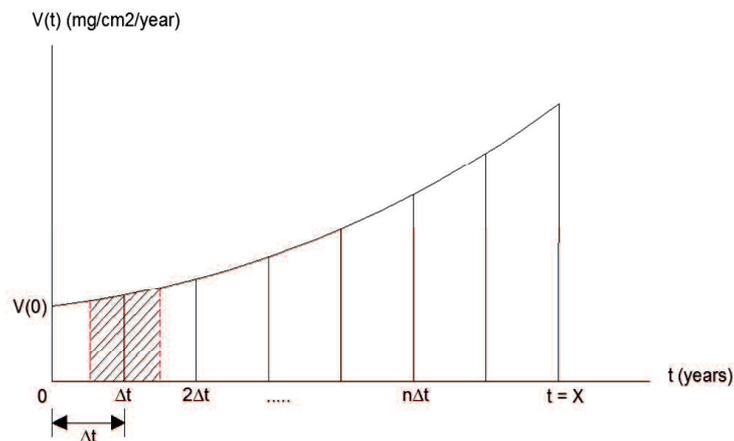
Fig. 3.12 Illustration of the basic equation to calculate  $Q$

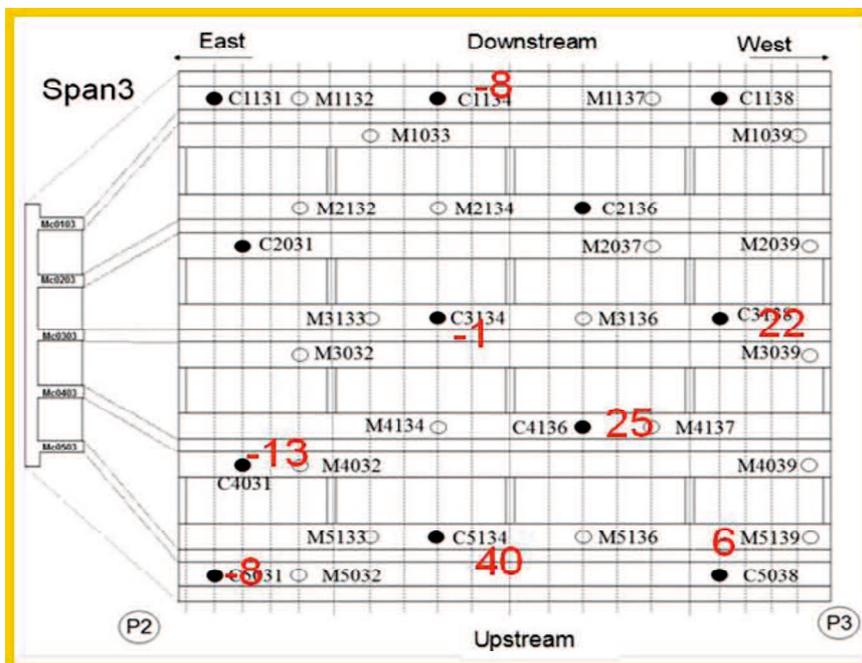
Fig. 3.13 Plotted of remaining life prediction based on the location of extracted concrete cores in Span 3 (1<sup>st</sup> case)

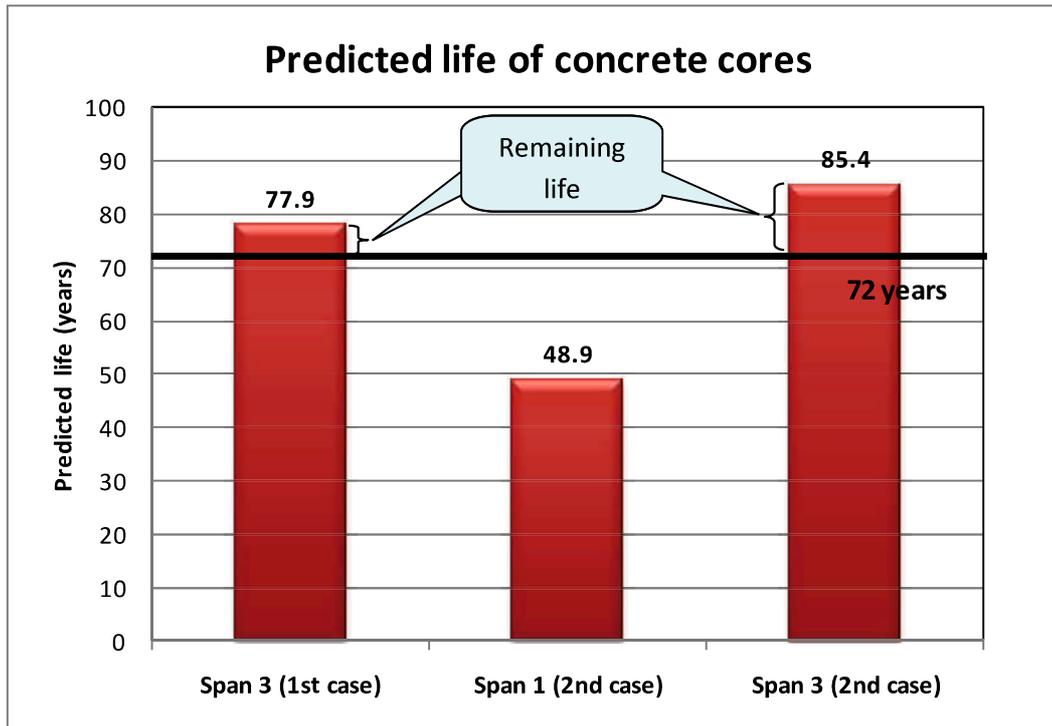
Fig. 3.16 Comparison of predicted life of extracted concrete cores between 1<sup>st</sup> case and 2<sup>nd</sup> cases.

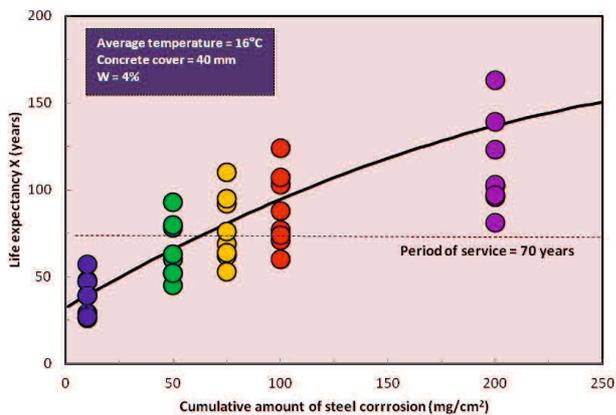
Fig. 3.17 Relationship between assumed cumulative amount of steel corrosion ( $Q$ ) and life expectancy ( $X$ )

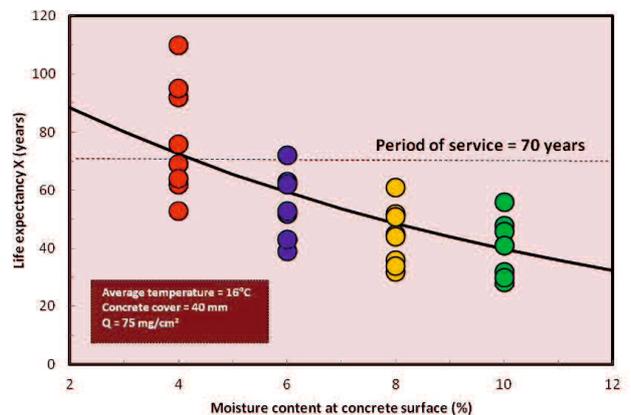
Fig. 3.18 Influence of moisture content ( $W$ ) on life expectancy( $X$ )

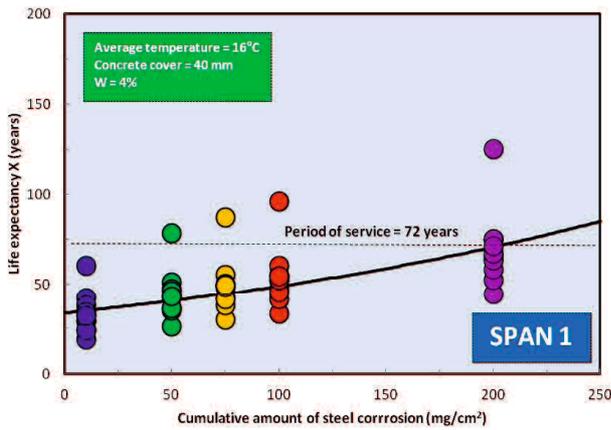
Fig. 3.19 Relationship between assumed cumulative amount of steel corrosion ( $Q$ ) and life expectancy ( $X$ )

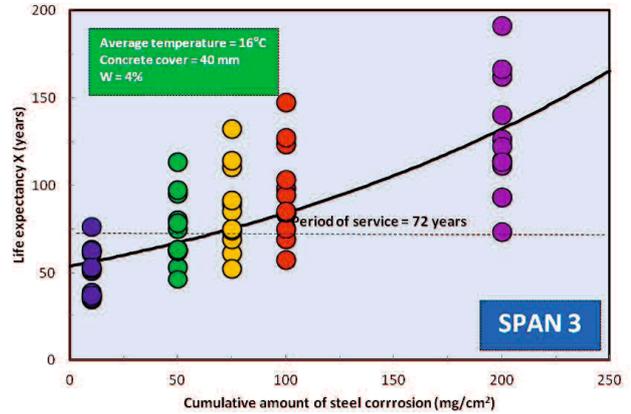
Fig. 3.20 Relationship between assumed cumulative amount of steel corrosion ( $Q$ ) and life expectancy ( $X$ )

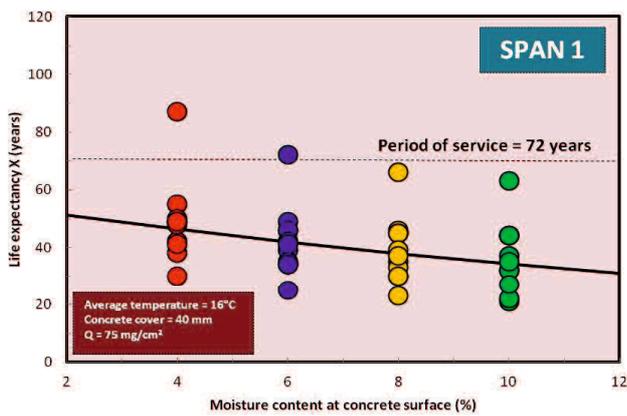
Fig. 3.21 Influence of moisture content ( $W$ ) on life expectancy ( $X$ )

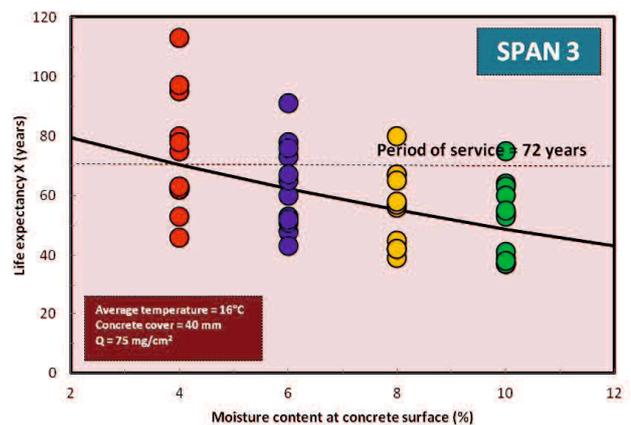
Fig. 3.22 Influence of moisture content ( $W$ ) on life expectancy ( $X$ )

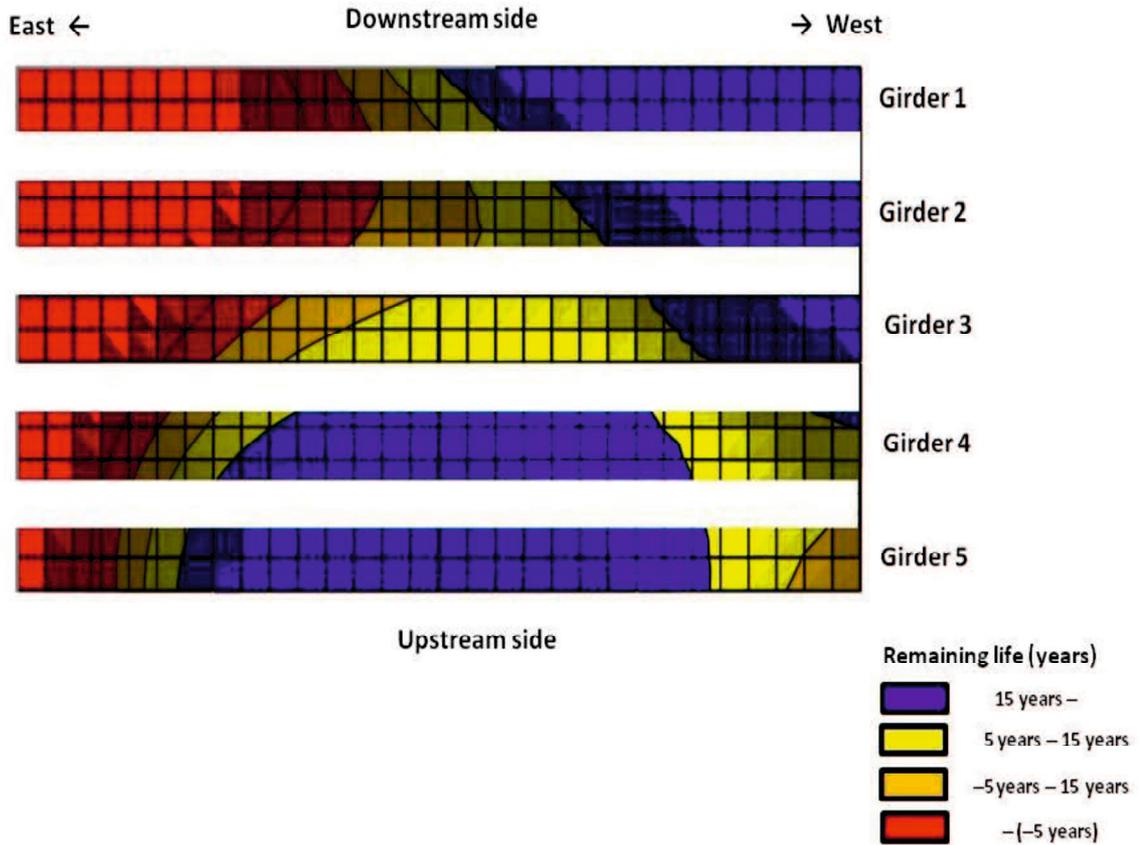
Fig. 3.23 In-span distribution of remaining life of main girder in case where only Type (c) distribution in Fig. 3.9 is involved

predicted remaining life with a certain level of accuracy are available, those results including distribution visualizations such as Figs. 3.23 and 3.24 can be used for evaluation of the entire spans.

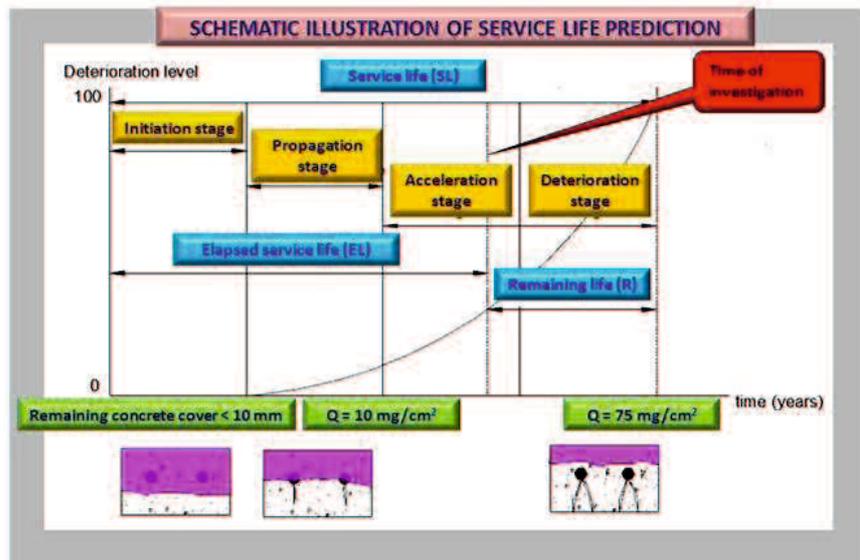
Fig. 4.1 Schematic illustration of service life prediction

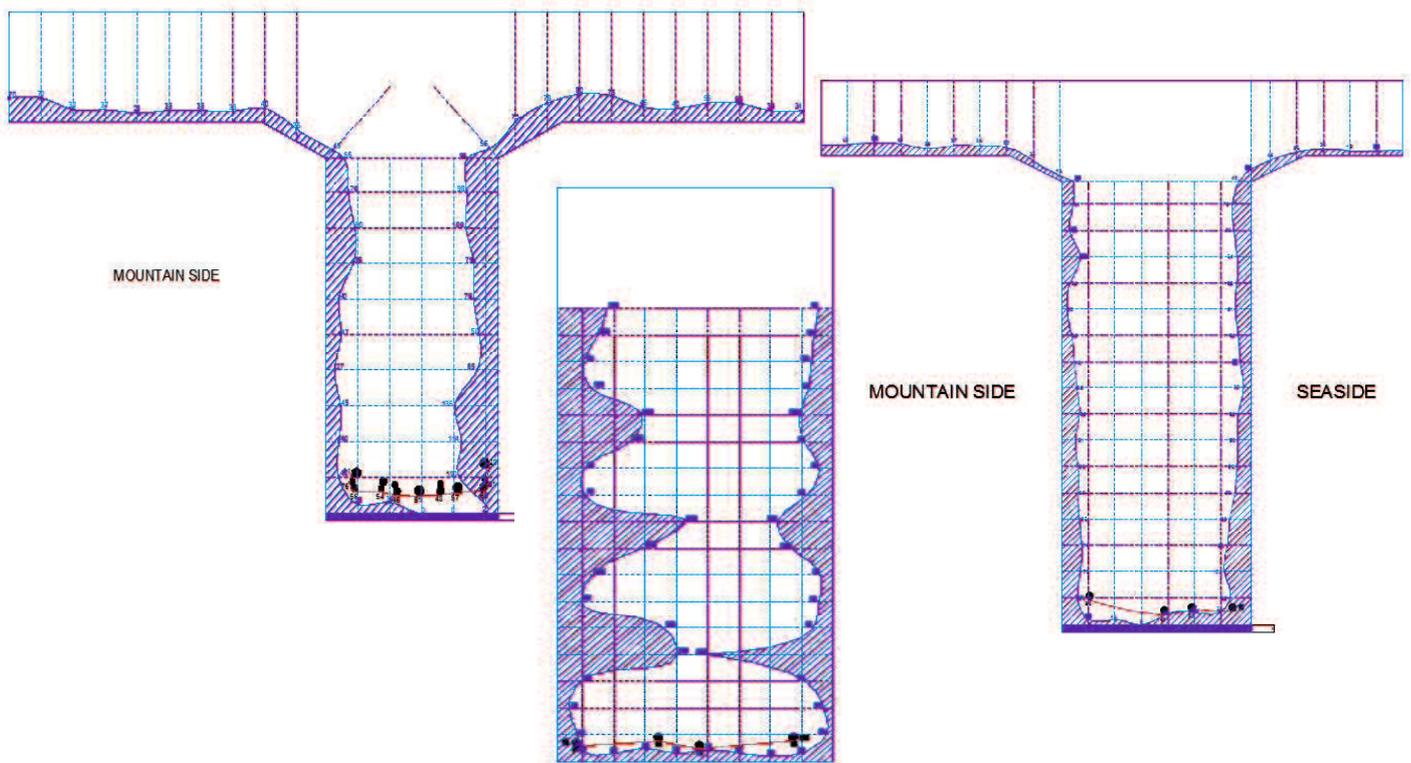
Fig. 4.5 Sketch of cross-section cutting-off girder of SK-Bridge

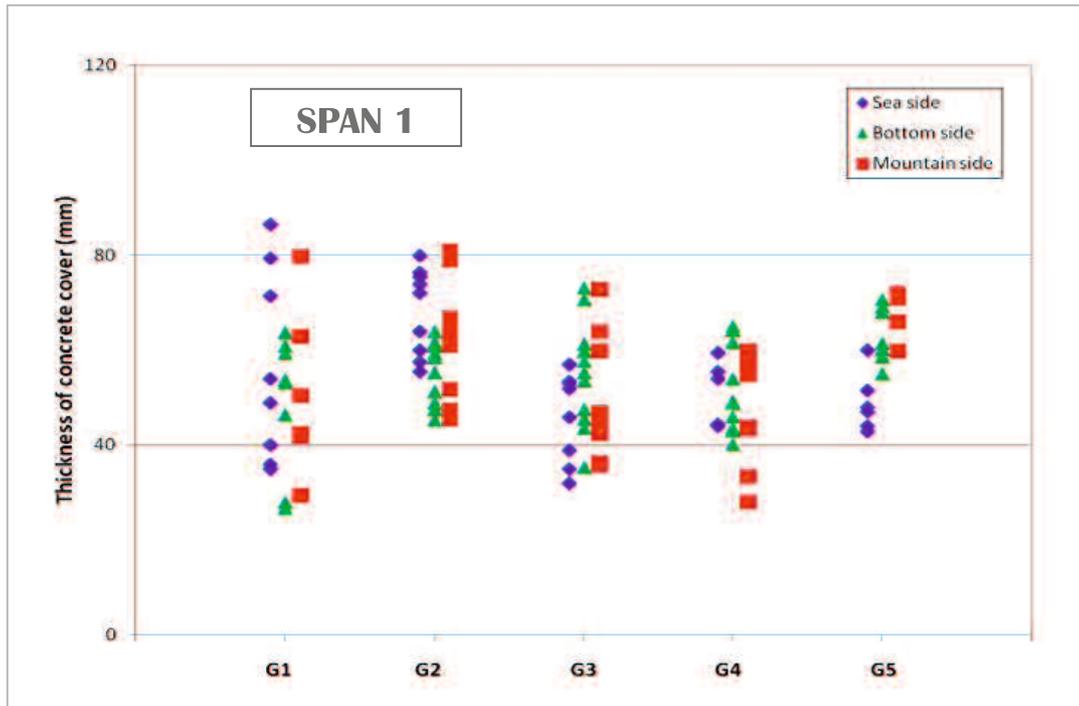
Fig 4.13 Thickness of concrete cover in Span 1

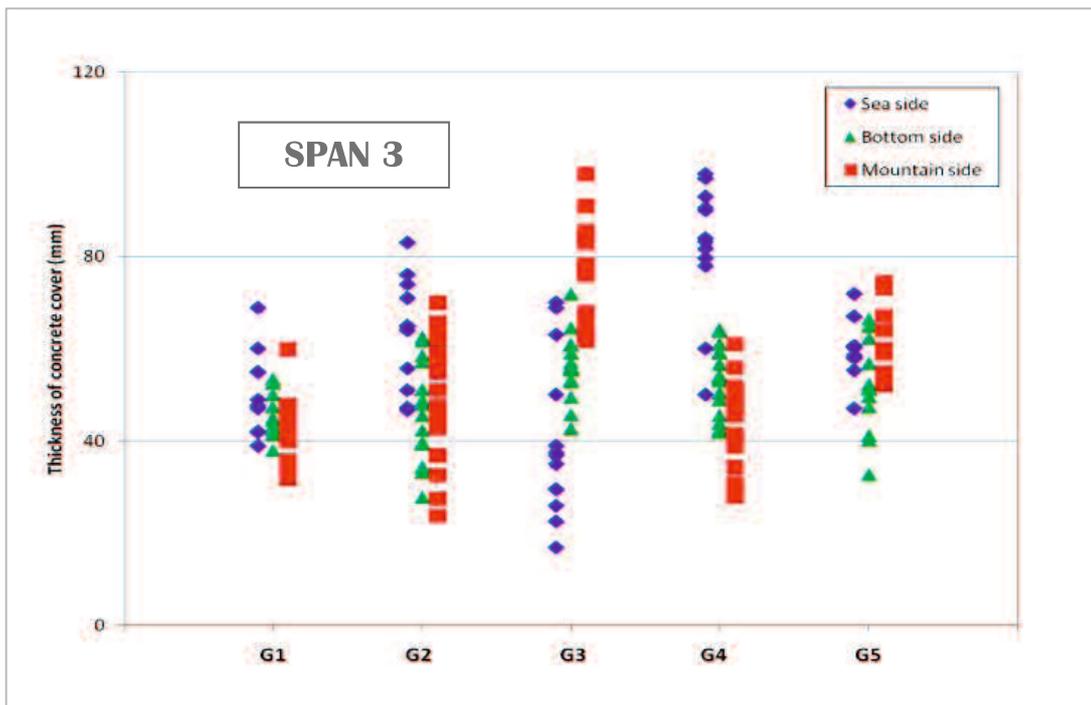
Fig. 4.14 Thickness of concrete cover in Span 3

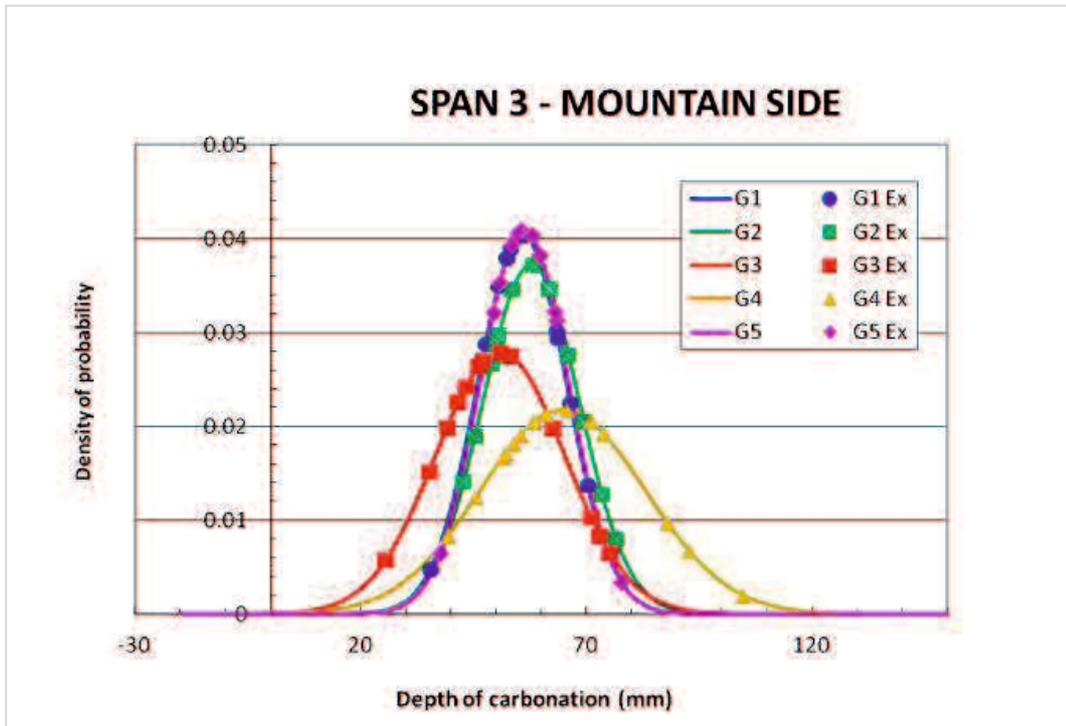
Fig. 4.27 Normal distribution of the carbonation in Span 3 mountain side

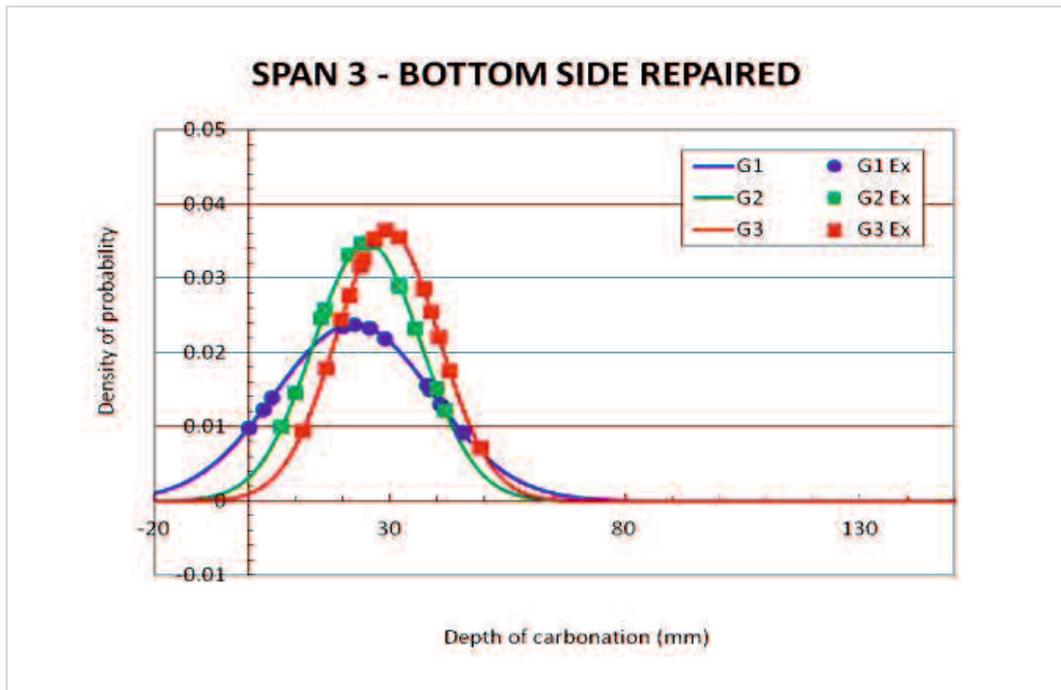
Fig. 4.28 Normal distribution of the carbonation in Span 3 bottom side (repaired)
