**Doctoral Dissertation**

**DEVELOPMENT OF A METHOD OF  
REMAINING LIFE PREDICTION FOR AN AGED BRIDGE BASED ON  
CONCRETE CORES AND CROSS-SECTION  
CUTTING-OFF GIRDERS**

**RATNA WIDYAWATI**

**Department of Environmental Science and Engineering  
Graduate School of Science and Engineering  
Yamaguchi University, Japan  
March, 2015**

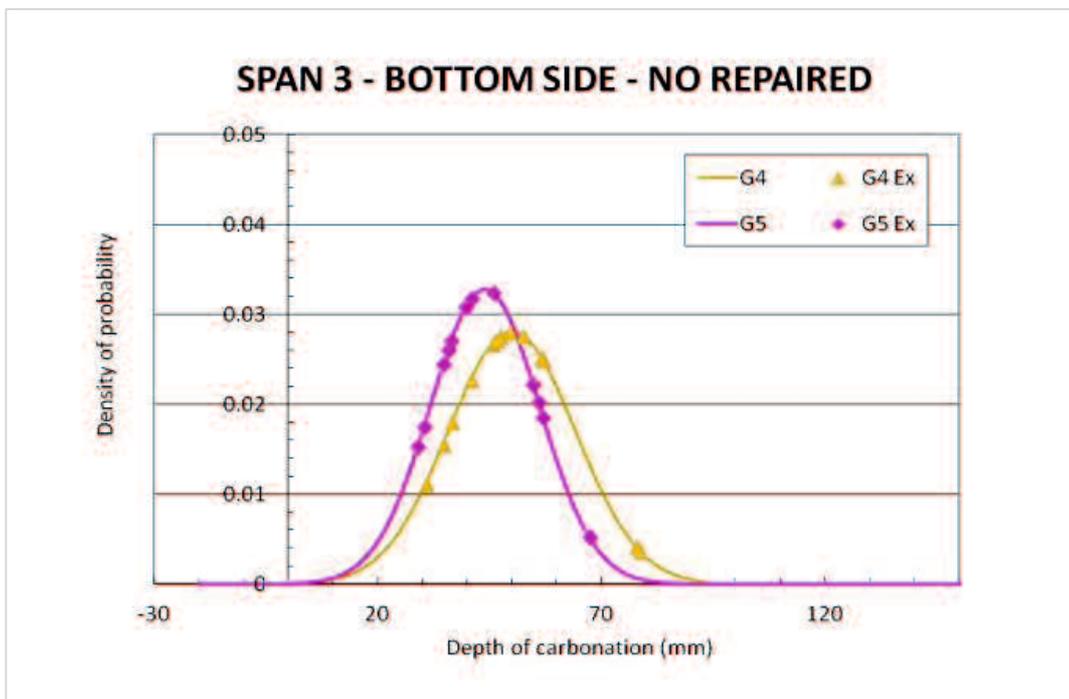
Fig. 4.29 Normal distribution of the carbonation in Span 3 bottom side (no repaired)

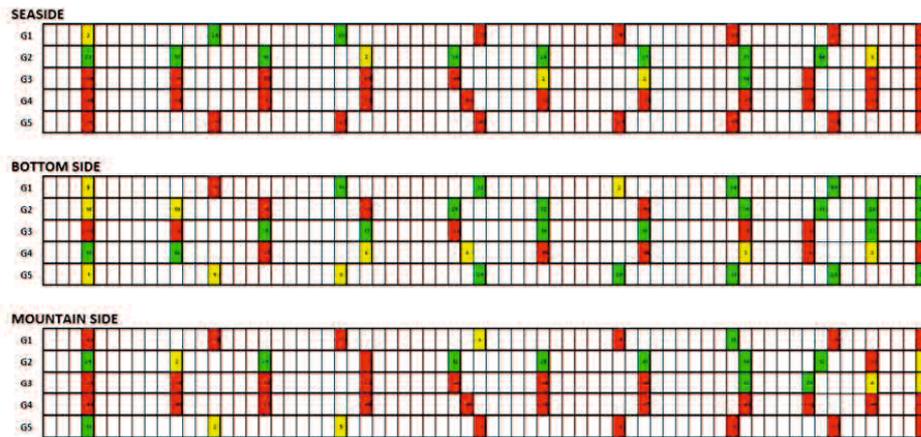
Fig. 4.30 Remaining concrete cover of Span 1

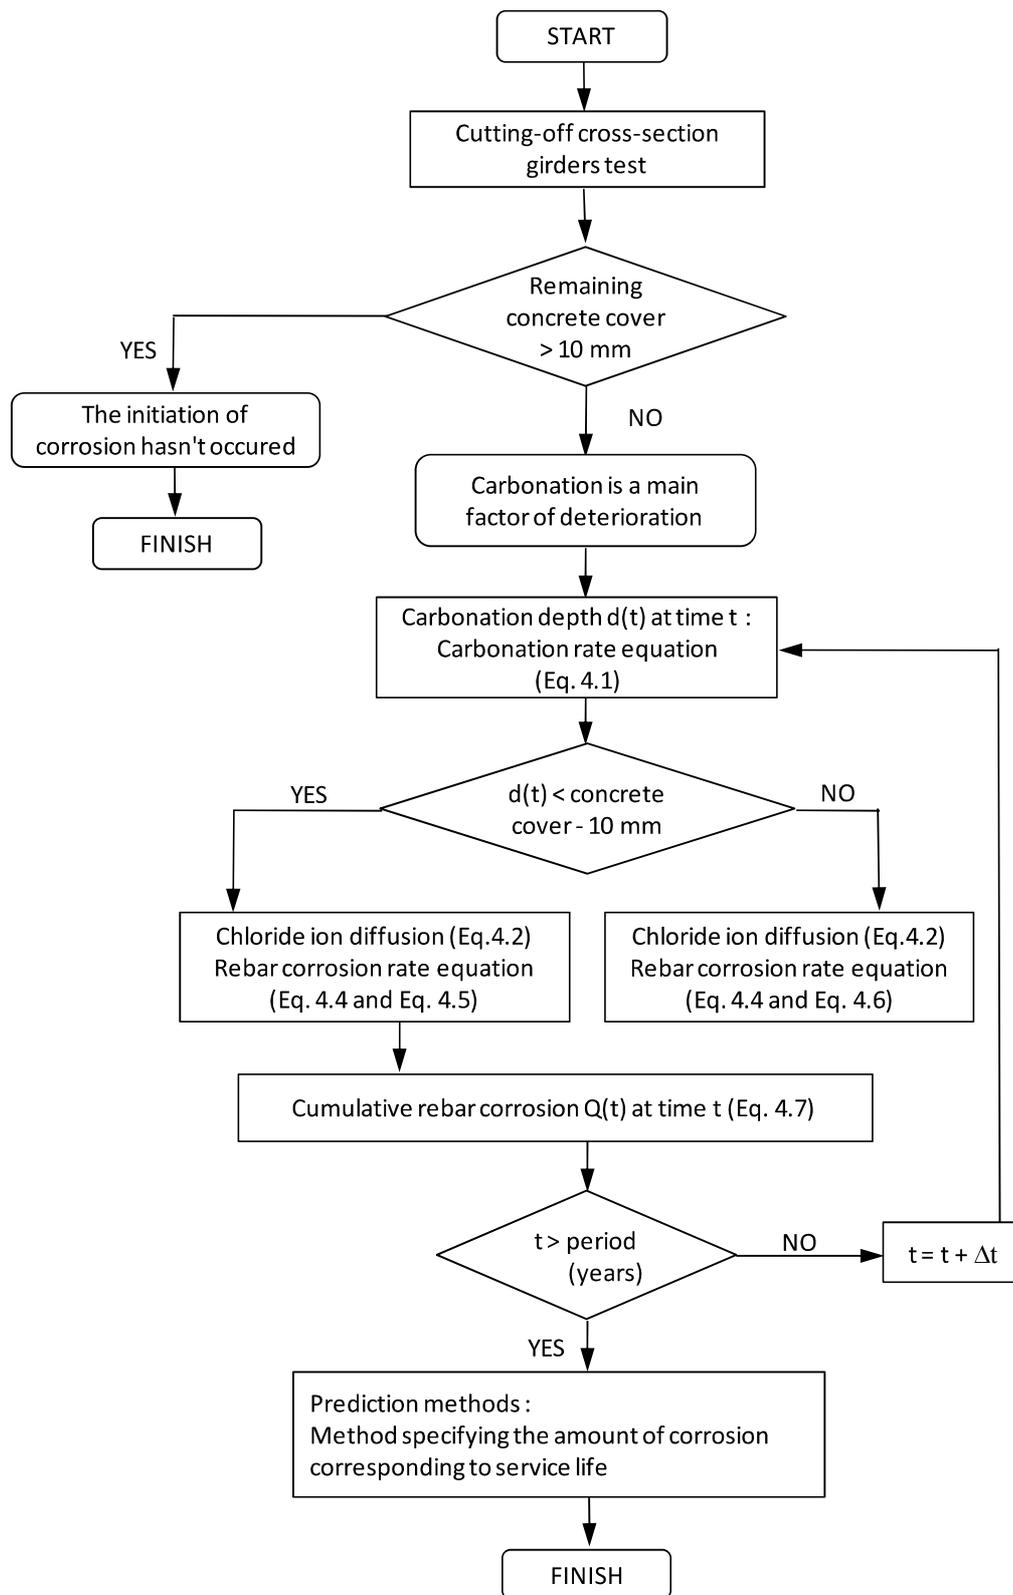
Fig. 4.32 Flowchart of remaining life prediction in this study

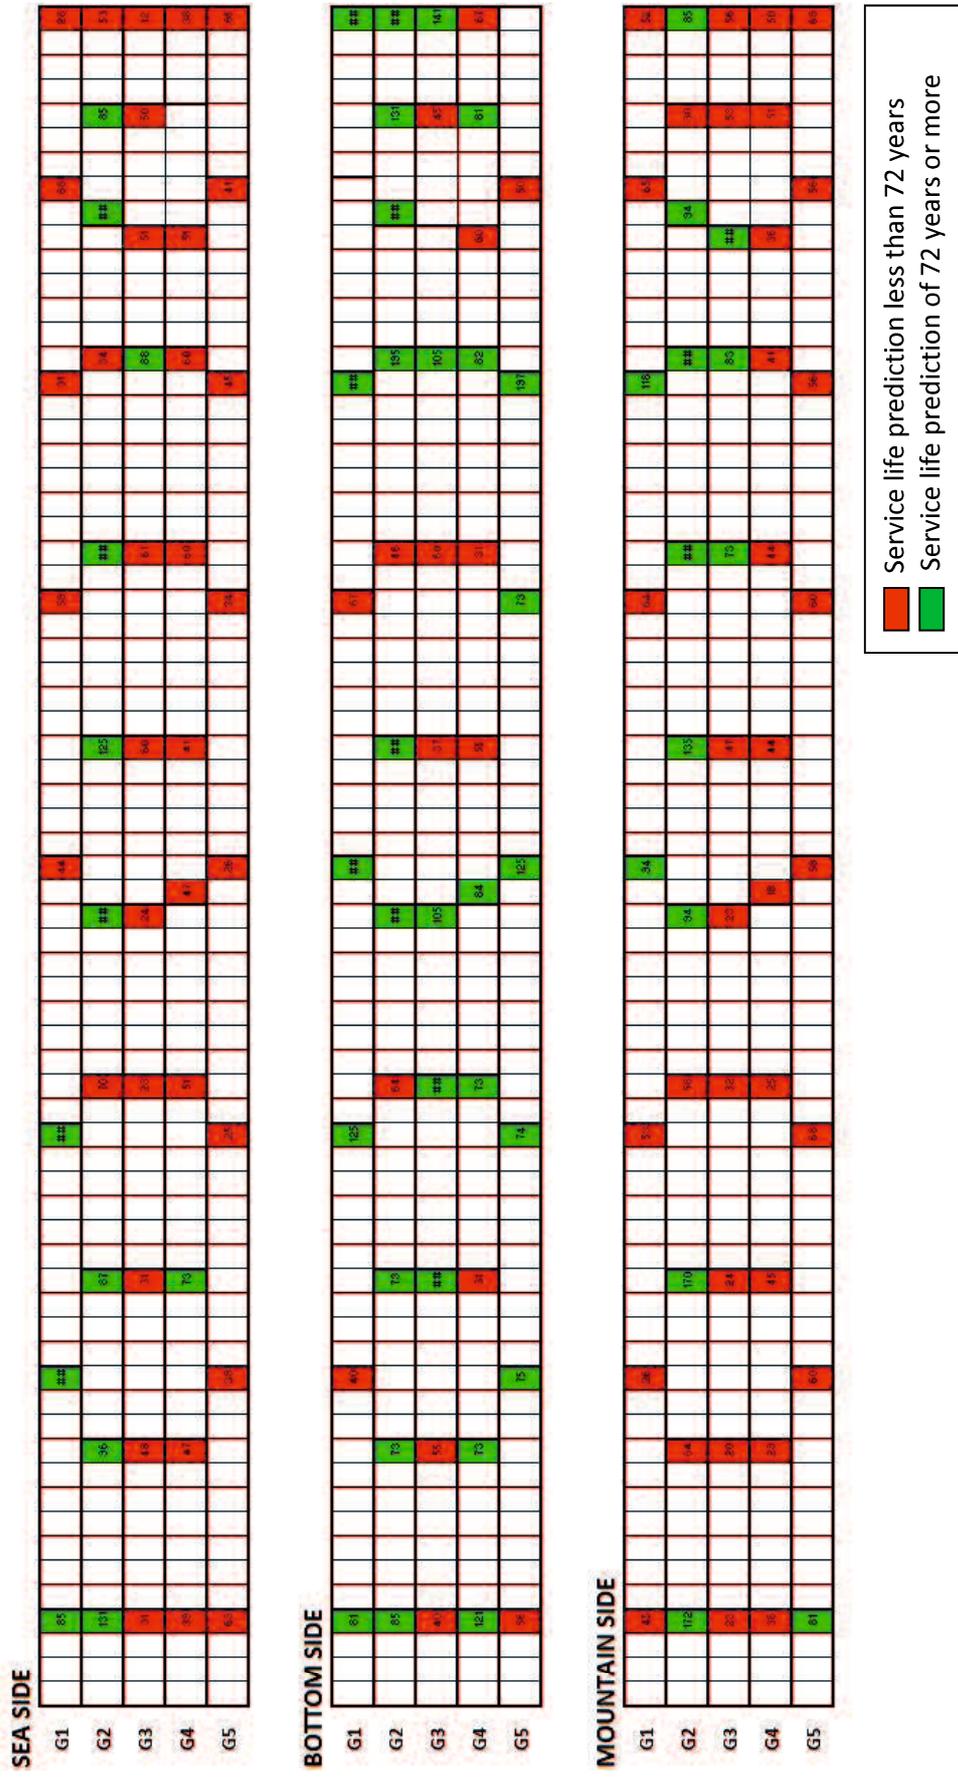
Fig. 4.33 Service life prediction due to carbonation and chloride ion of Span 1

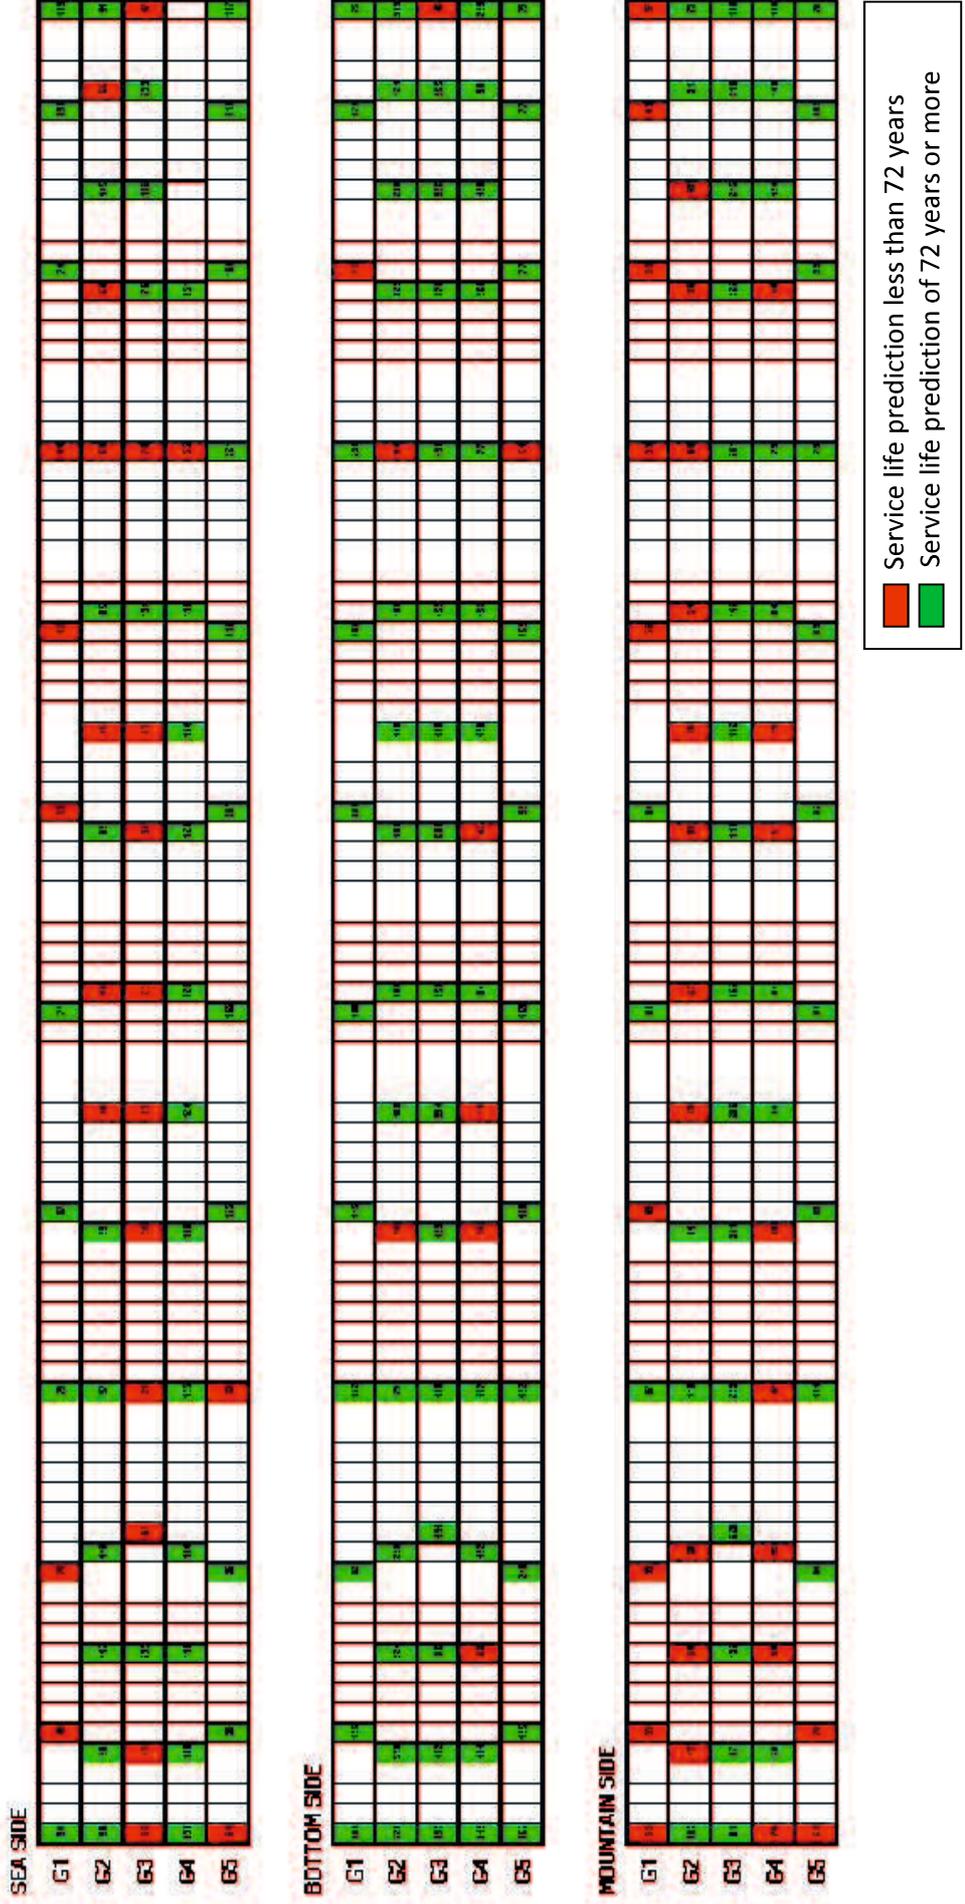
Fig. 4.34 Service life prediction due to carbonation and chloride ion of Span 3

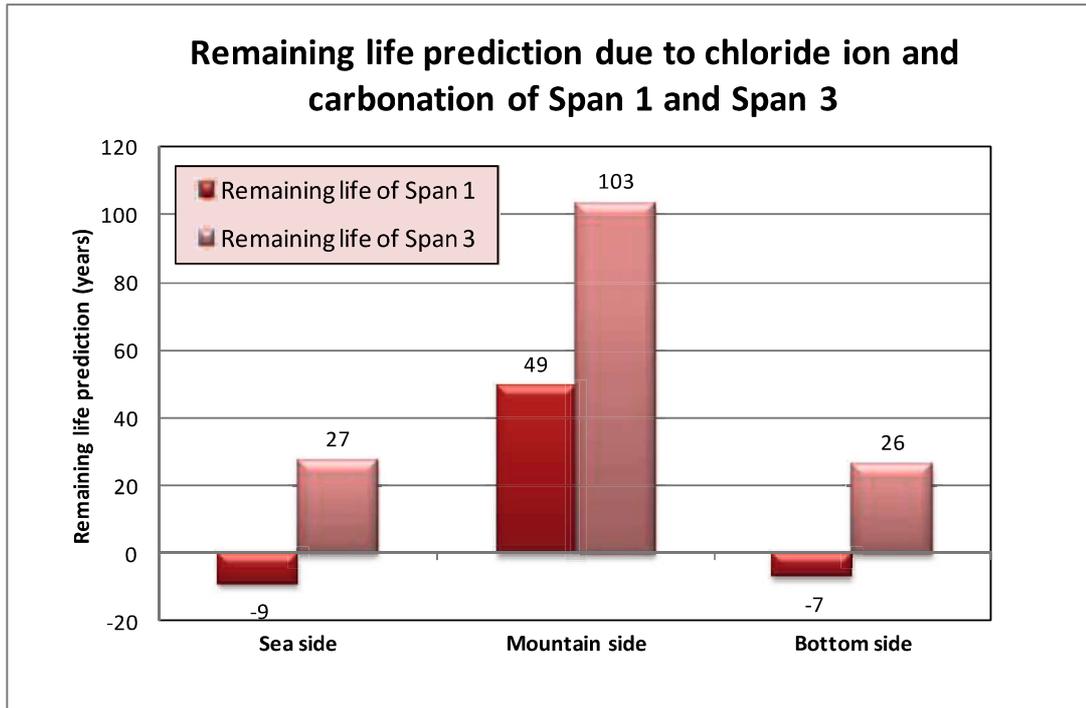
Fig. 4.35 Remaining life prediction due to carbonation and chloride ion of Span 1 and Span 3

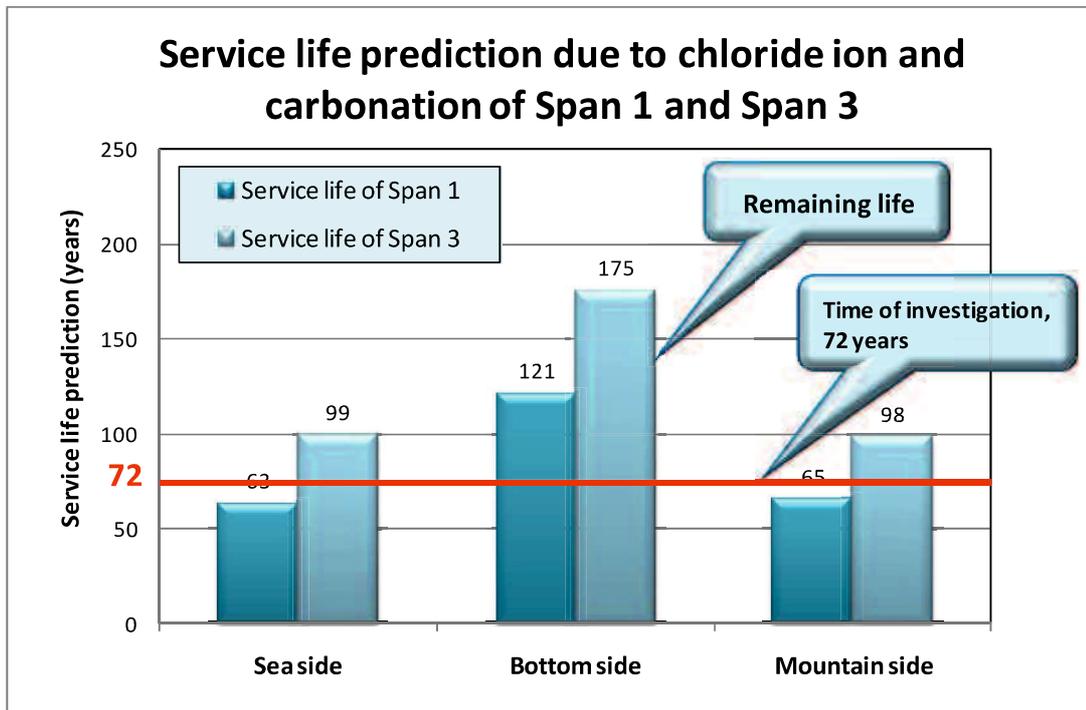
Fig. 4.36 Service life prediction due to carbonation and chloride ion of Span 1 and Span 3

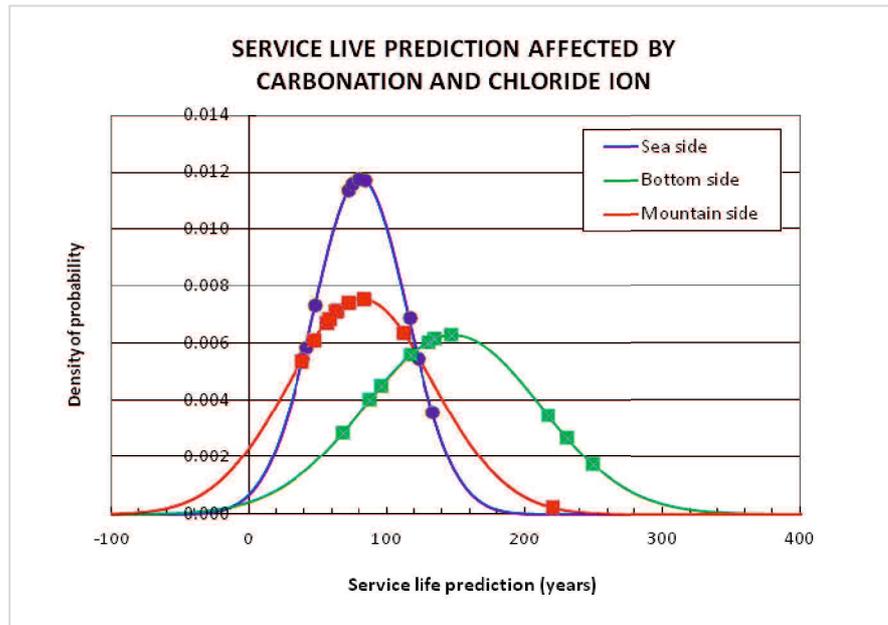
Fig. 4.37 Normal distribution of service life prediction due to carbonation and chloride ion in Spans 1 and 3

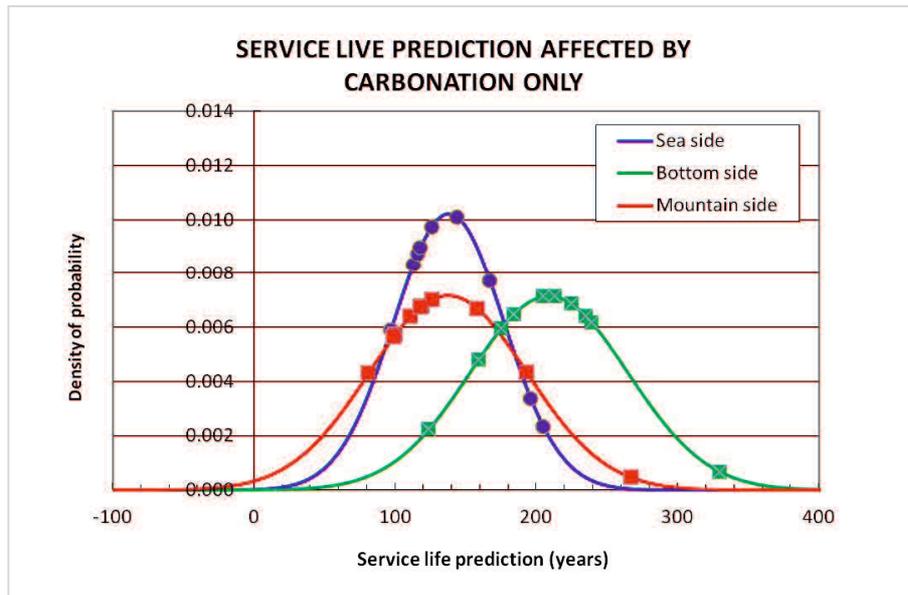
Fig. 4.38 Normal distribution of service life prediction due to carbonation only in Spans 1 and 3

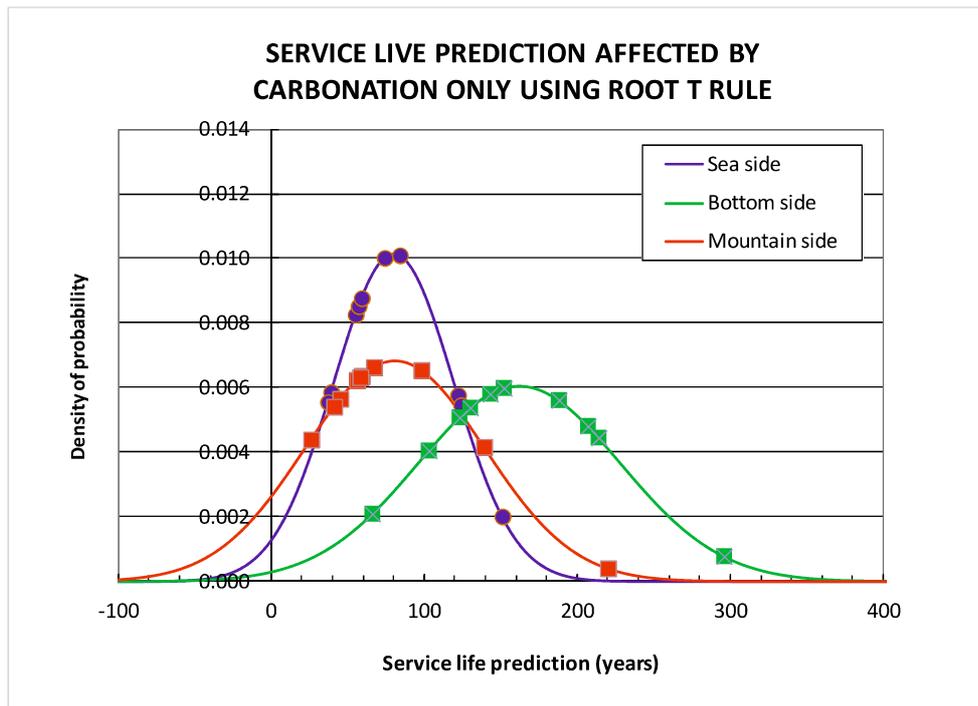
Fig. 4.39 Normal distribution of service life prediction due to carbonation only in Spans 1 and 3 calculated using the  $\sqrt{t}$  rule

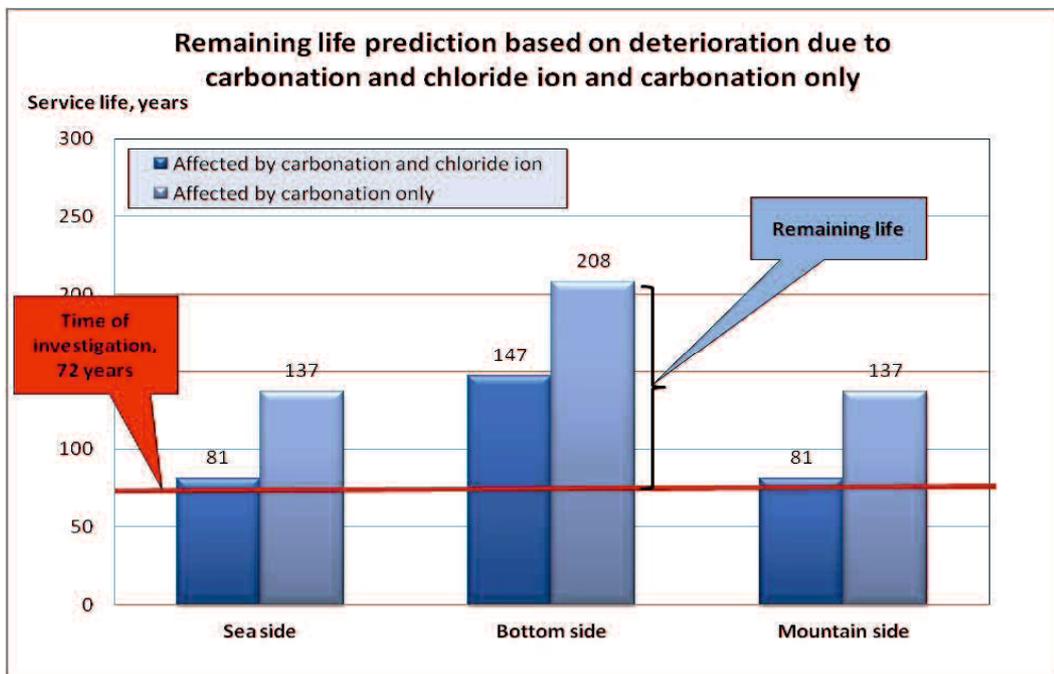
Fig. 4.40 Comparison of remaining life prediction due to carbonation and chloride ion and carbonation only of Span 1 and Span 3

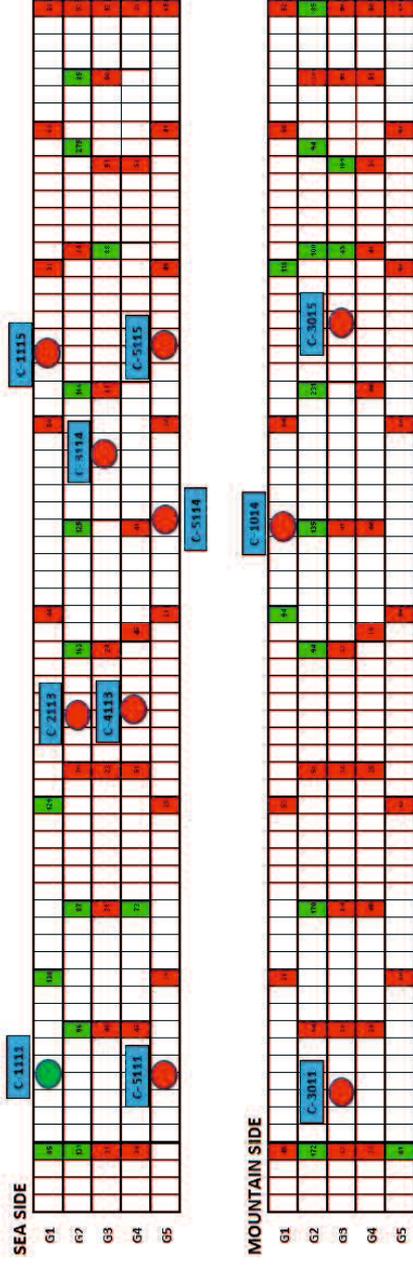
Fig. 5.2 Service life prediction of concrete cores of Span 1

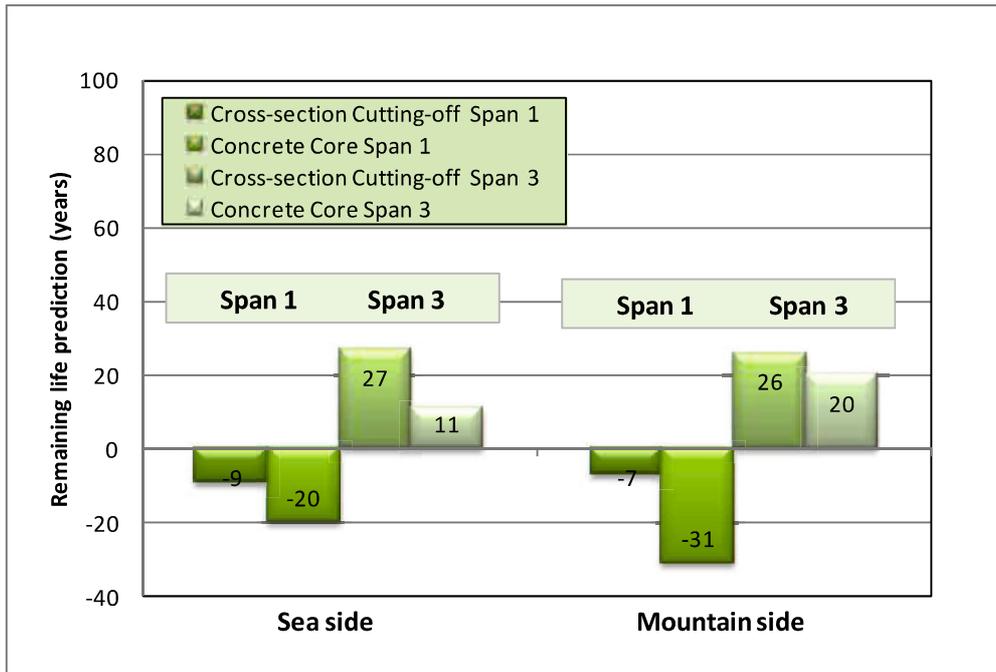
Fig. 5.4 Comparison of remaining life prediction results between concrete cores and cross-section cutting-off girders in both Spans 1 and 3 on average

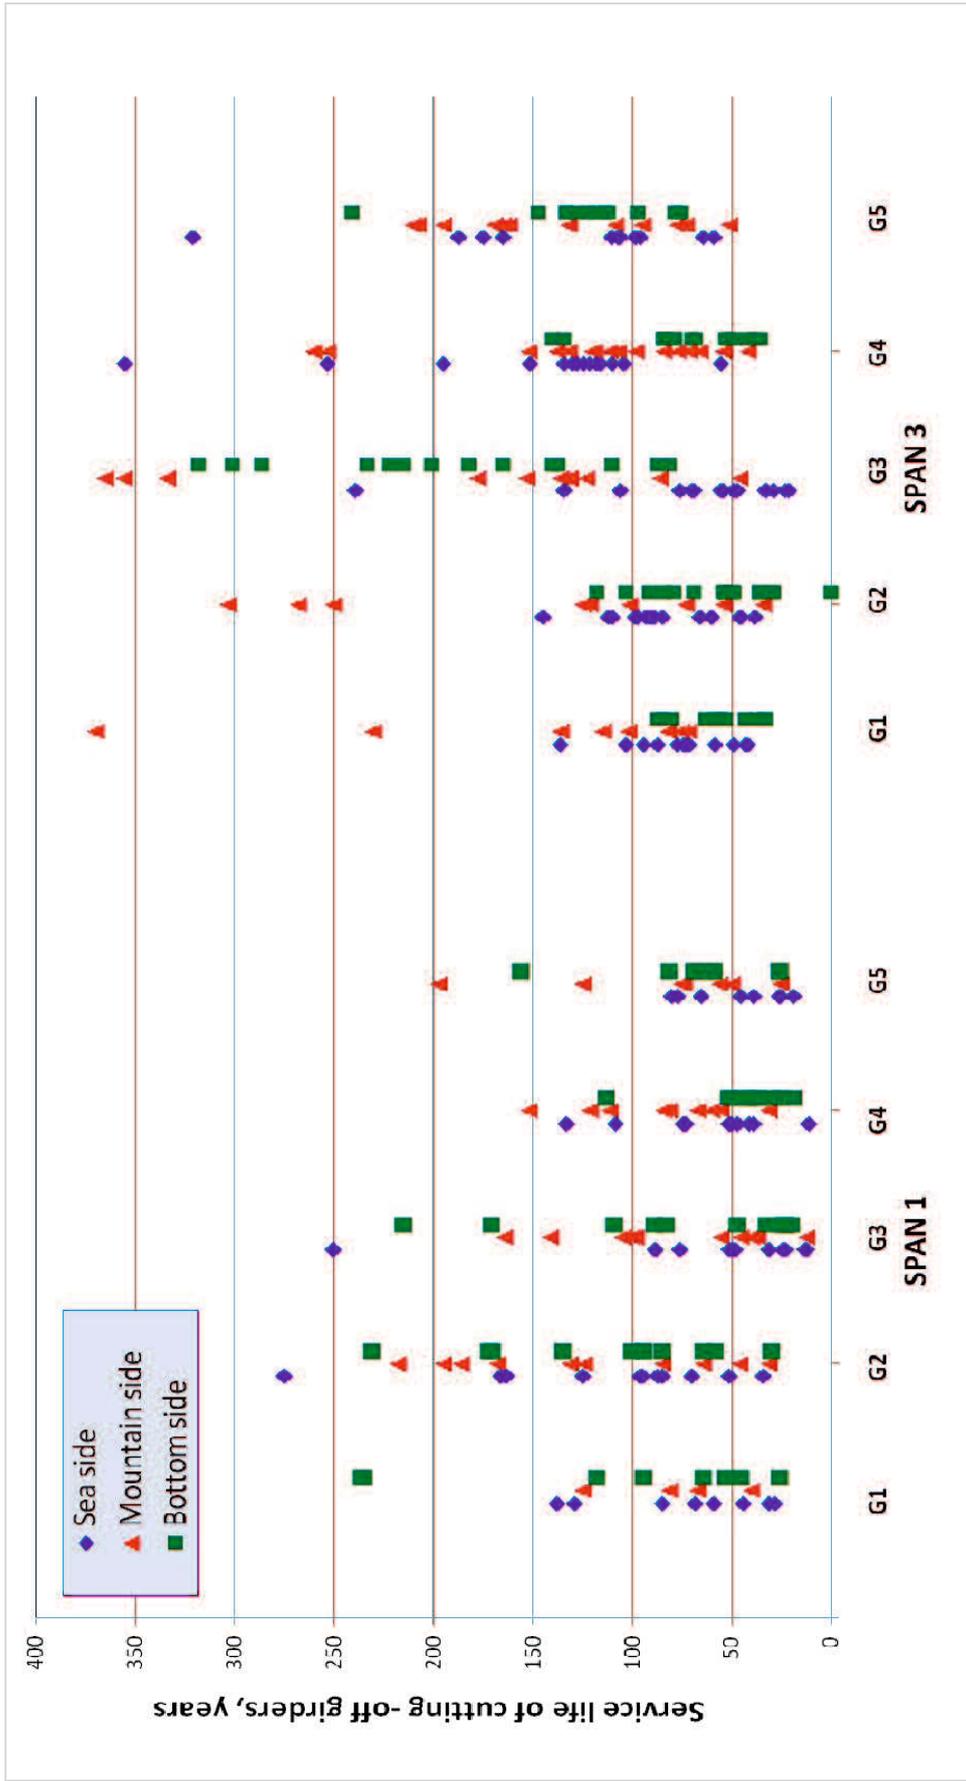
Figure 5.9 Comparison between distribution of service life prediction of cross-section cutting-off girders in Span 1 and Span 3 based on the location of girders of each span

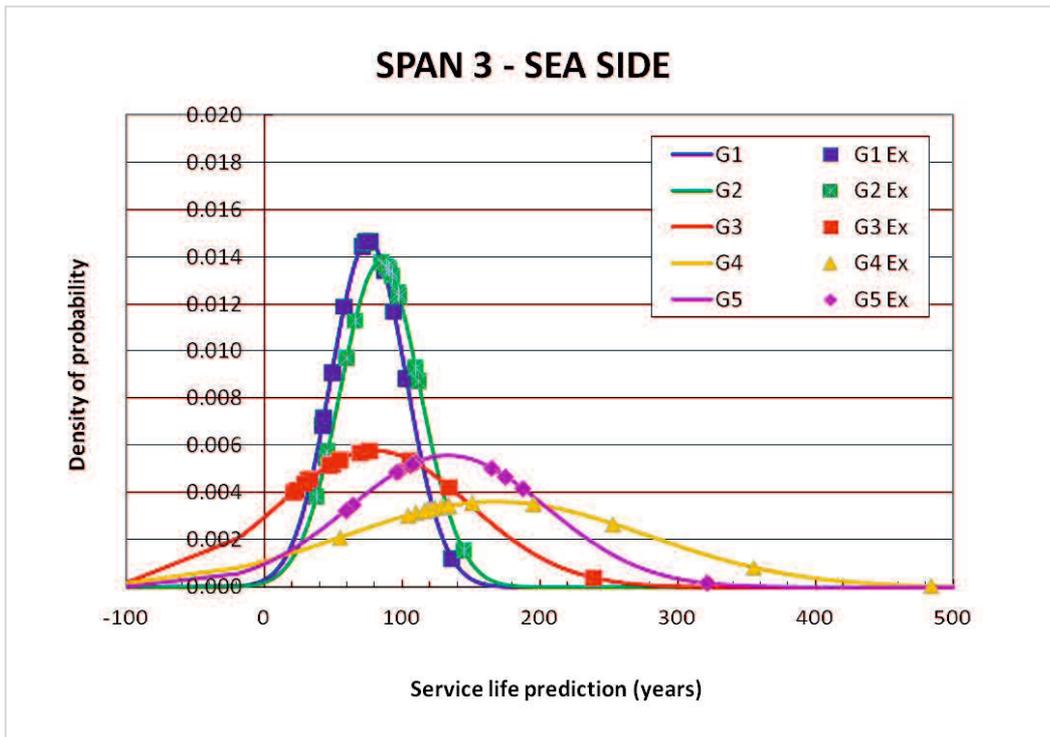
Figure 5.11 Normal distribution of service life prediction in Span 3 sea side

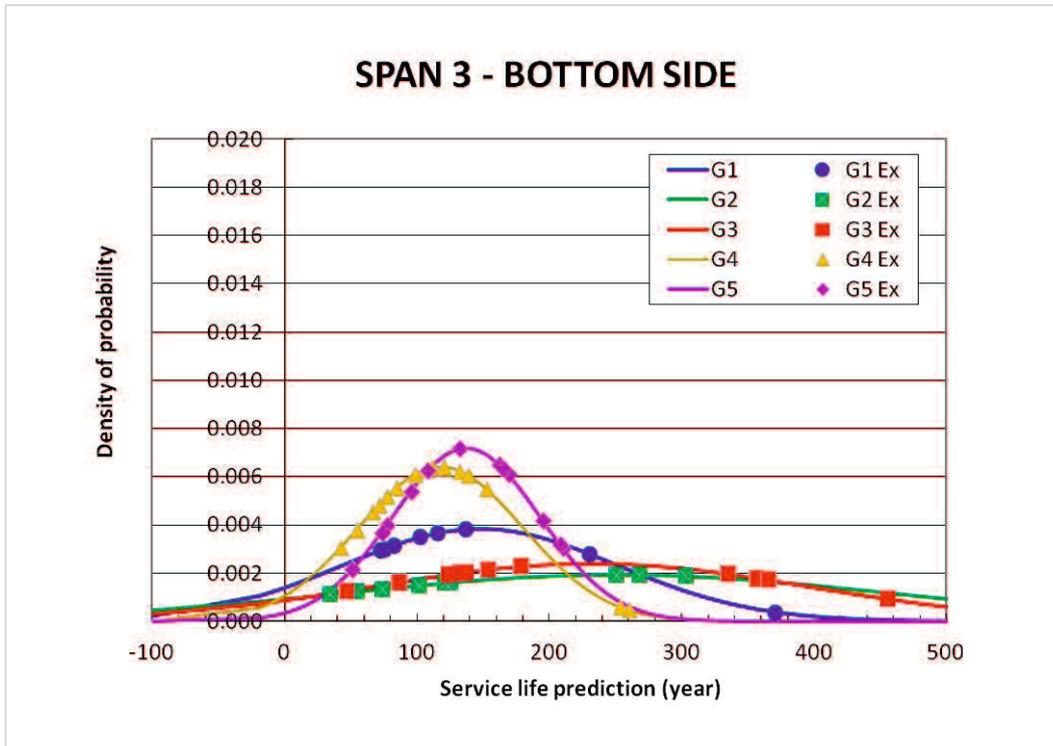
Figure 5.13 Normal distribution of service life prediction in Span 3 bottom side

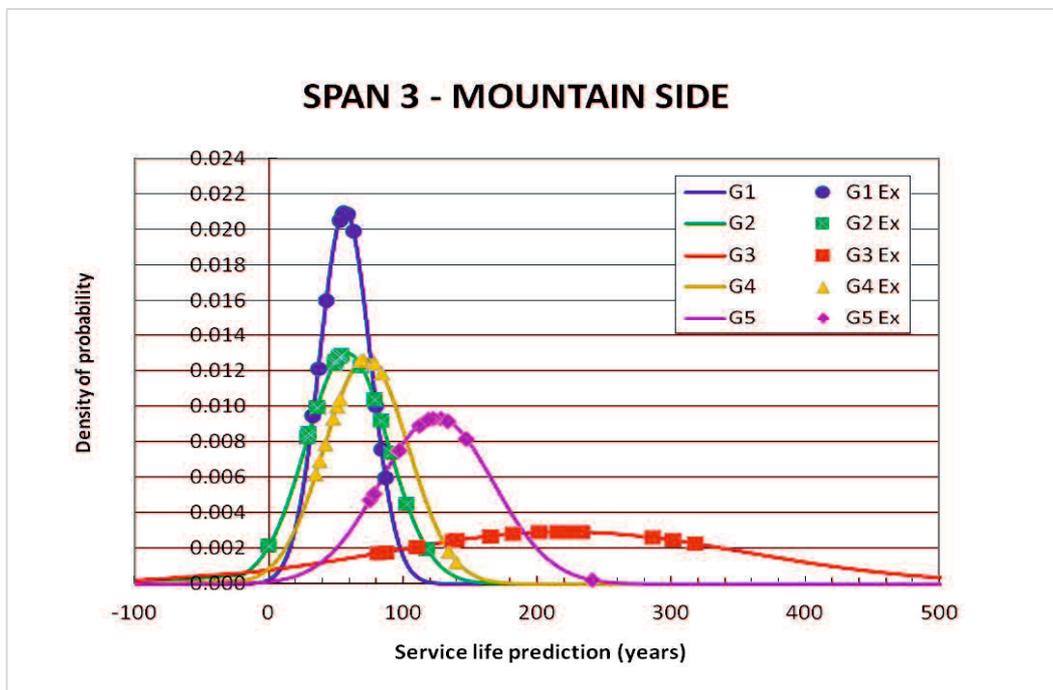
Figure 5.15 Normal distribution of service life prediction in Span 3 mountain side

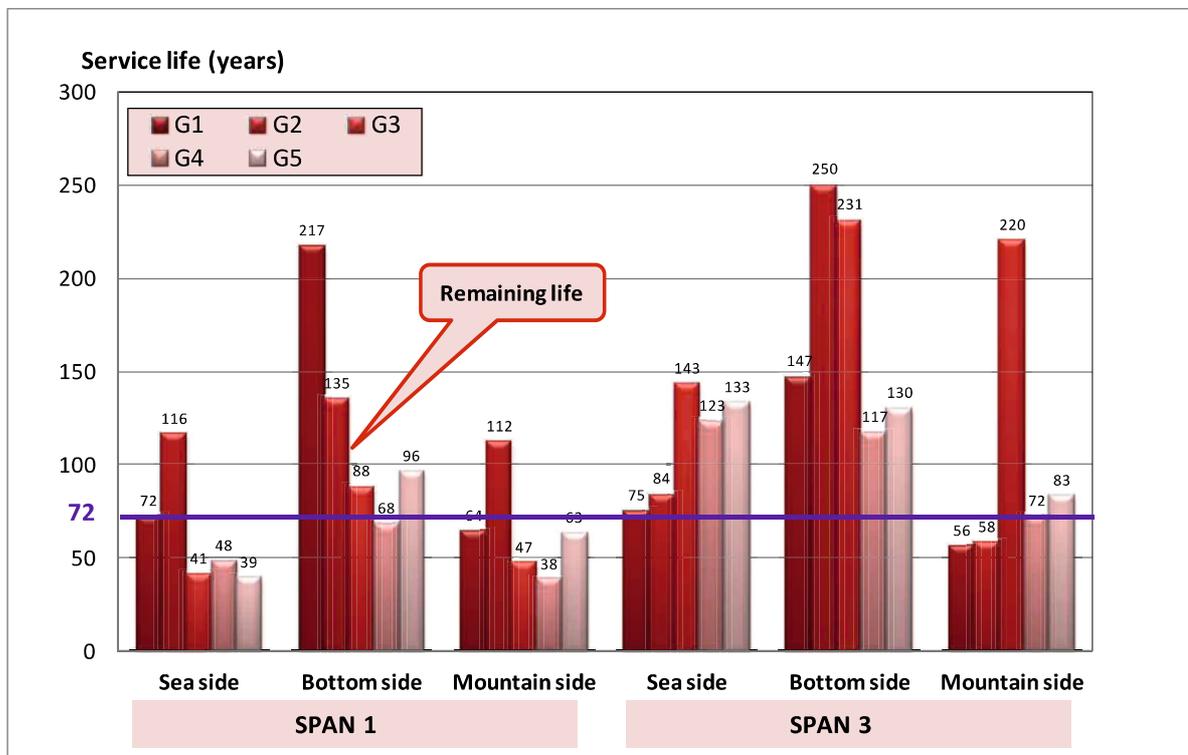
Figure 5.16 Comparison of remaining life prediction of cross-section cutting-off girders in Span 1 and Span 3 based on the location of girders of each span

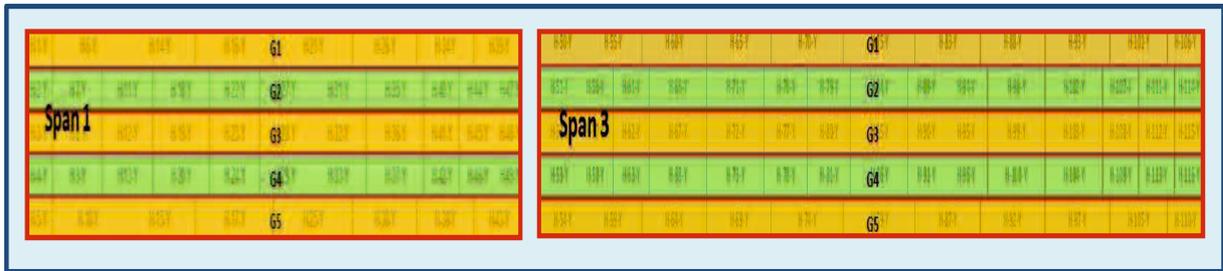
Figure 5.17 Merged girders of spans 1 and 3 based on the location of girders

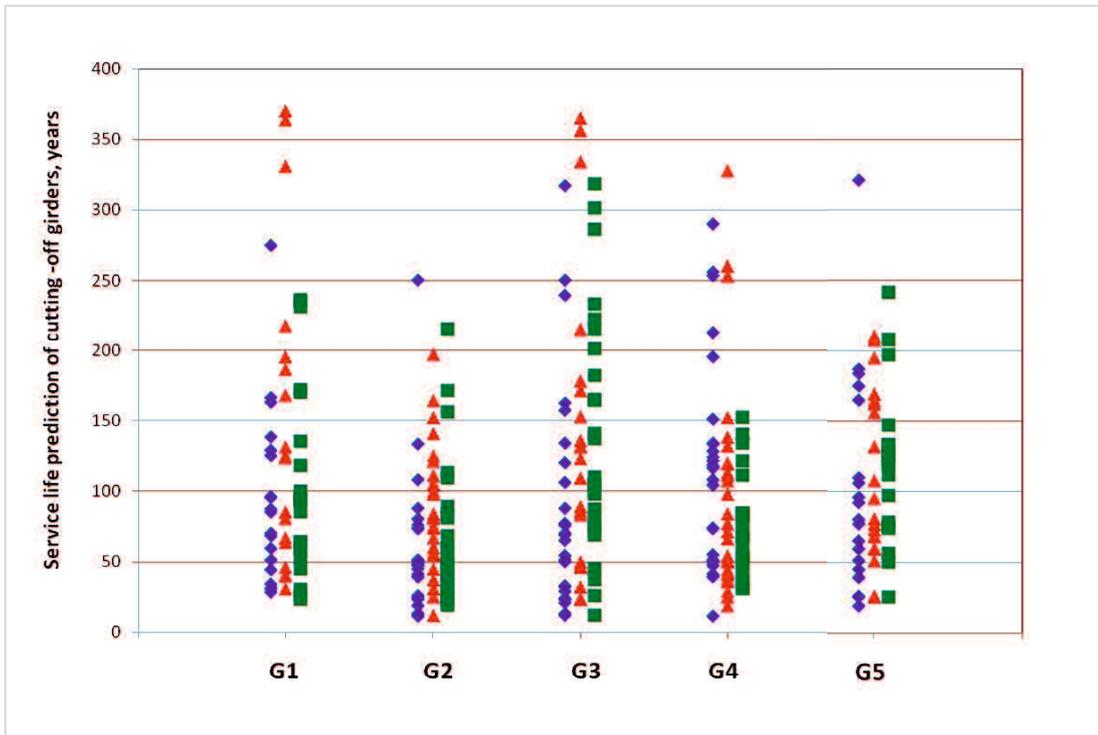
Figure 5.18 Service life distributions of the merged girders of spans 1 and 3

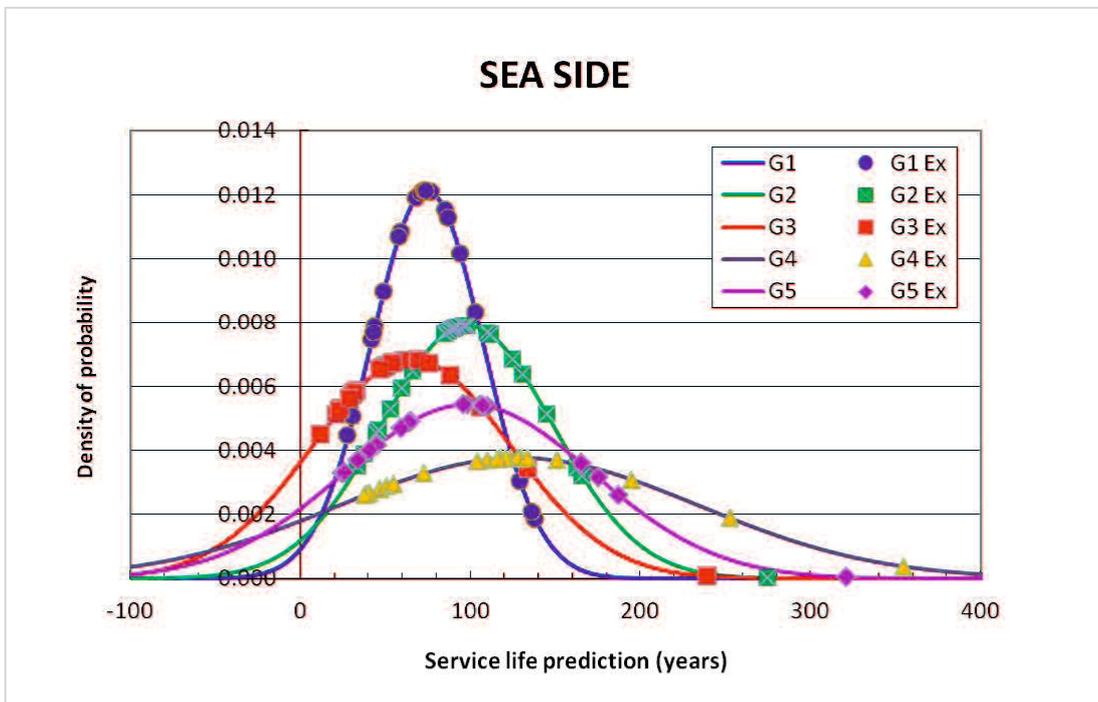
Figure 5.19 Normal distribution of service life prediction of spans 1 and 3 sea side

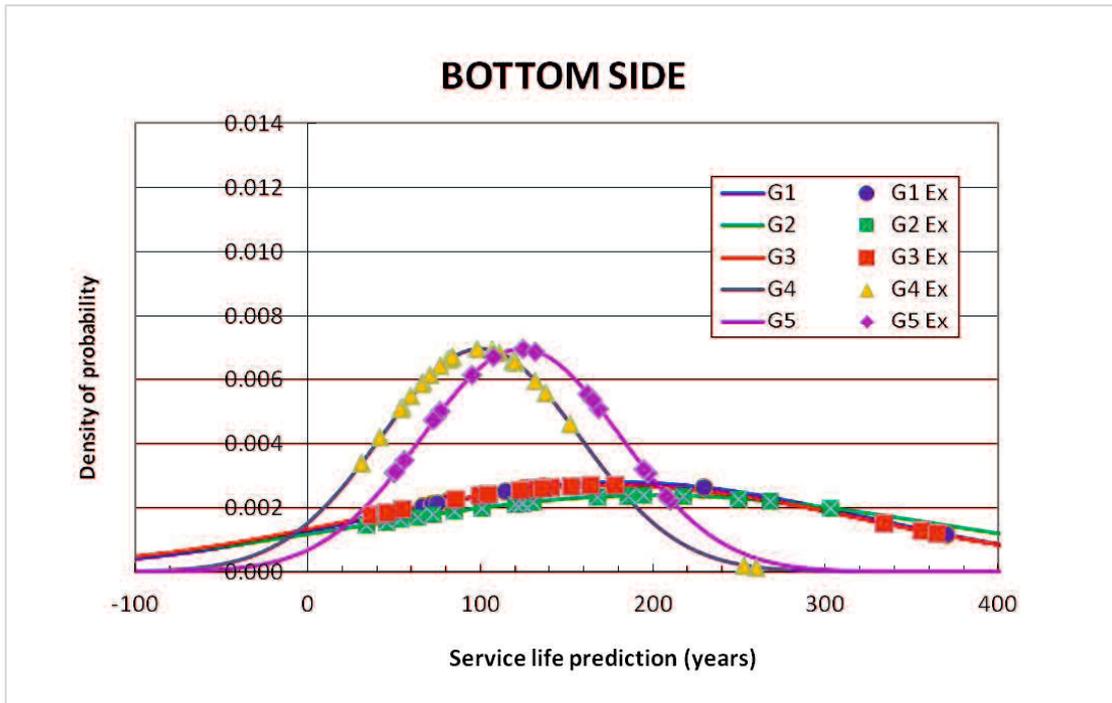
Figure 5.20 Normal distribution of service life prediction of Spans 1 and 3 bottom side

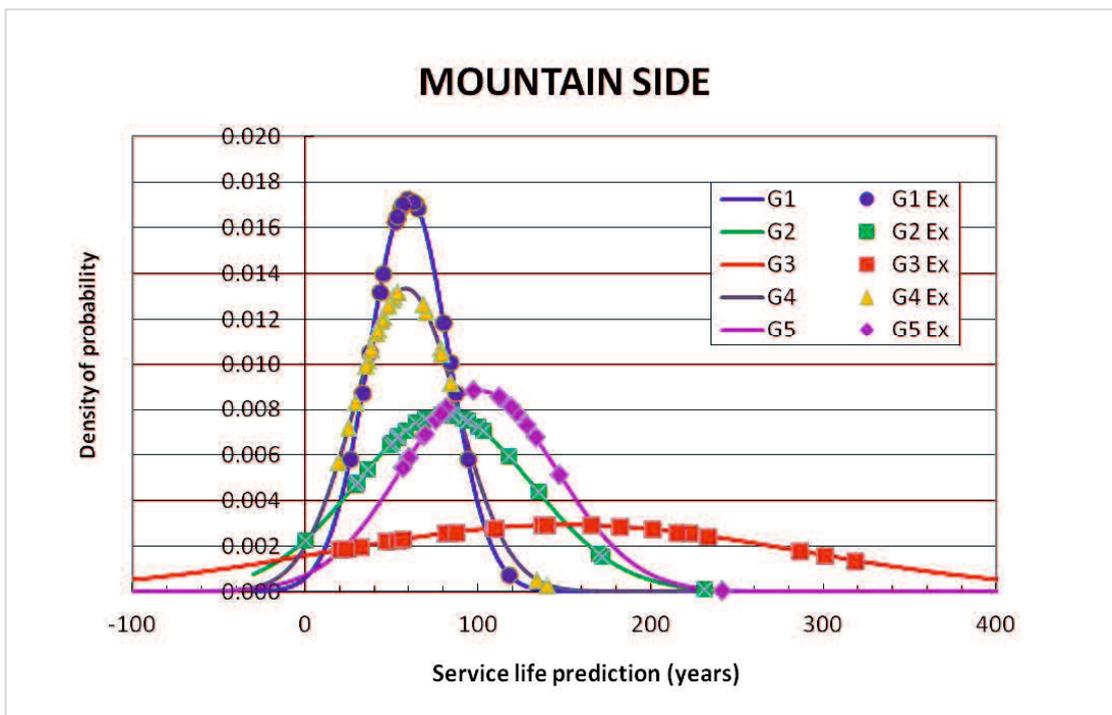
Figure 5.21 Normal distribution of service life prediction of Spans 1 and 3 mountain side

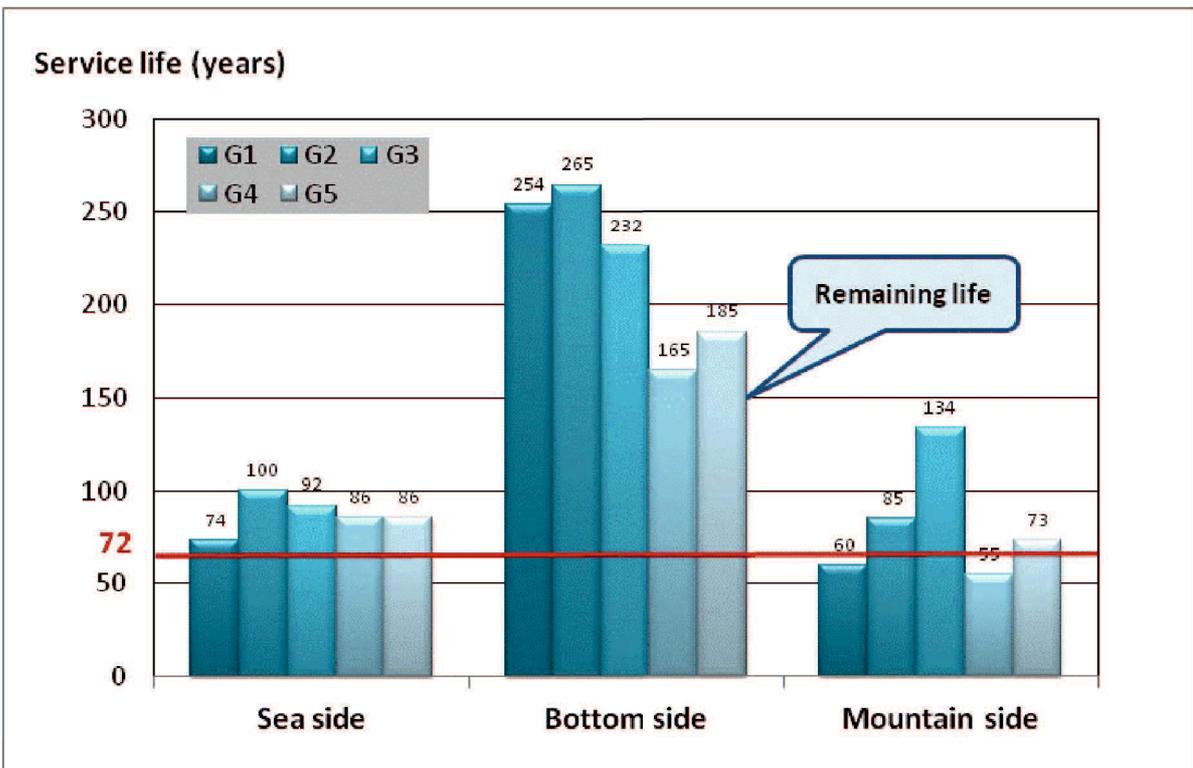
Figure 5.22 Comparison of remaining life prediction of merged girders of Span 1 and Span 3 based on the location of girders

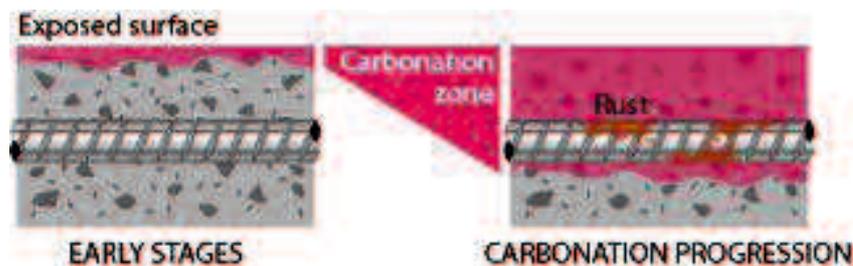
Figure A3. The carbonation process

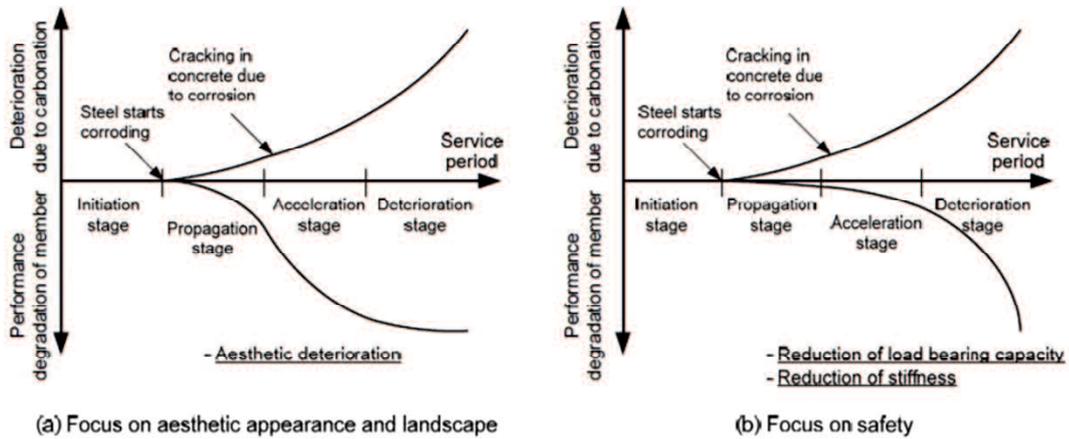
**Figure A5. Conceptual view of deterioration progress due to carbonation**

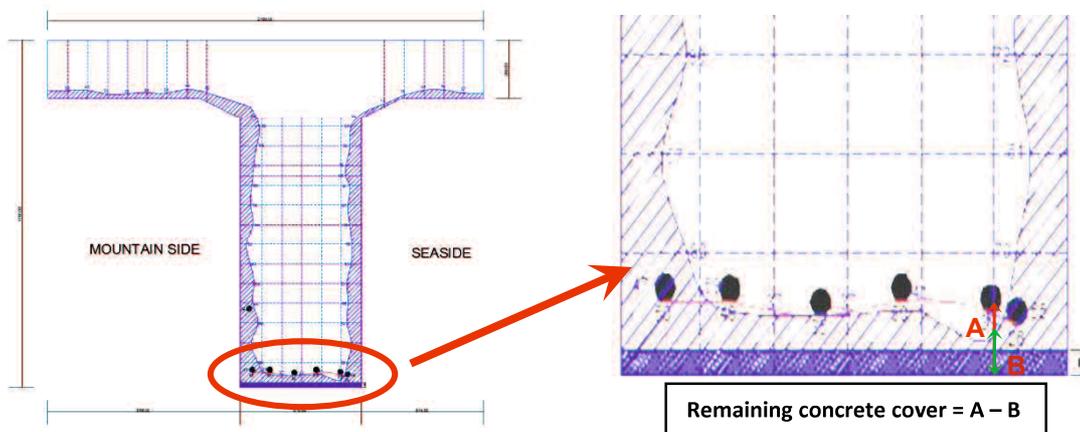
Figure A16. The remaining of concrete cover
