**Doctoral Dissertation**

**DEVELOPMENT OF A METHOD OF  
REMAINING LIFE PREDICTION FOR AN AGED BRIDGE BASED ON  
CONCRETE CORES AND CROSS-SECTION  
CUTTING-OFF GIRDERS**

**RATNA WIDYAWATI**

**Department of Environmental Science and Engineering  
Graduate School of Science and Engineering  
Yamaguchi University, Japan  
March, 2015**

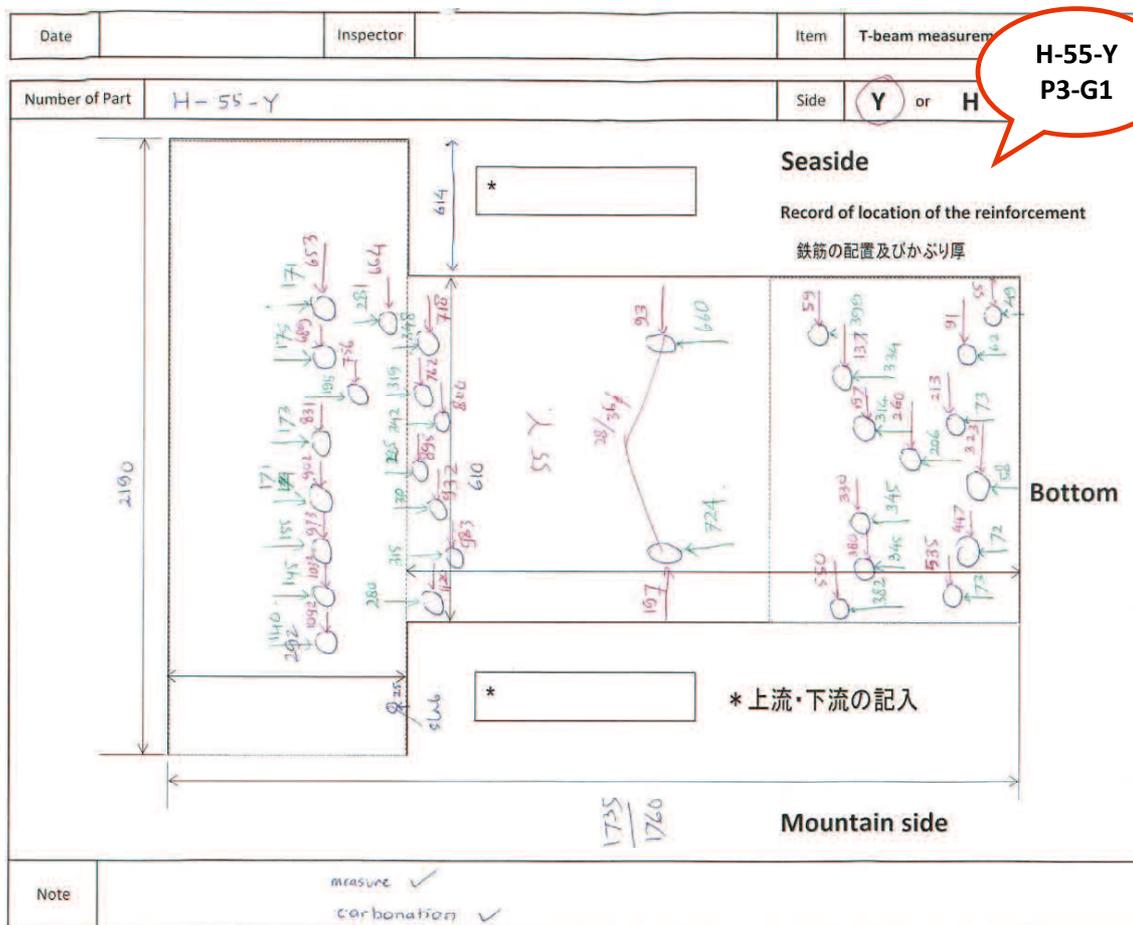
Figure A19. Original data of the location of steel reinforcement

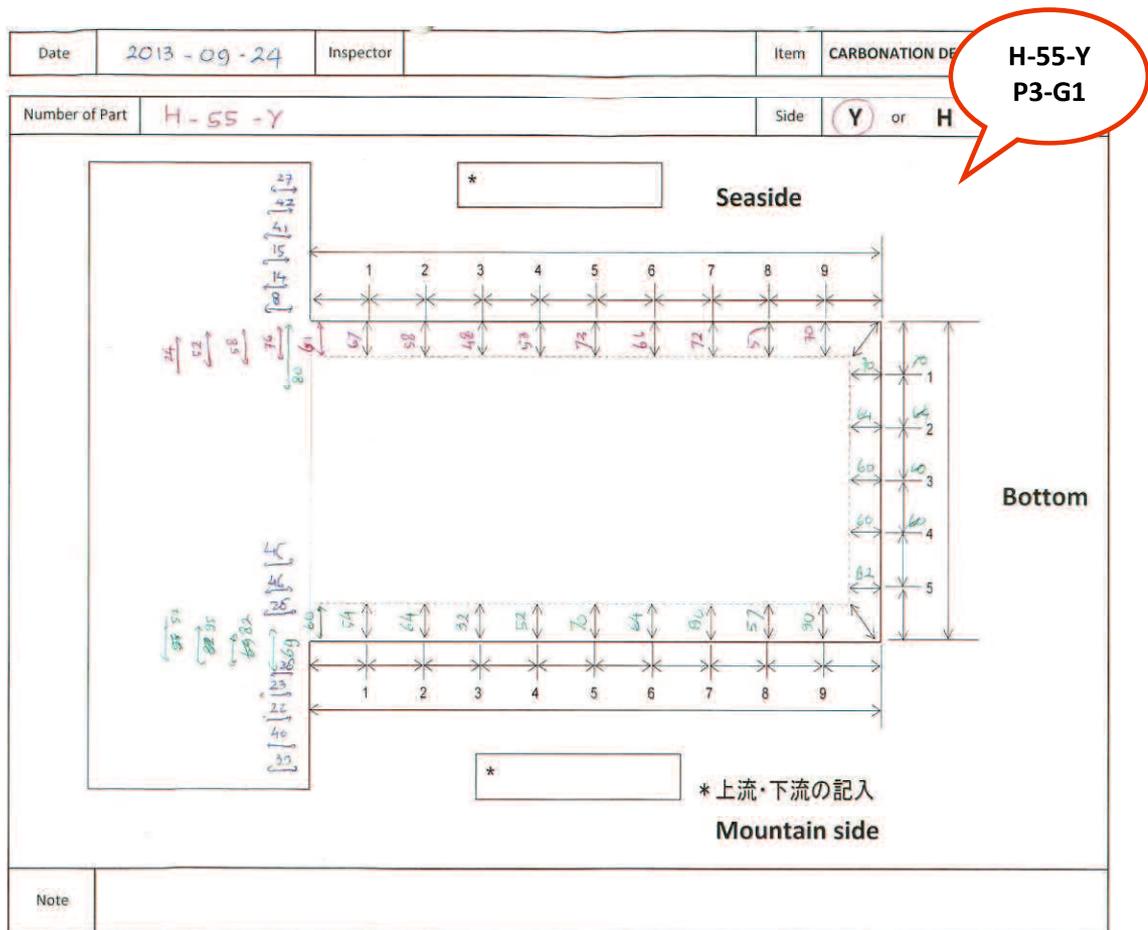
Figure A20. Original data of the carbonation depth measurement

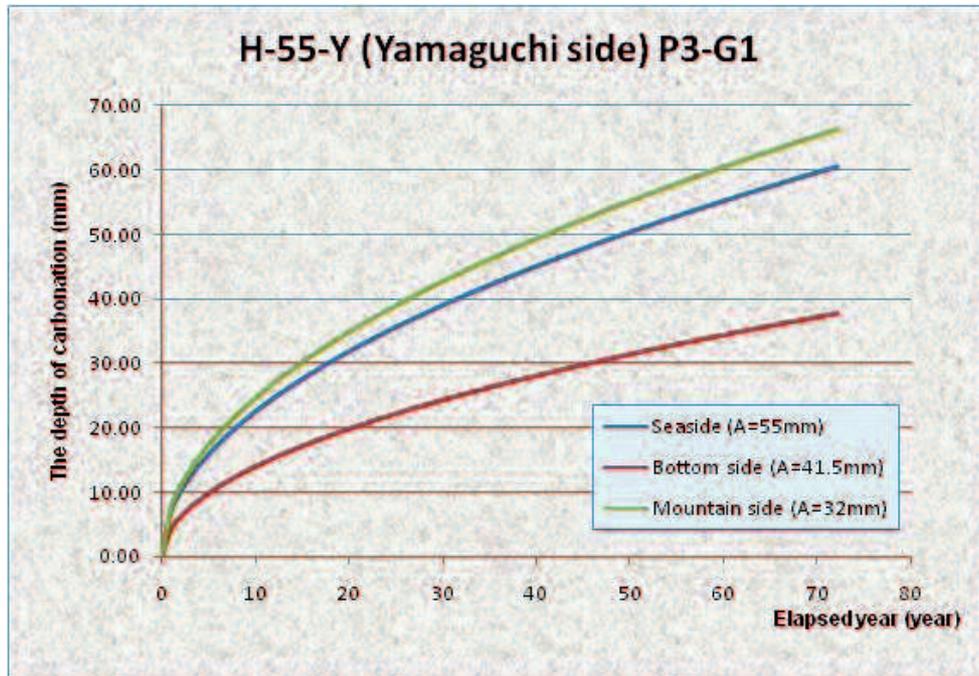
Figure A26. The carbonation rate distribution
