Doctoral Dissertation

**Observation and Evaluation of Surface Deformation in  
Complex Landslide Slope of Bobonaro in Timor-Leste  
by using Remote Sensing**

Graduate School of Sciences and Technology for Innovation  
Yamaguchi University

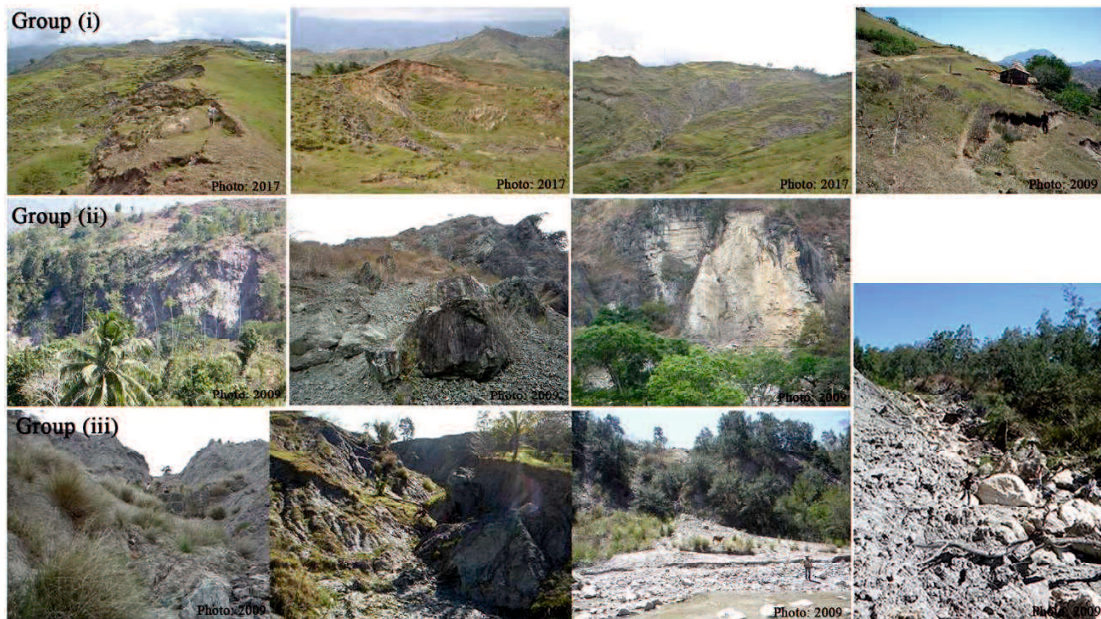
**Figure 2.3.** Types of ground deformation mechanisms in the Bobonaro Region: **Group (i)** located closest to crest of a mountain, **Group (ii)** on a steep slope, and **Group (iii)** at the base of slopes and close to water courses

The processes of ground deformation and landslides observed in the Bobonaro region are herein described following the Varnes (1978) classifications. The types of mechanisms vary from simple and isolated occurrences to more complex ones in a chain sequence from the peak of the mountain to the base. Figure 2.3 illustrates the types of mechanisms and their locations classified into three groups: (i) slopes closest to the top of the mountain, (ii) steep slopes or ravines, and (iii) more at the base of the slopes, that is, specifically in the areas near watercourses.

The slope became unstable along the riverbank; and consequently, it collapsed and was followed by other types of slope movements such as fall, topple, spread, sliding, and flow. It also resulted in the appearance of the deposition of detritus material close to the watercourses as a result of the flow-type movement. Sliding movements (translational or rotational) and debris flows normally contain large amounts of materials that can intercept the main streamline, consequently, generating a natural dam with the capacity to temporarily flood a wide area until the sediment is removed and transported naturally by the water stream.

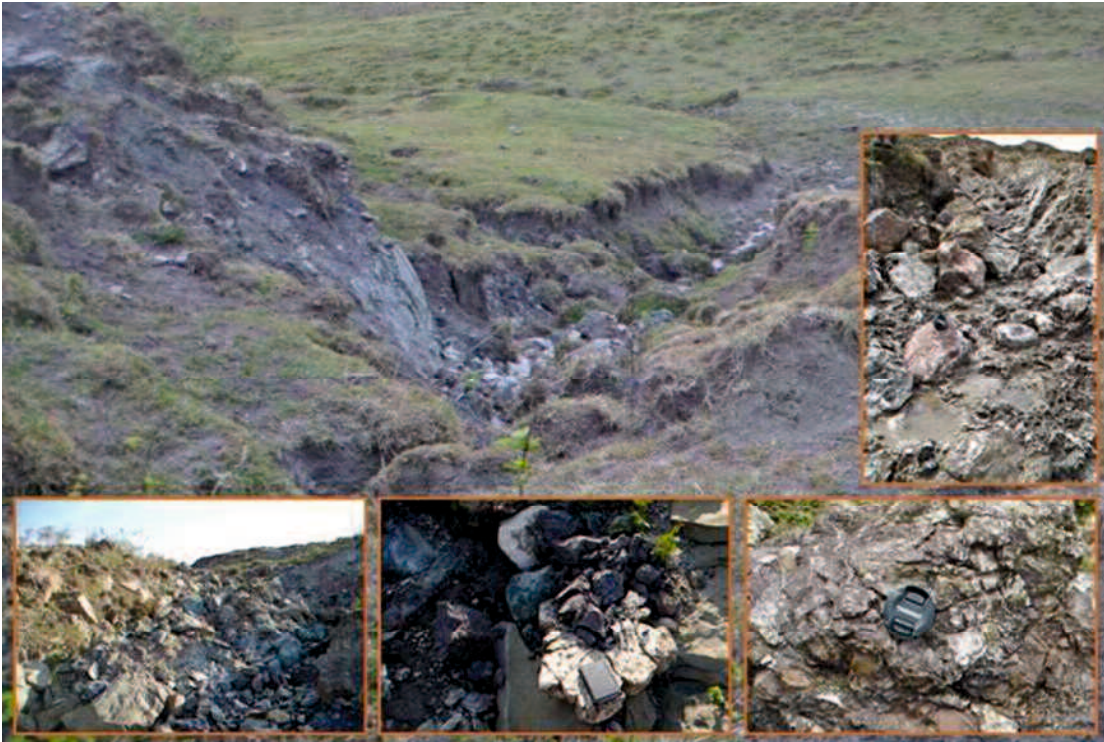
**Figure 2.5.** Types of material outcrops essentially composed of serpentinites and metaigneous rocks and surrounded by a clay matrix.

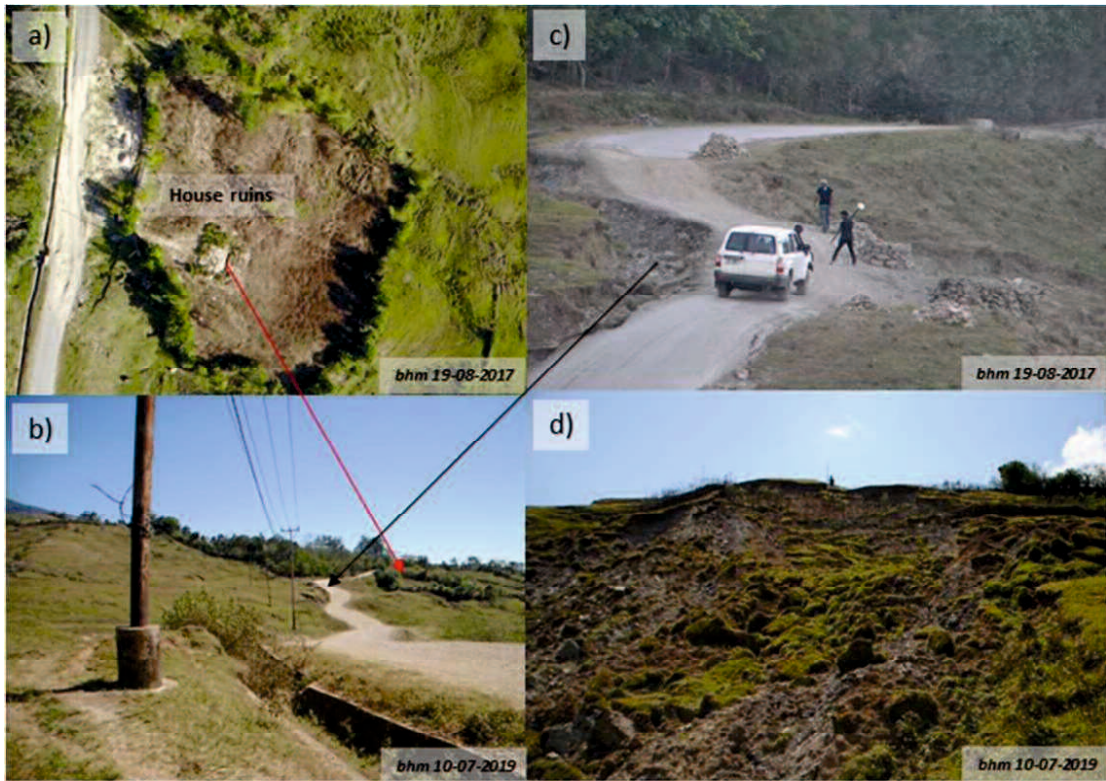
**Figure 2.6.** Evidence of ground deformation and its impact: **a)** house ruins, **b)** electrical pole that moved and tilted, **c)** degraded road conditions, and **d)** small landslide induced by an earthquake

house, (Figures 2.4 and 2.6). Additional relevant information was collected from the local people and Google Earth historical imagery in order to confirm the evidence. The present authors clarified and recorded the four most notable pieces of evidence. The first three occurred at AOI2 and AOI3 and the fourth at AOI4. First, a masonry house was destroyed by a landslide in January 2017 during heavy rain, with material losses but no victims. Second, the electrical transmission line established in 2012 was deviated from the original alignment and tilted. Third, very frequent road restoration work has been performed during the rainy season with minimum conditions to allow the passage of transport vehicles. Fourth, a small slope failure induced by an earthquake event on 24 June 2019, with a magnitude of 7.3, occurred 518 km from the epicenter with a focal depth of 212 km.

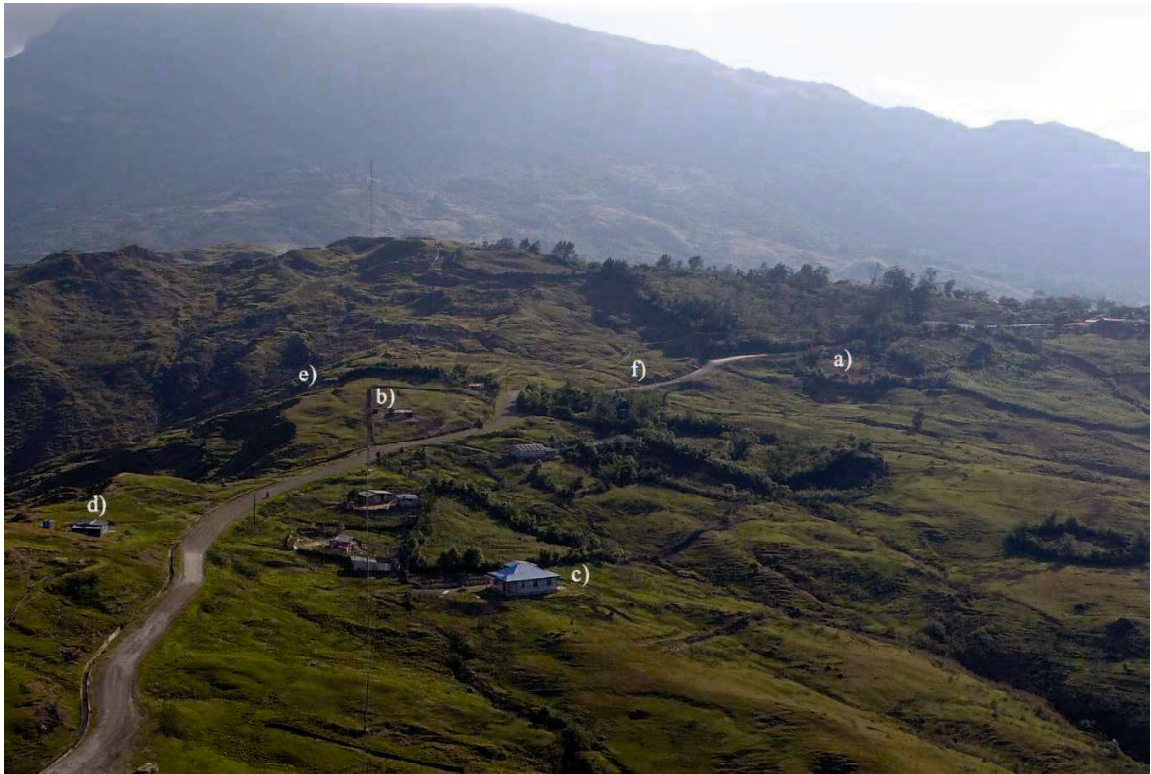
**Figure 3.8.** a) Location of house destroyed by a landslide in January 2017, b) New place chosen to build new house after January 2017 landslide, c) Expensive house built on unstable ground, d) House roof destroyed by a windstorm in February 2018, e) Landslide induced by an earthquake on 24<sup>th</sup> June 2019, and f) Location of the study area related to the ground deformation

results are presented in Appendix 2. Figure 3.8 presented an example of the conditions in the study area, for example, how the people are living and dealing with geo-disasters and how they make decisions in terms of survival in times of geo-disasters.

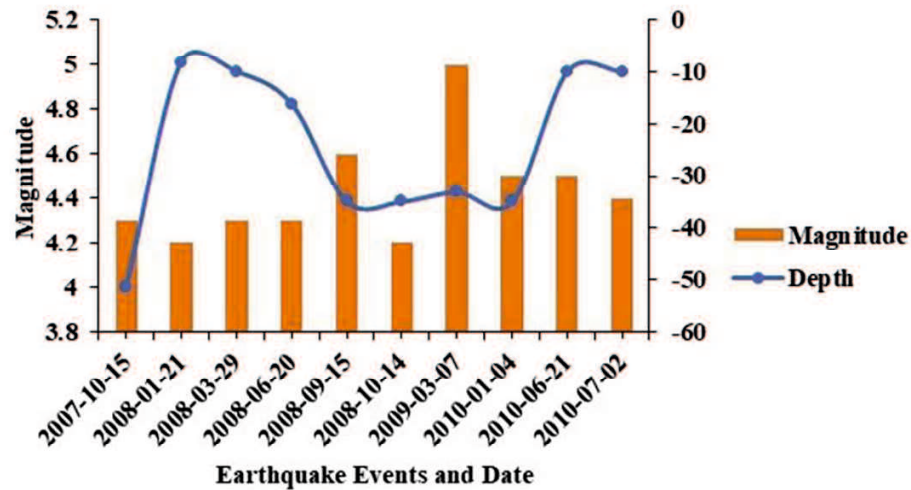
**Figure 4.3.** Earthquake depth and magnitude from 2007 to 2010

earthquake with the maximum magnitude occurred in 2009 and the deepest earthquake occurred in 2007 (Figure 4.3).

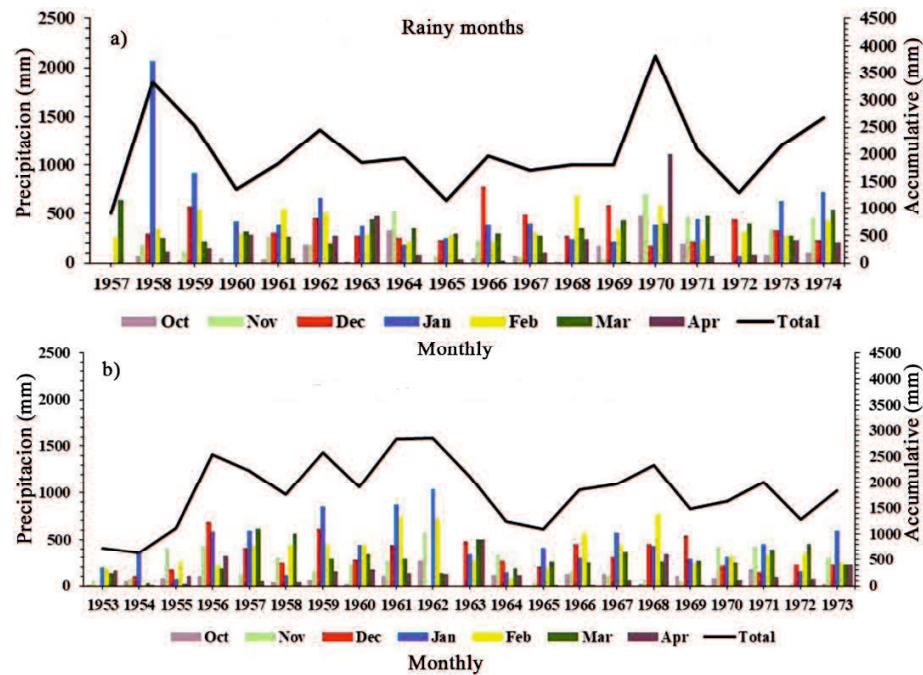
**Figure 4.5.** a) Rainfall data obtained from Bobonaro Meteorology Station, from 1957 until 1974 and b) Rainfall data obtained from Maliana Meteorology Station, from 1953 to 1973

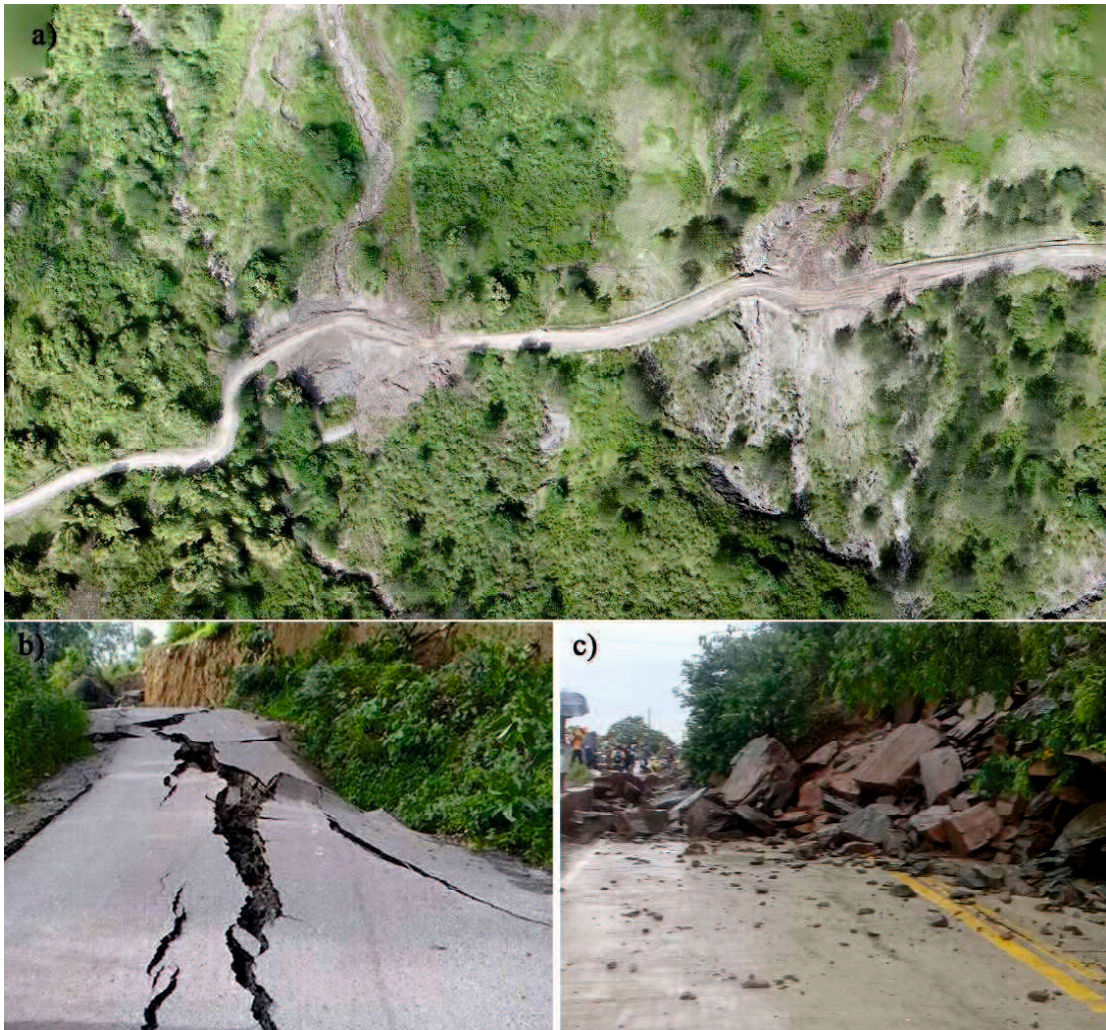
**Figure 4.6.** a) Aerial photo of Lekiatchi Landslide area, b) Landslide in Builico and affecting the road, photo *by Biky*, and c) Landslide in Batuboro and affected road, photo *by Babo*

Three recent landslides triggered by rainfall were analyzed in this study. These landslides occurred on the same date, that is, in the early morning of 17 January 2018. The first landslide occurred in the village of Lekiatchi, located approximately 8 km from the RGS (Figure 4.6a). The second landslide occurred in the village of Bullico, located approximately 20 km from the RGS (Figure 4.6b). The third landslide occurred in the village of Batuboru, located approximately 46 km from the RGS (Figure 4.6c).

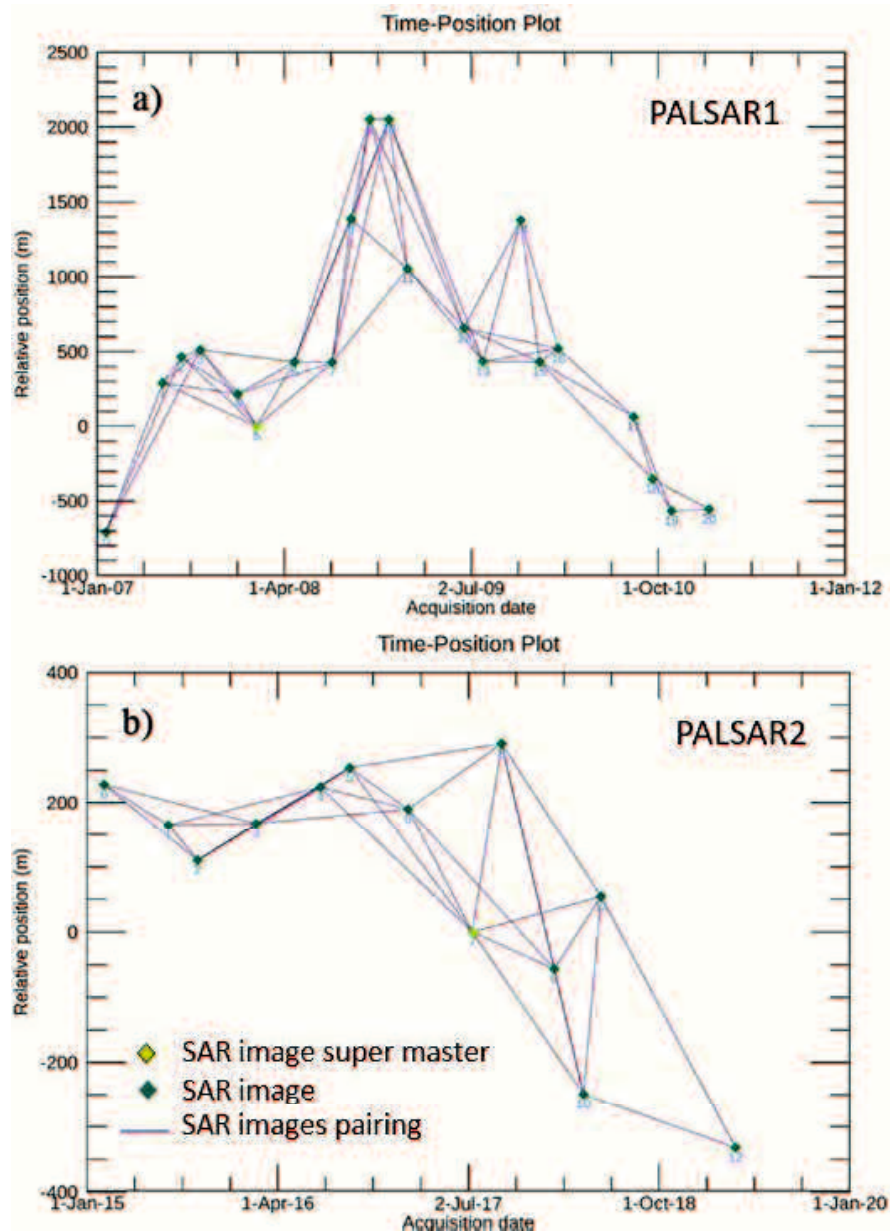
**Figure 5.1.** Small Baseline Subset (SBAS) Differential Interferometry Synthetic Aperture Radar (DInSAR) baseline tables: **a)** Phased Array type L-band Synthetic Aperture Radar (PALSAR) 1 for the first period and **b)** PALSAR2 for the second period

For the PALSAR1 data, the maximum perpendicular and temporal baselines of the interferogram for the SBAS processing are  $\pm 2000$  m and 270 days, respectively. Accordingly, 55 pairs of interferograms met the criteria. For the PALSAR2 data, the maximum perpendicular and temporal baselines of the interferogram for the SBAS processing are  $\pm 400$  m and 365 days, respectively. Thus, 33 pairs of interferograms met the criteria for further processing. Figure 5.1 a and b show the baseline tables of SBAS DInSAR for PALSAR1 and PALSAR2, respectively.

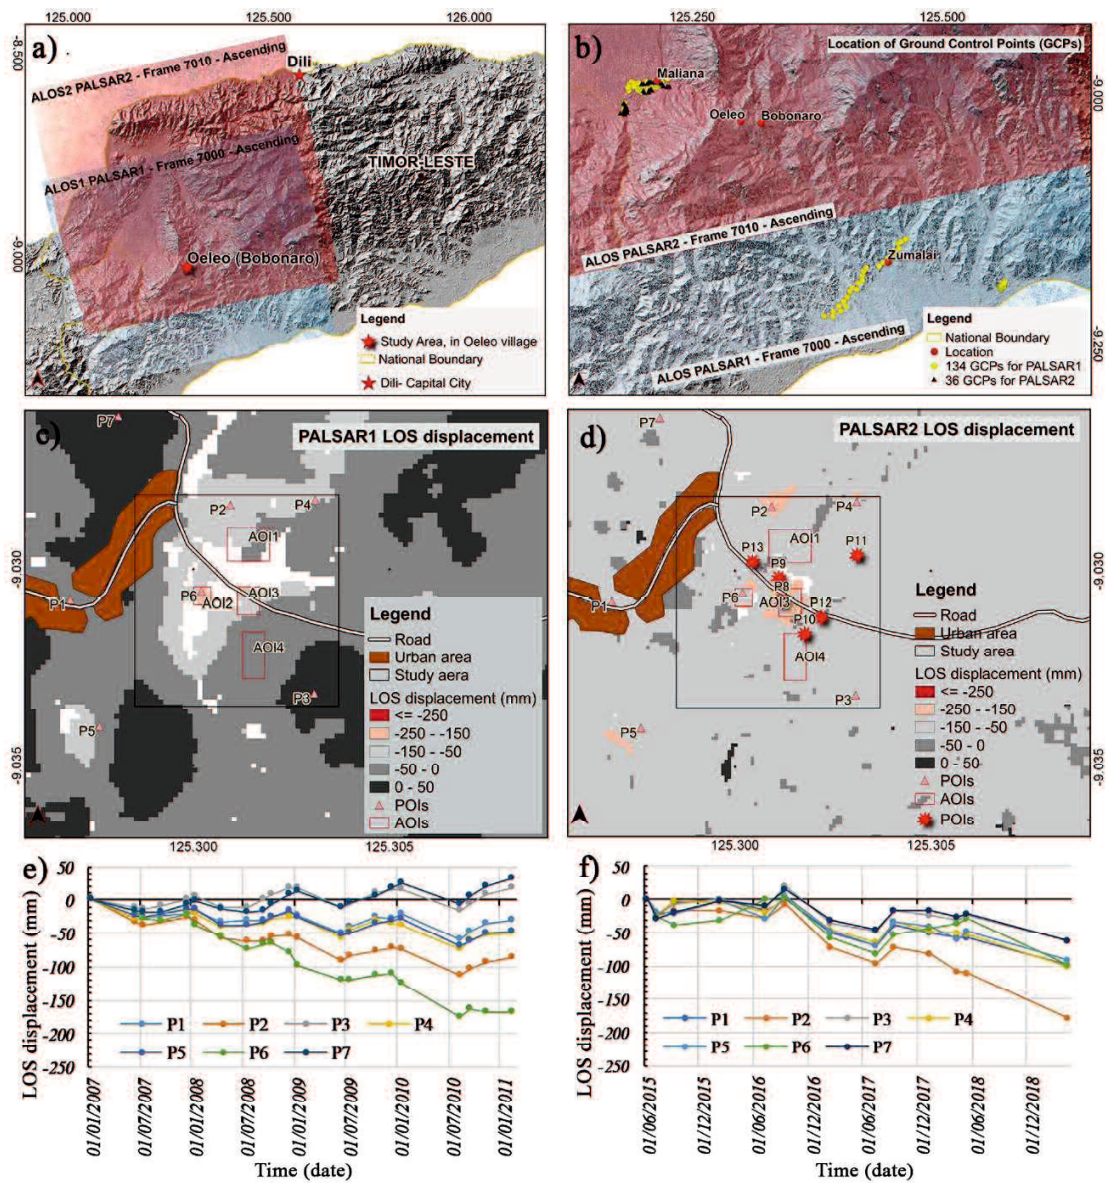
**Figure 5.5.** a) PALSAR1 and PALSAR2 data frames covering study the area, b) spatial distribution of ground control points (GCPs), c) spatial distribution of line of sight (LOS) displacement from PALSAR1, d) spatial distribution of LOS displacement from PALSAR2, e) LOS displacement time-series from PALSAR1, and f) LOS displacement time-series from PALSAR2.

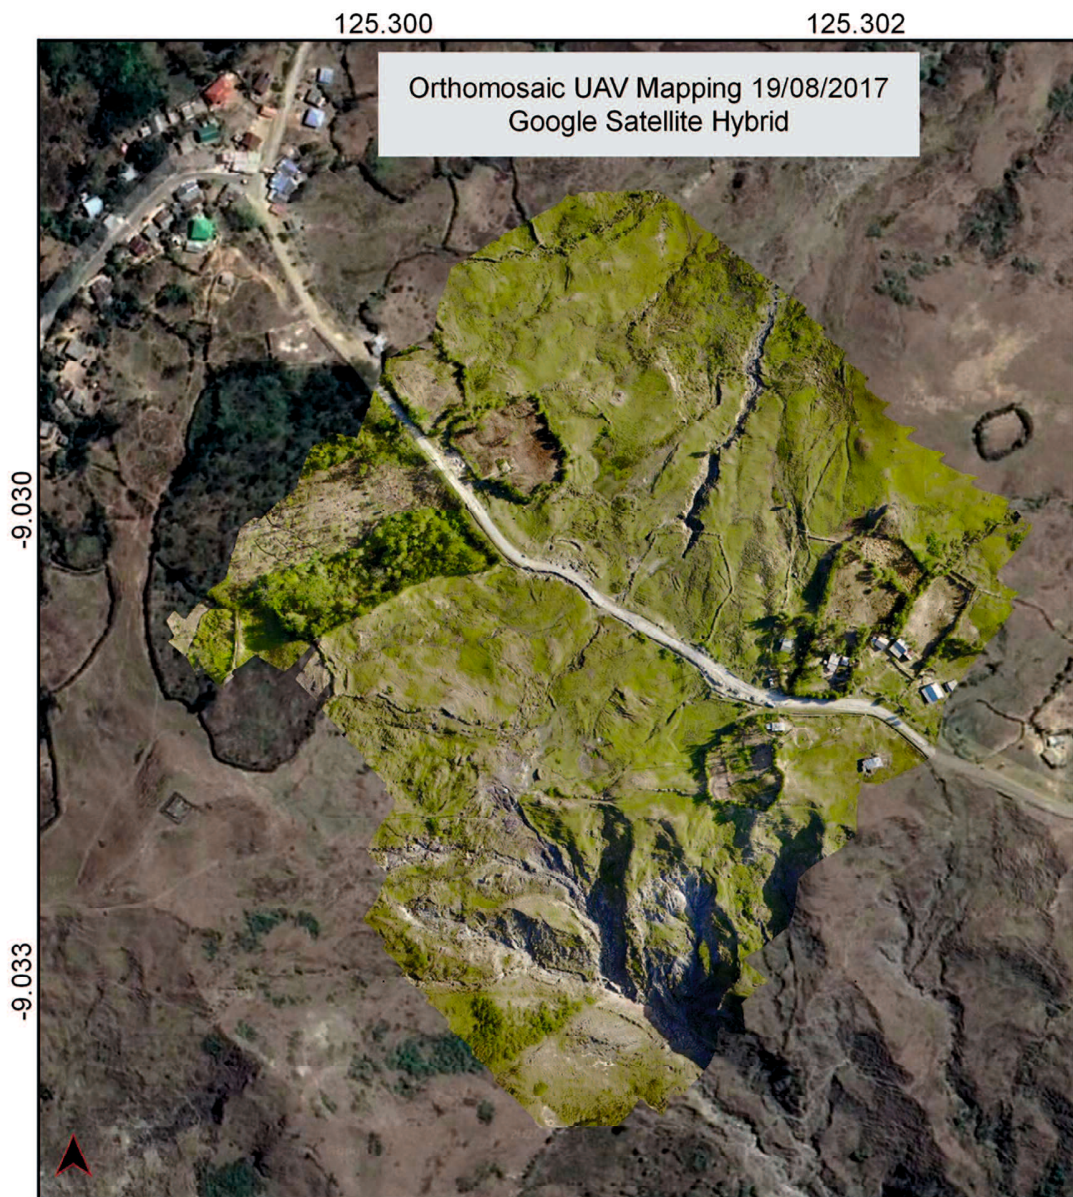
**Figure 5.7.** Unmanned Aerial Vehicle (UAV) orthomosaic image overlaid on Google Maps Hybrid

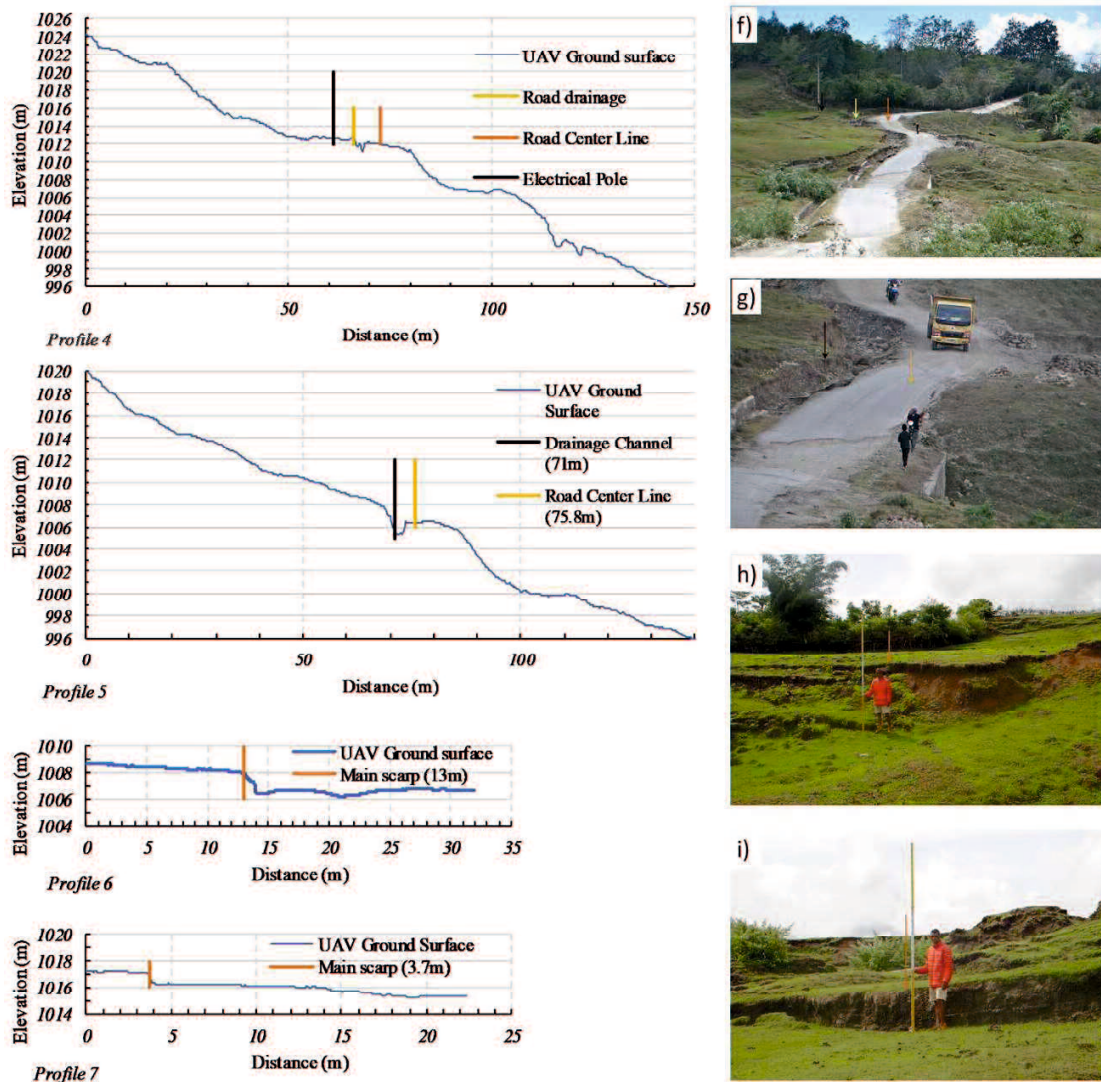
**Figure 5.13.** f) Illustration of Profile 4, g) Illustration of Profile 5, h) Illustration of Profile 6, and i) Illustration of Profile 7

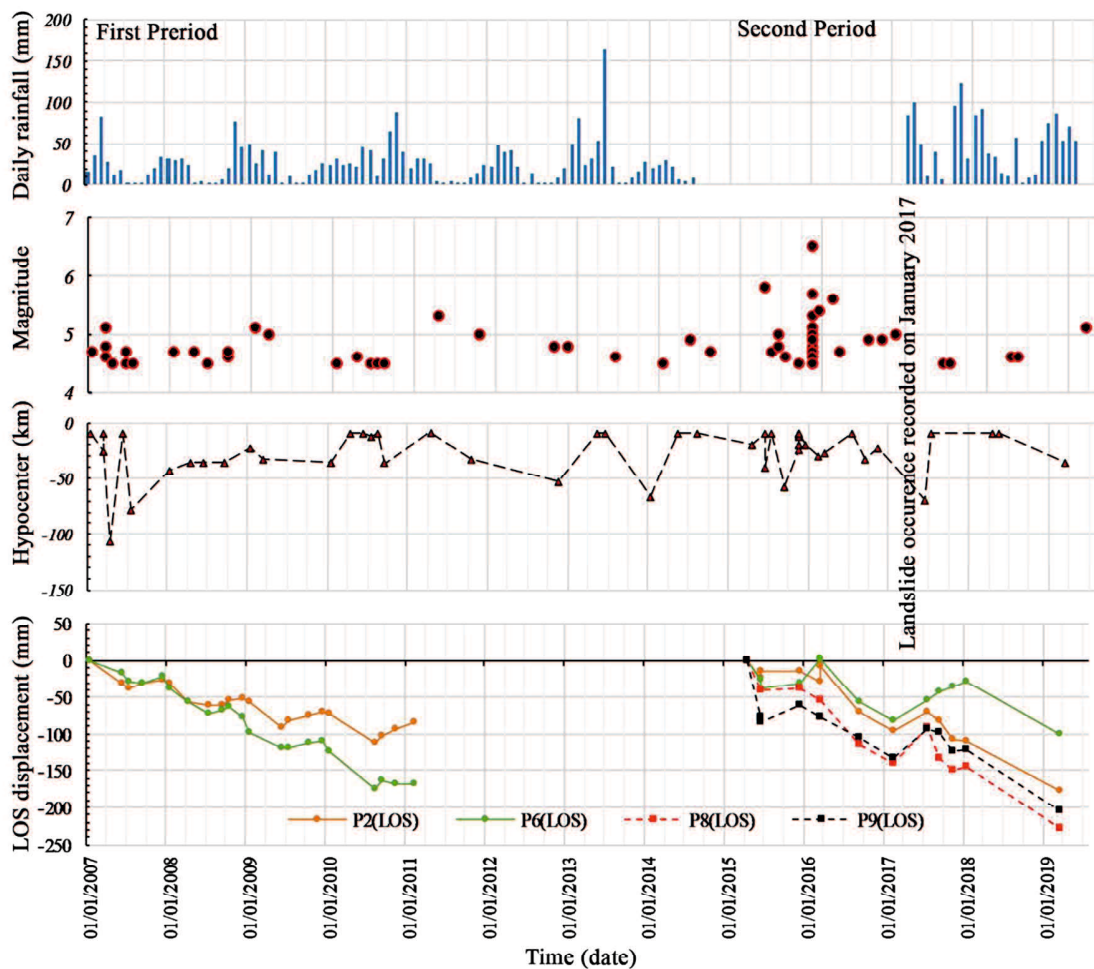
**Figure 5.14.** Relationship in time occurrences of PALSAR1 and PALSAR2 LOS displacement time-series with earthquake events and daily rainfall data.
