Influence of Surface Bugholes on Freeze-Thaw Degradation of Tunnel Lining Concrete

Dr. Eng. Thesis

**DEPARTMENT OF ENVIRONMENTAL ENGINEERING
YAMAGUCHI UNIVERSITY
UBE, JAPAN
September 2020**

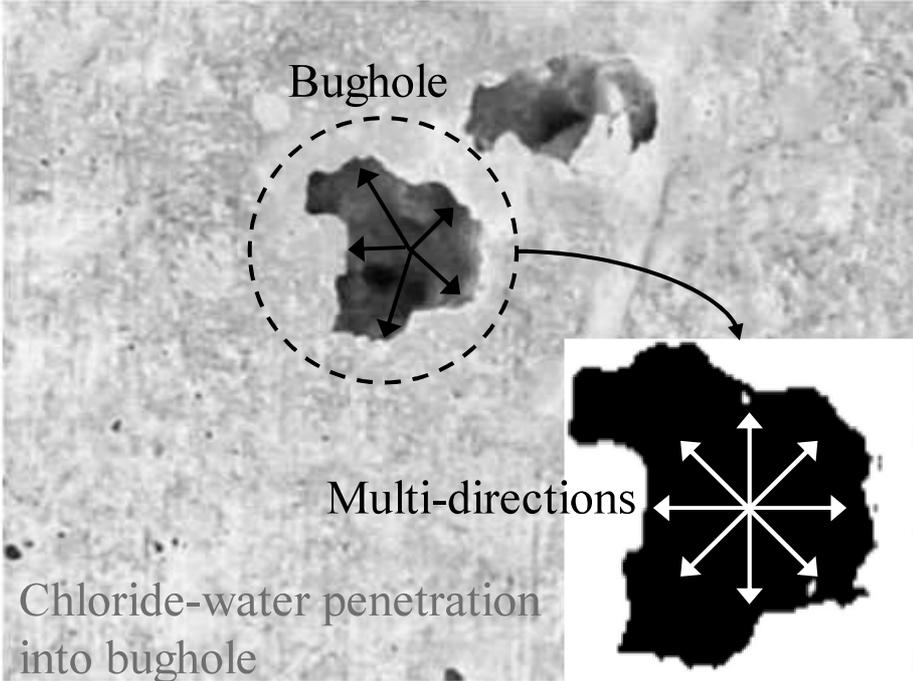
Figure 1-1 Bughole edge subjected to frost attack from various directions

Compared with a smooth concrete surface, bugholes increase the superficial area that is in direct contact with the environment. Consequently, the surface holes hold more adsorbed liquid. A concrete surface is heterogeneous (Sadowski and Mathia, 2016). The concrete surface with bugholes is more heterogeneous than the surface without bugholes, and this may cause further effects on the erosion. The edges of bugholes are affected by the environment from multiple directions. In contrast, a smooth and low-heterogeneous concrete surface is usually affected by the environment in a single direction, as shown in **Figure 1-1**.

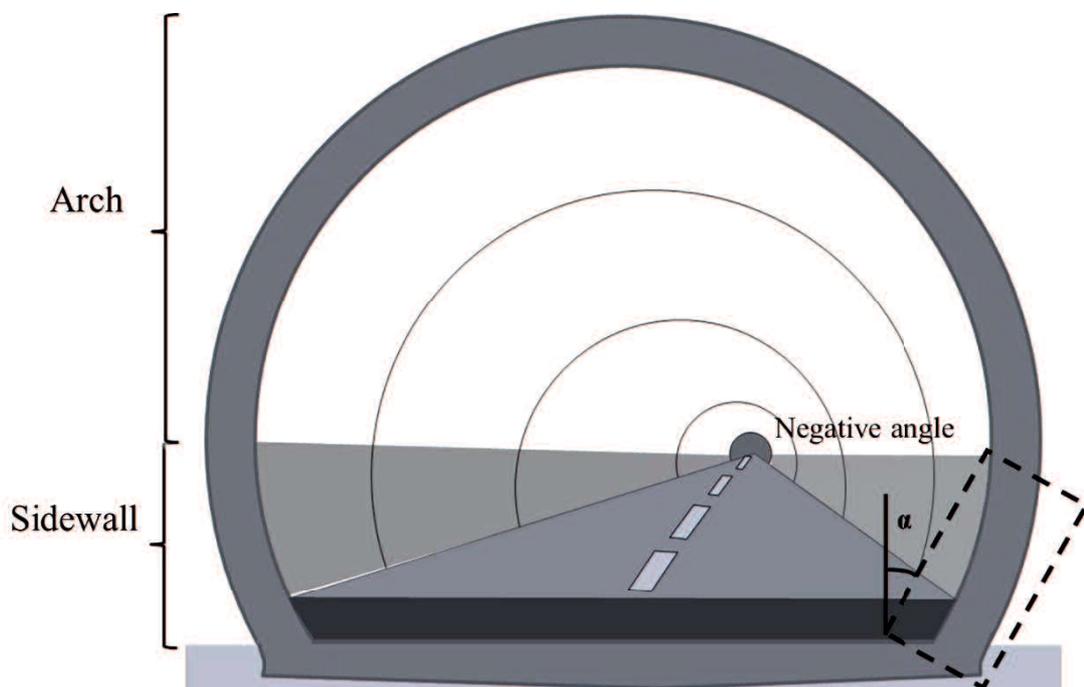
Figure 2-1 Sidewall of a tunnel lining with a negative angle

The sidewall of tunnel lining typically has a negative angle, as shown in **Figure 2-1**. Because of the negative angle, bugholes often appear on the concrete surface of the sidewall (Maeda *et al.*, 2014). In addition, the narrow workspace of form makes the vibration and casting work more difficult in the sidewall concreting. **Figure 2-2** shows the typical surface bugholes on a sidewall of tunnel lining concrete. Since a tunnel lining is large volume concrete pours, the maximum size of bughole can be more significant. In this study, the diameter of surface bughole is defined as smaller than 38 mm.

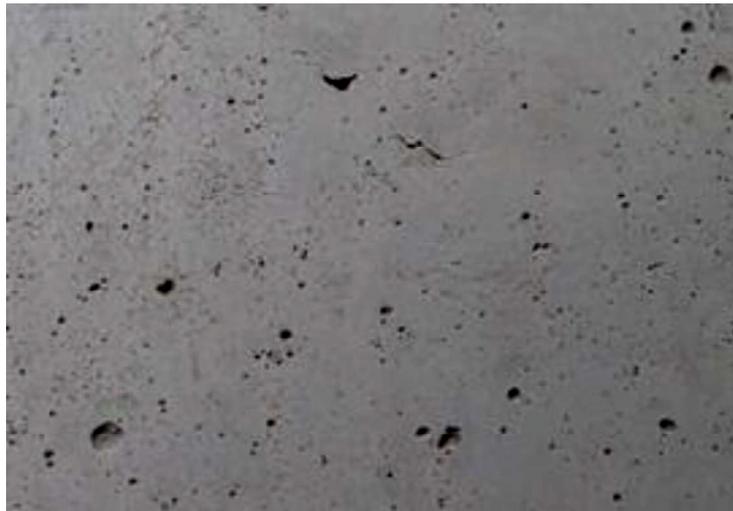
Figure 2-2 Surface bugholes on the sidewall of tunnel lining concrete

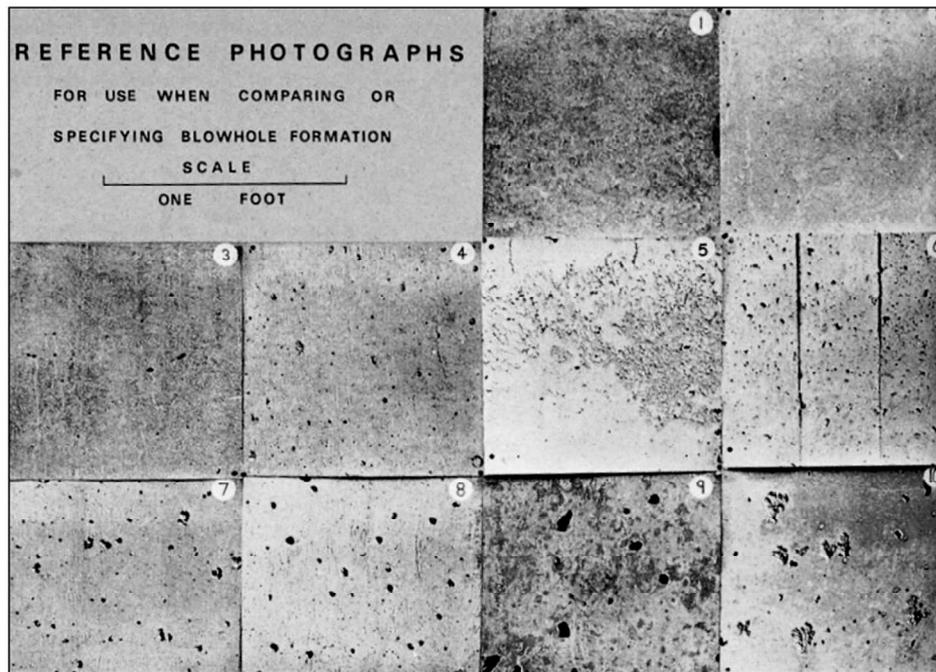
Figure 2-5 Reference photographs used for comparing surface finishes (Thompson, 1969)

Thompson (1969) proposed a set of 10 photographs of concrete surface bugholes as a standard reference (**Figure 2-5**). He described a surface quality of finish by using the percentage area of the concrete surface covered by one or more photographs. Conseil International du Batiment (CIB) (1973) gave a reference bubble scale to classify concrete containing bugholes (**Figure 2-6**). They inspected a concrete element and compared it with the standard templates. CIB W29 is the simplest method found, although it does not quantify. However, the CIB W29 method leaves room for some

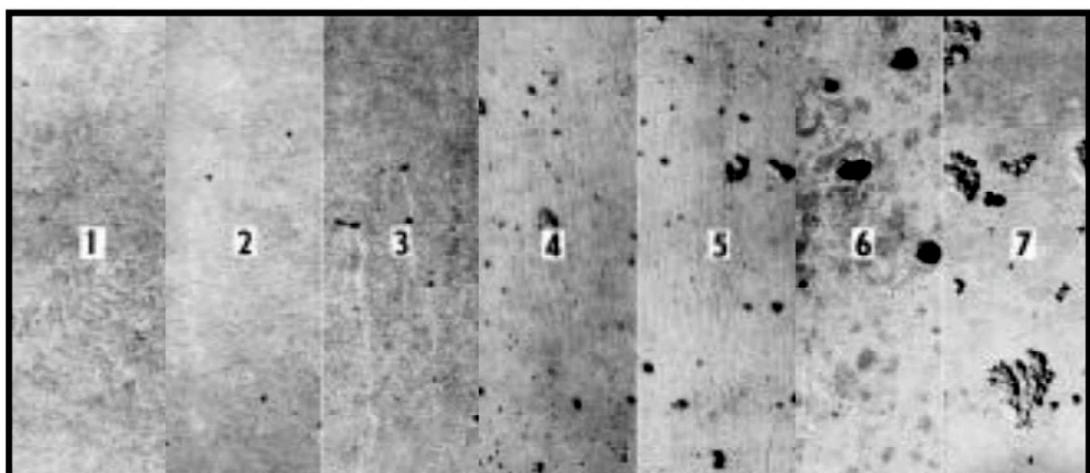
Figure 2-6 Bughole scale (CIB W29, 1973)

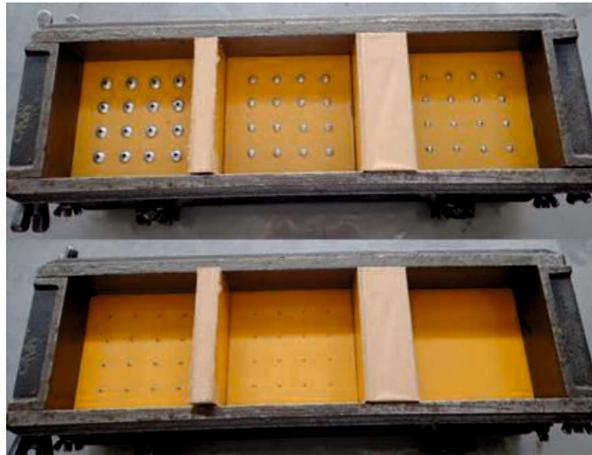
Figure 3-1 Steel mold with wood plates having various sizes of round screws

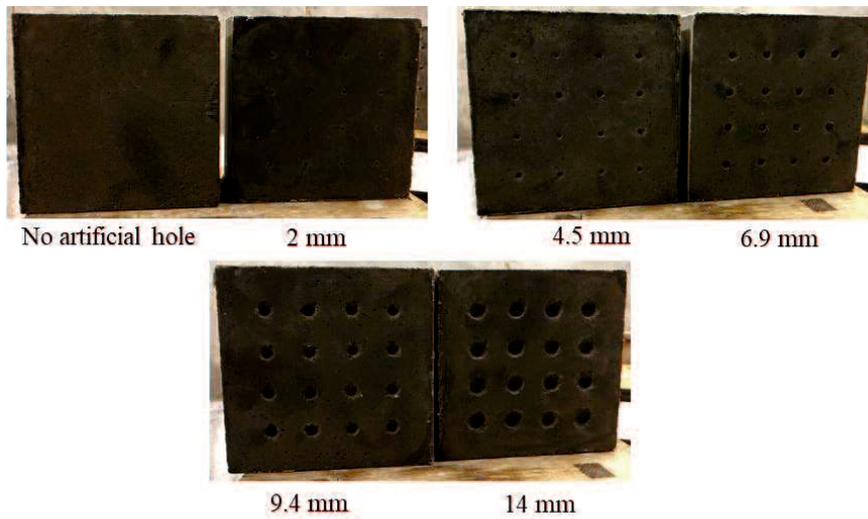
Figure 3-2 Surfaces of mortar specimens with holes in various diameters

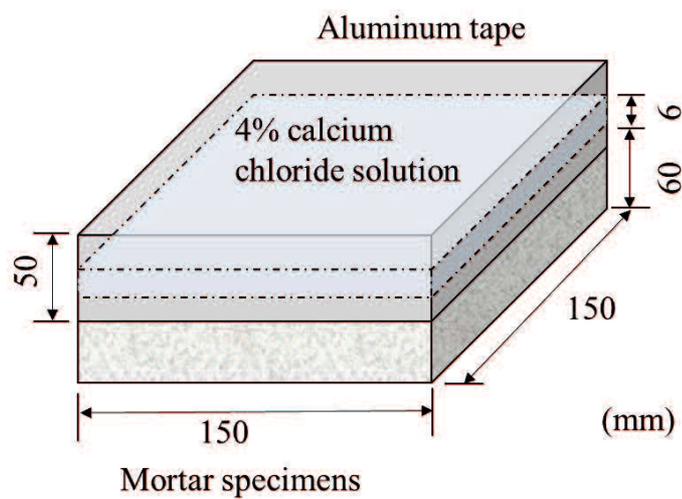
Figure 3-3 Mortar specimen in the F-T test

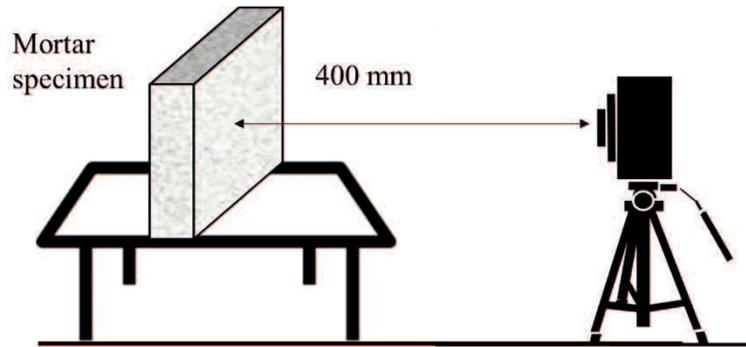
Figure 3-4 Photographic test condition

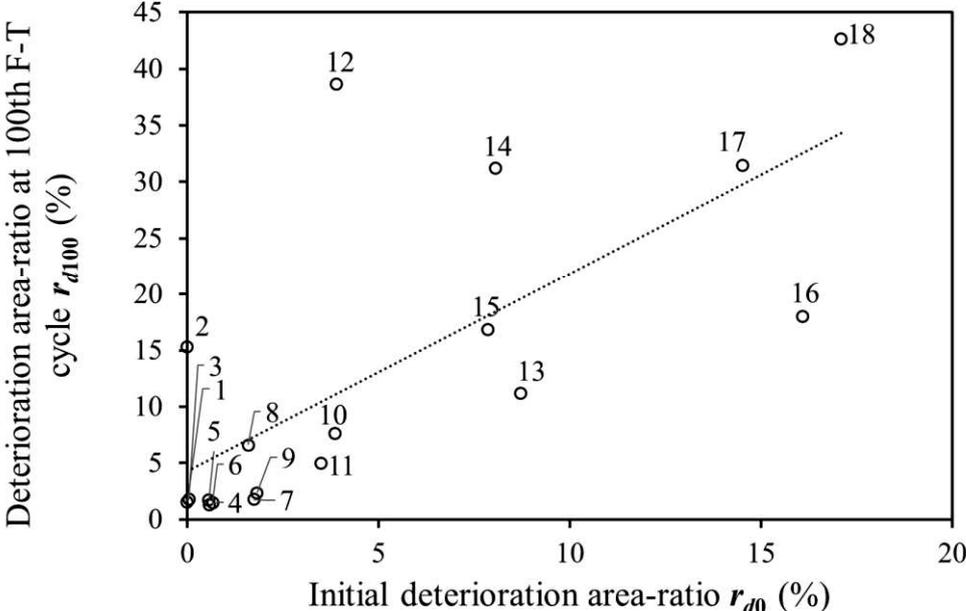
Figure 3-5 Relation of deterioration area-ratio before and after 100 F-T cycles

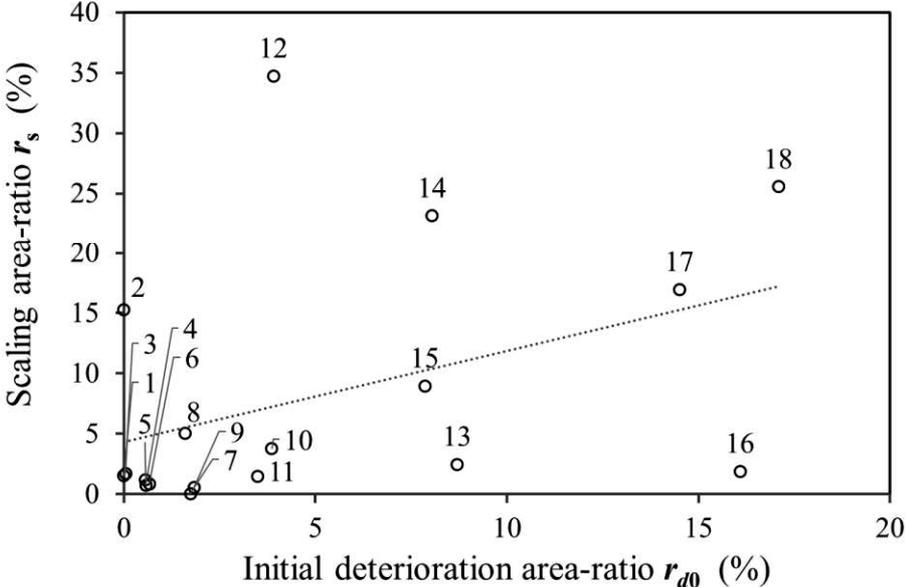
Figure 3-6 Relation of initial deterioration area-ratio r_{d0} and scaling area-ratio r_s in 100 F-T cycles

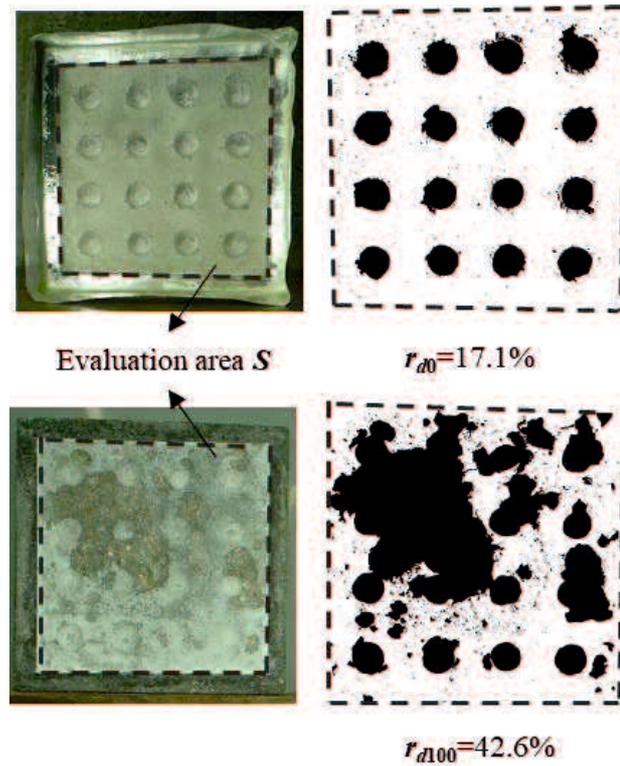
Figure 3-7 Processed images of specimen 18 by image analysis before and after 100 F-T cycles

Figure 3-7 shows the processed image of Specimen 18 before and after the F-T test. The scaling, occurring around holes in a slight depth, was detected by the image analysis. It is confirmed that the image analysis is applicable to quantify surface deteriorations.

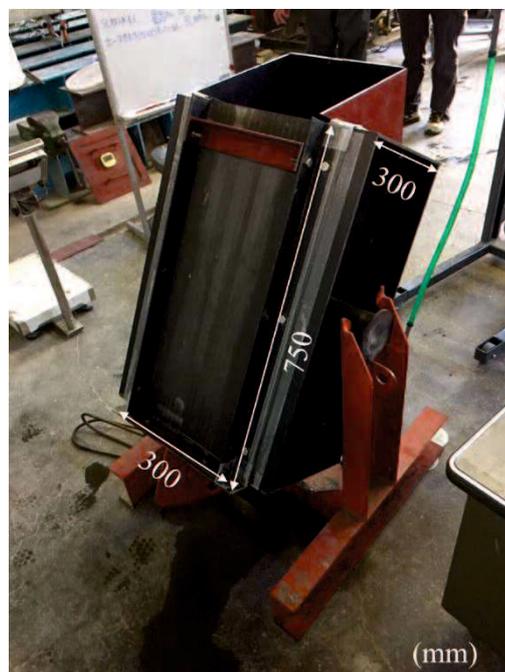
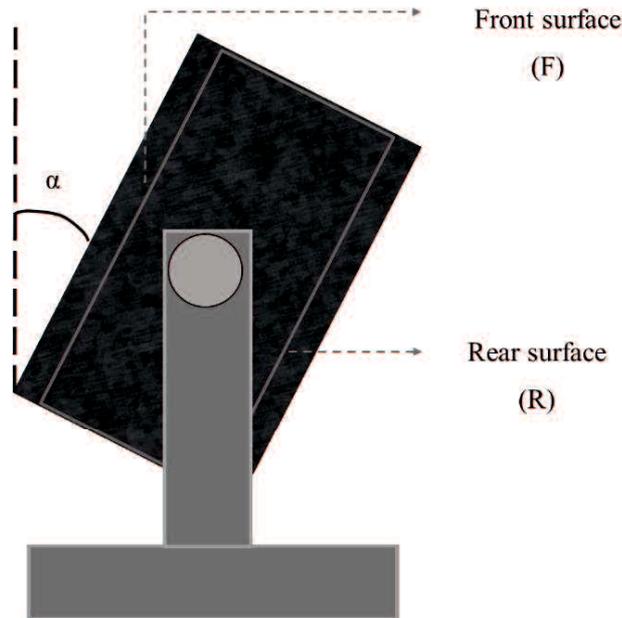
(a) dimension of steel form

(b) front surface and rear surface of specimen and the negative α -angle of form

Figure 4-1 Steel form simulating tunnel lining constructed by NATM

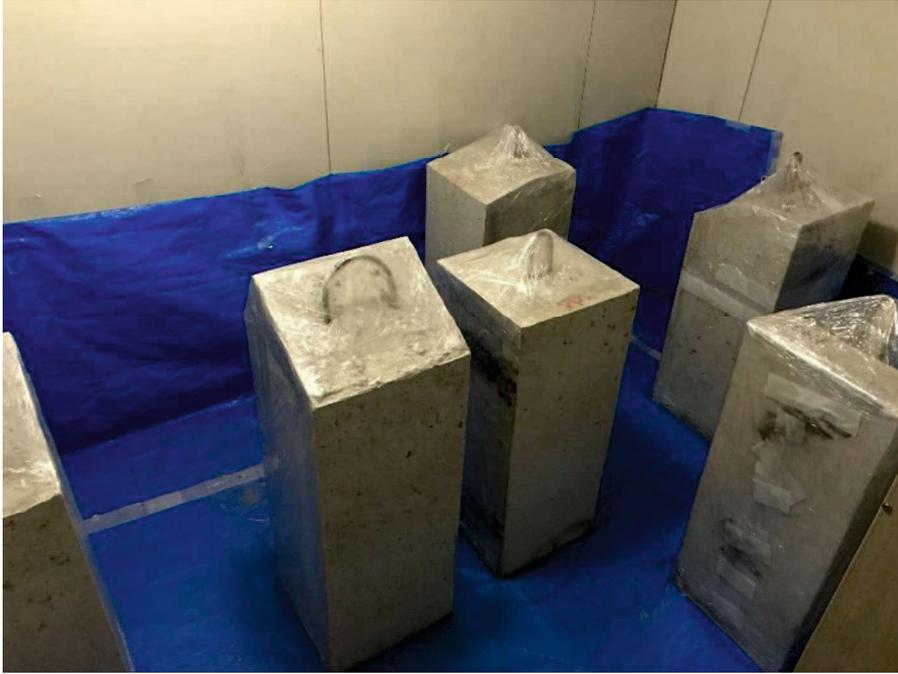
Figure 4-2 Specimens in the freezing chamber

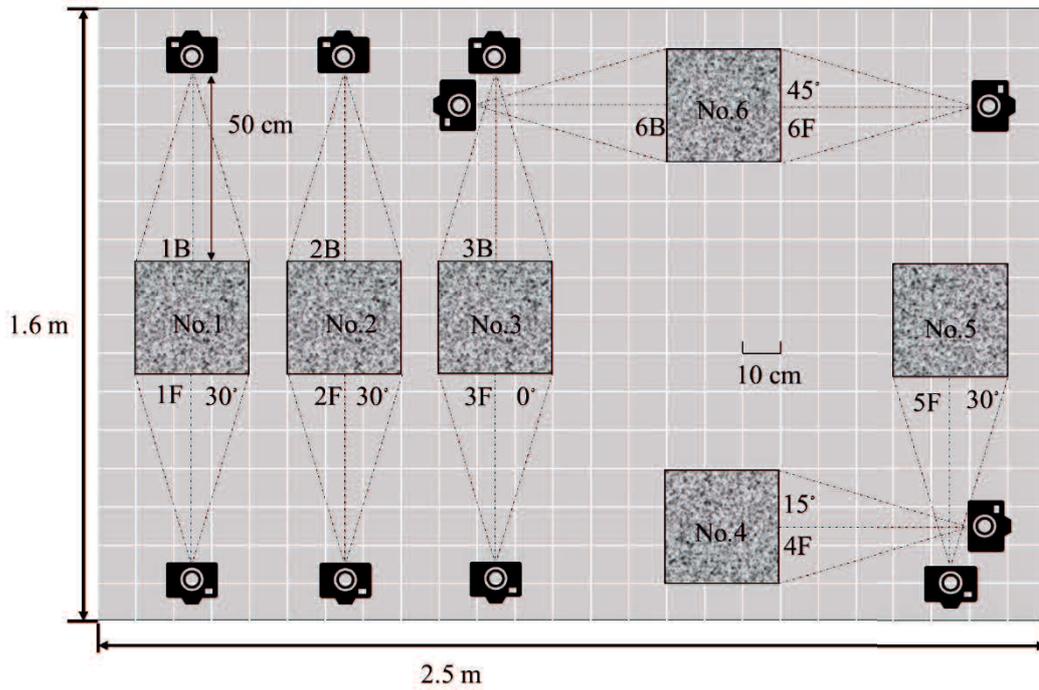
Figure 4-3 Position of concrete specimens in cooling chamber

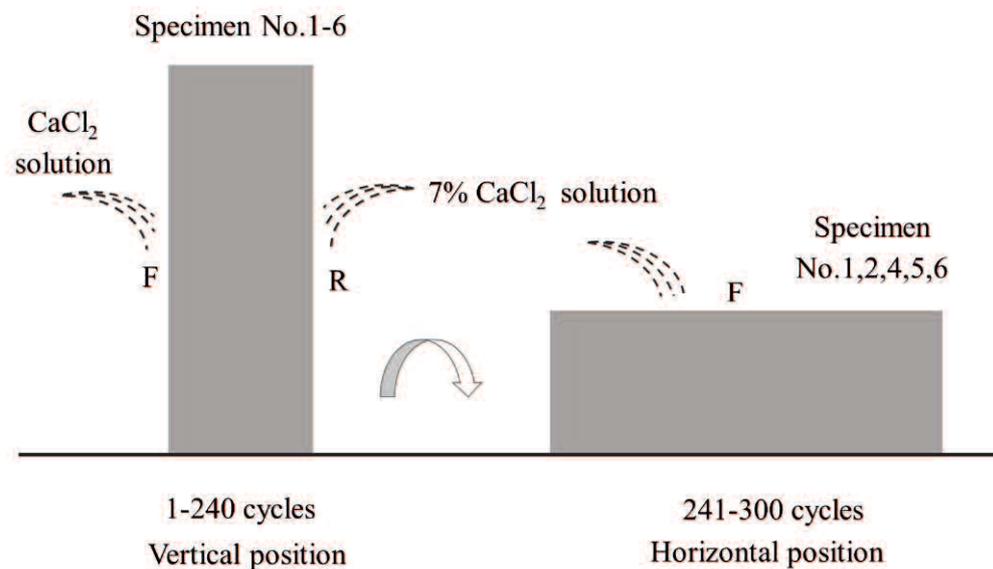
Figure 4-4 Vertical and horizontal positions of specimens in F-T test

After 240 F-T cycles, to examine the effect of horizontal position on frost durability, the concrete specimens No.1, 2, 4, 5, and 6 were horizontally laid on the floor such that the front surfaces faced upside and the front surfaces were evaluated, while the chloride solution was sprayed on the front surfaces in each cycle. **Figure 4-4** shows a schematic of the vertical and horizontal positions of specimens in the test. Specimen No.3 was vertically erected, and the chloride solution was sprayed on both front and rear surfaces.

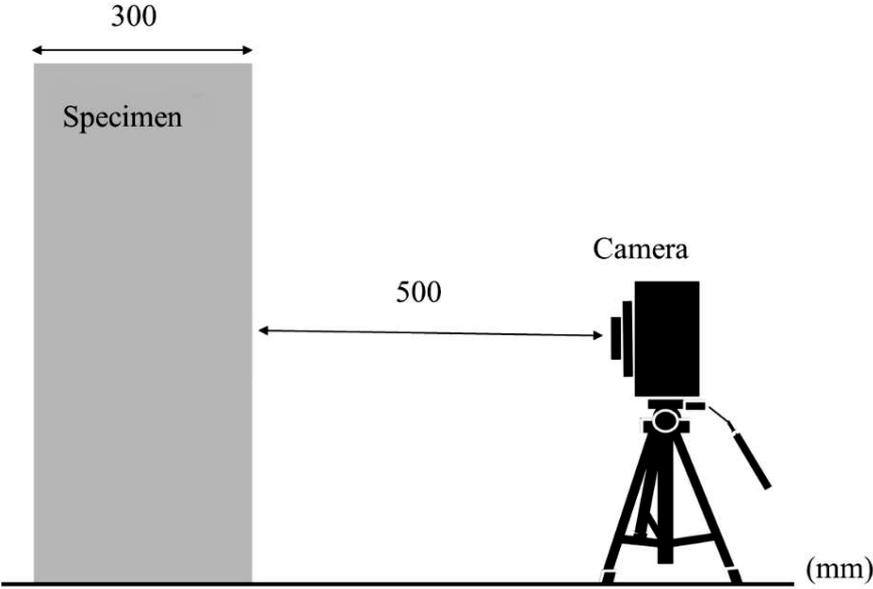
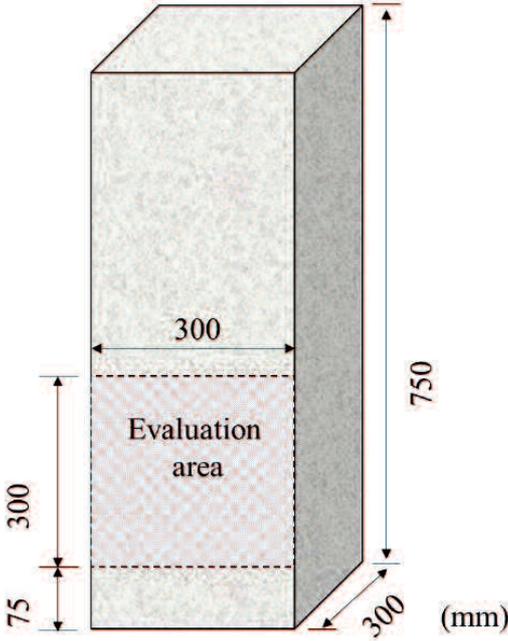
(a) schematics of the photographic method

(b) evaluation area of 300 mm × 300 mm of the concrete surface

Figure 4-5 Evaluation method

rear surface. The image analysis used high-quality photographs shot by the same digital still camera under a constant test condition. The shooting distance was 500 mm.

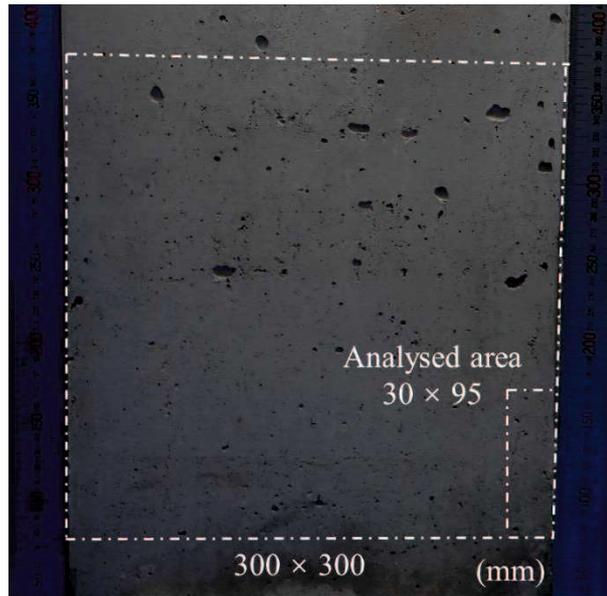
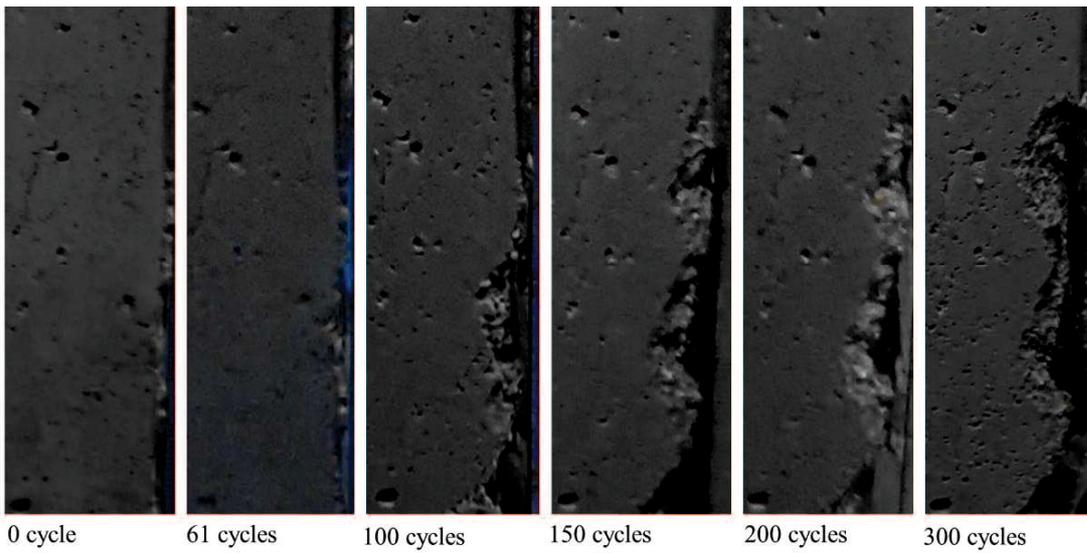
(a) position of scaling damage

(b) frost damage from 0 to 300 cycles

Figure 4-6 Scaling at the right corner of the surface 4F

Figure 4-6 (a)-(b) shows the frost damage at the right corner of the surface 4F from 0 to 300 F-T cycles. Any relation between the concrete deterioration and the presence of surface bugholes was not observed. The main goal of this chapter was to evaluate the effect of surface bugholes. Therefore, the deterioration of the concrete edge was not analyzed in the evaluation.

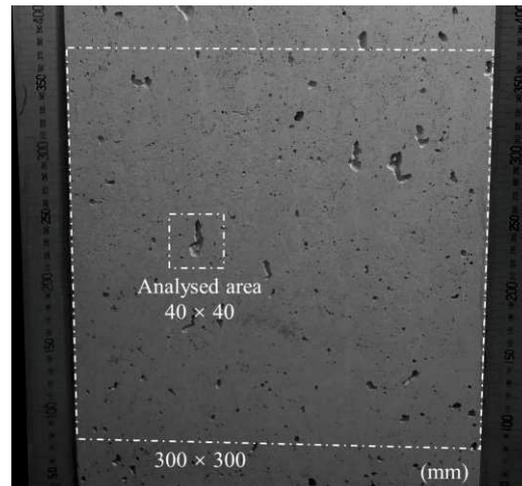
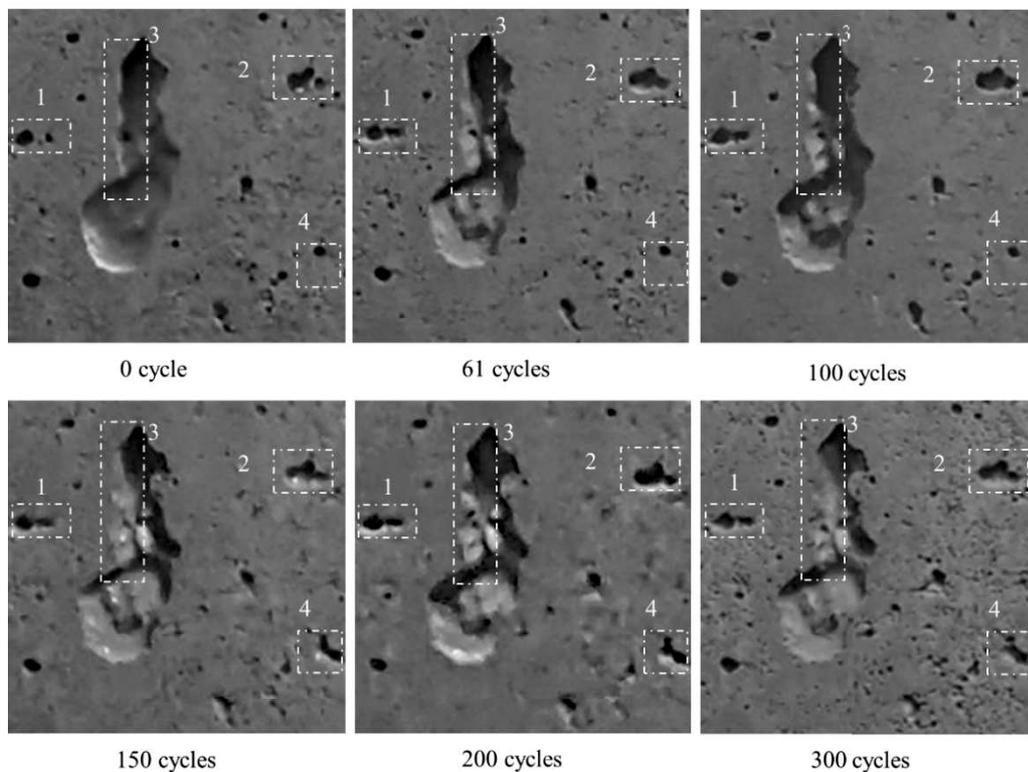
(a) position of deterioration

(b) surface holes mergence 1, 2, and enlargement 3, 4 from 0 to 300 cycles

Figure 4-7 Typical local scaling on the surface 1F

Figure 4-7 shows the merging process of bugholes 1 and 2 on surface 1F. After 60 F-T cycles, bugholes that were initially in proximity to each other merged into newly formed larger holes. The cover-concrete in proximity to bugholes was damaged by frost attack. The bughole-mergence occurred both in visible and invisible bugholes. The mergence of invisible bugholes resulted in larger and more visible holes, as well as pits and craters.

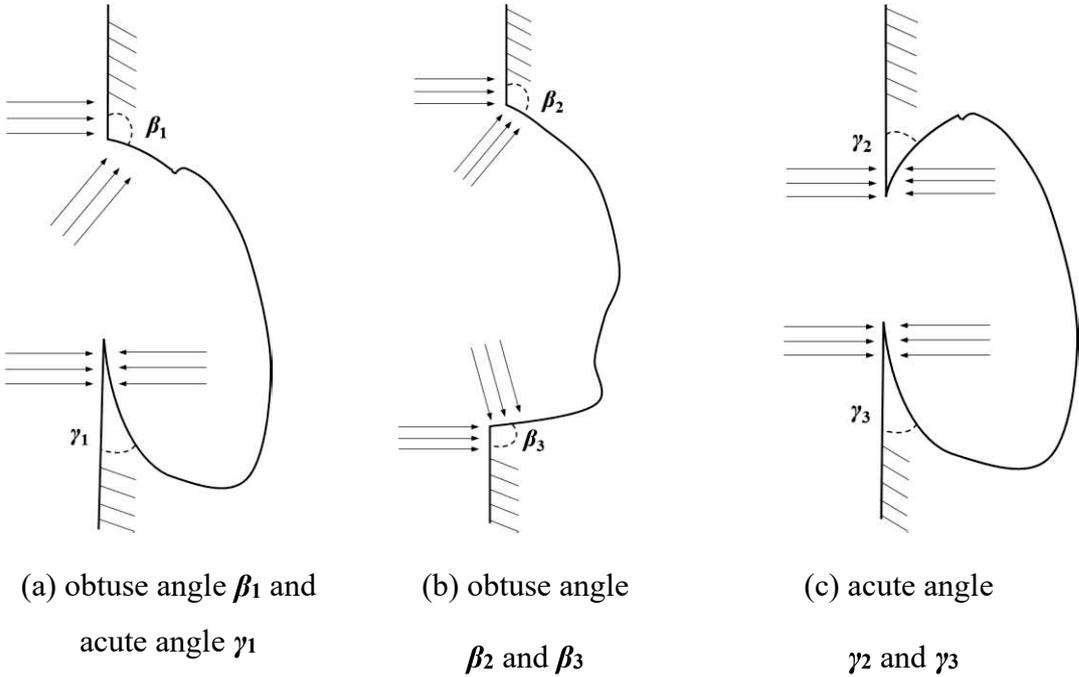
Figure 4-8 The angle between bughole interior surface and flat surface

Single bugholes enlarged due to the frost damage on the edges. Generally, a bughole has both acute and obtuse angles at the flattening surface (**Figure 4-8 (a)**). If a surface bughole can be clearly seen in its whole size, the interior surface and the normal concrete surface are characterized by obtuse angles β_2 and β_3 , as shown in **Figure 4-8 (b)**. On the contrary, when a surface bughole does not show its maximum cross-section, the angle between the concrete outer surface and the bughole is usually an acute angle, γ_2 and γ_3 , as shown in **Figure 4-8 (c)**. Compared with the obtuse-angle edges, cover-concrete of acute-angle edges are more susceptible to flaking. **Figure 4-9 (a)** and **(b)** illustrates the enlargement of a bughole on surface 4F, the area of which, at 300 F-T cycles, is three times that of the initial area. In addition, **Figure 4-7 (b)** shows the enlargement of surface air-voids 3 and 4. The results show that invisible bugholes enlarged to visible holes. It is of interest that the enlargement and mergence of bugholes happen simultaneously.

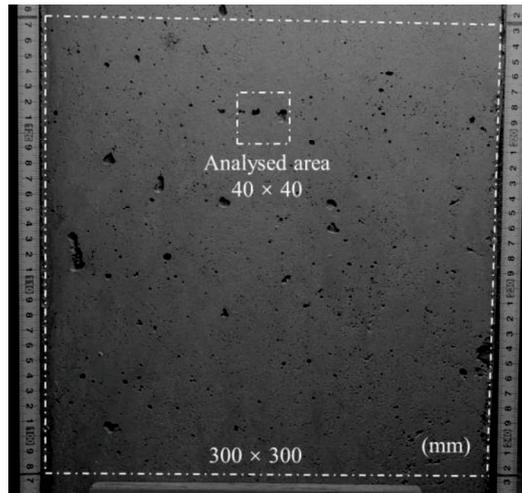
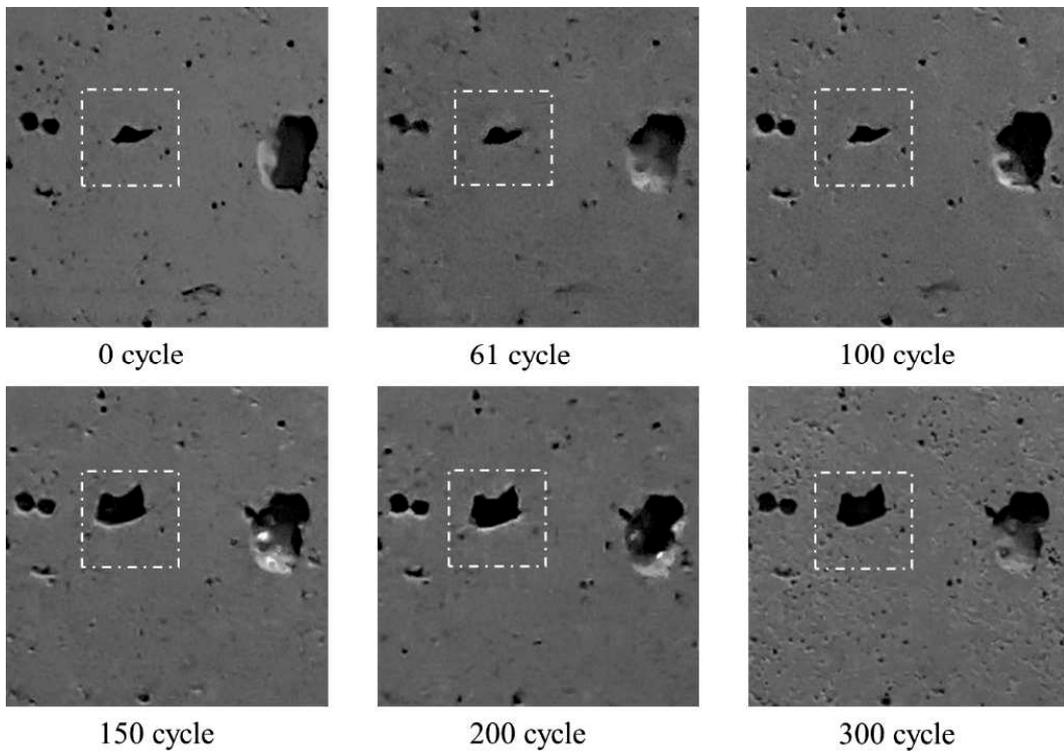
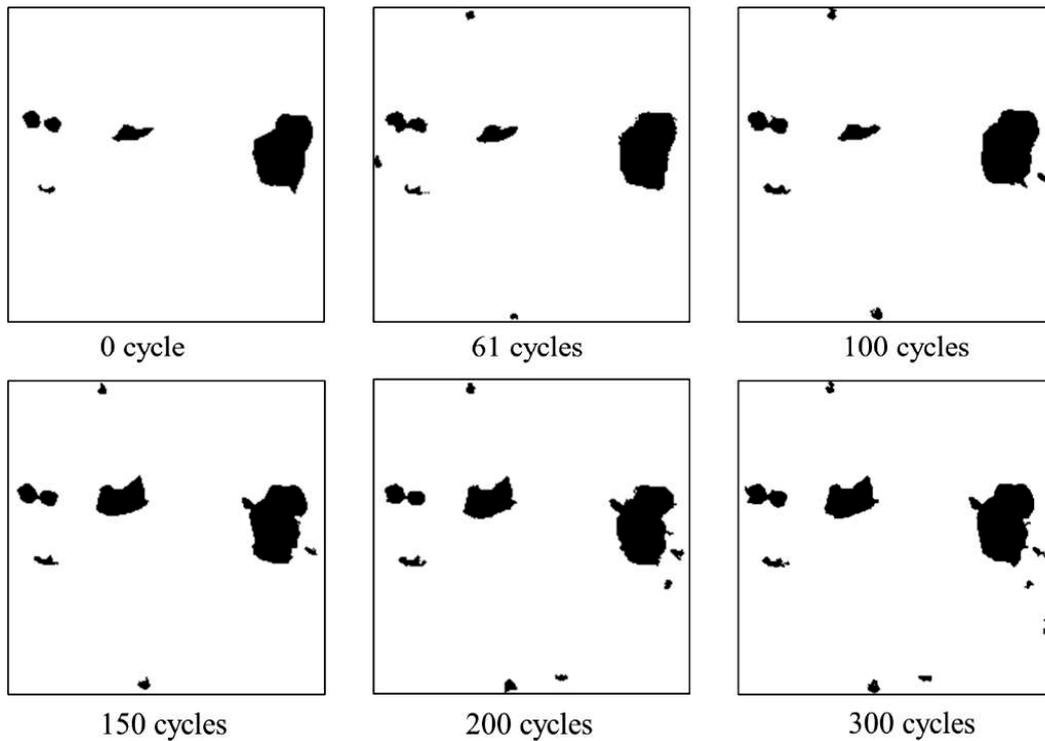
(a) position of analyzed area

(b) enlargement of the hole from 0 to 300 cycles

(c) image analysis results (dia. > 1 mm)

Figure 4-9 Enlargement of a hole on surface 3R

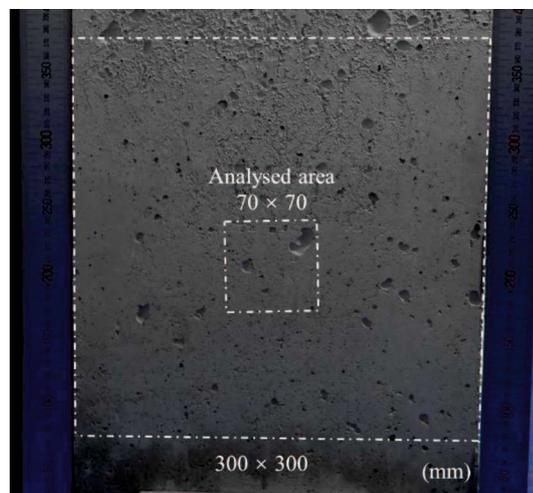
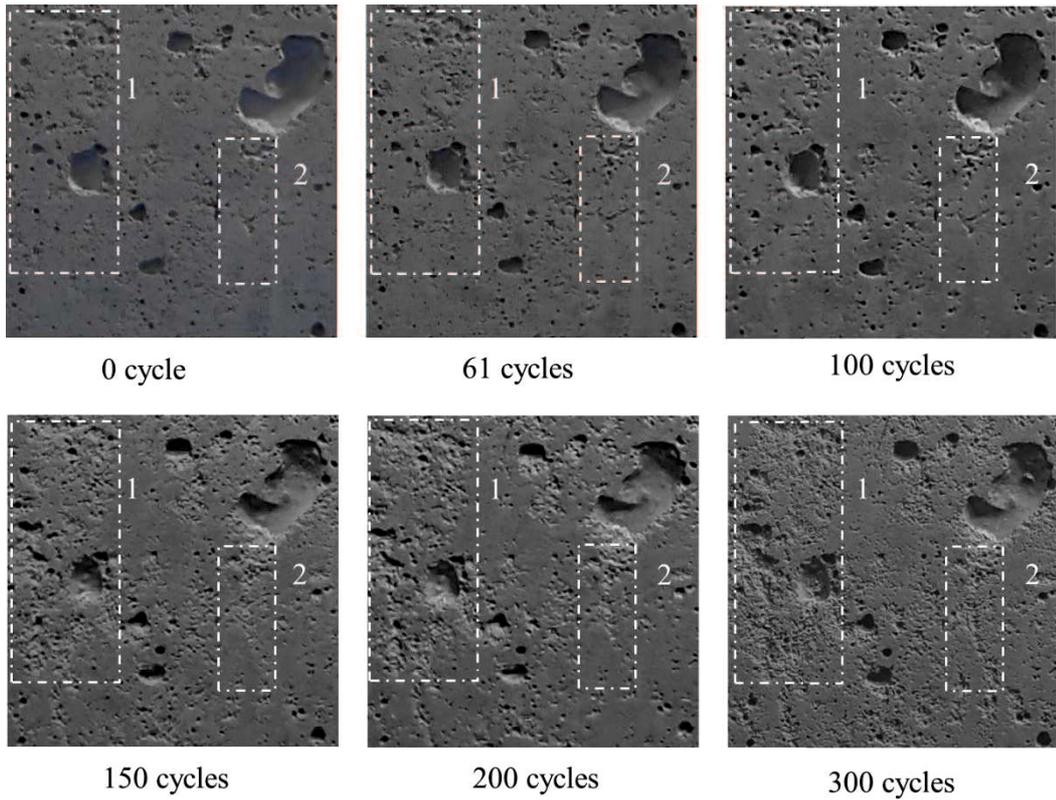
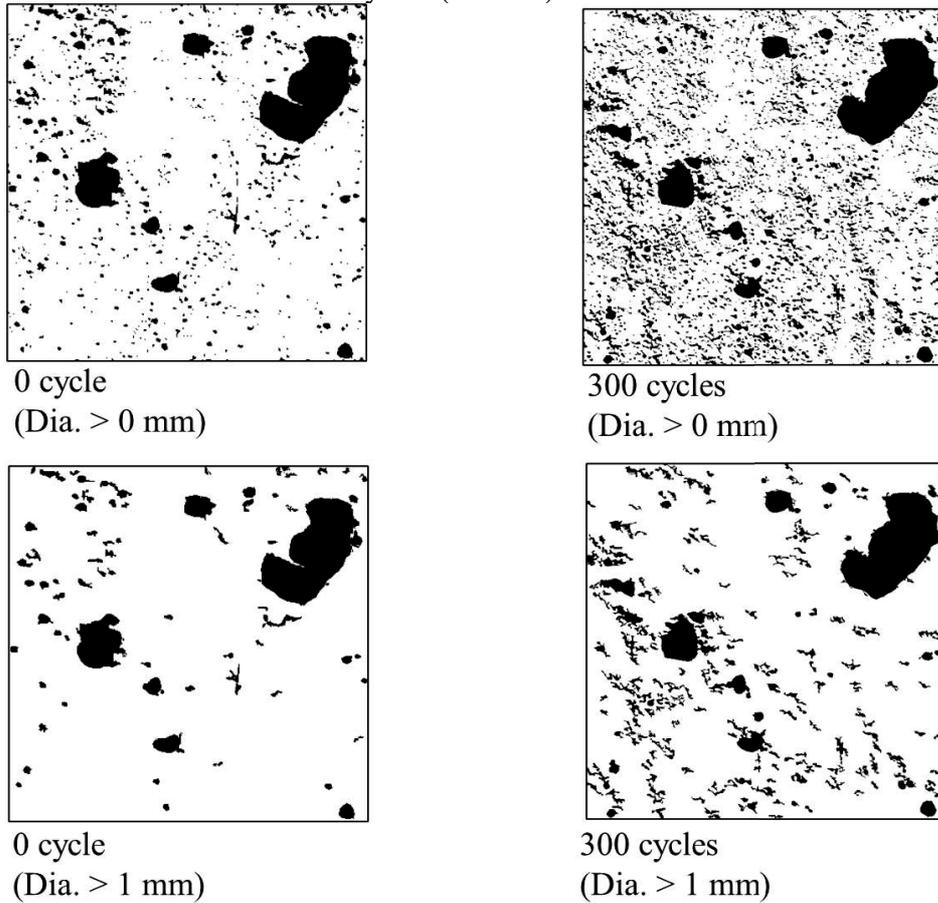
(a) position of analyzed area

(b) pits and craters from 0 to 300 cycles (1 and 2)

(c) image analysis results

Figure 4-10 Pits and craters on surface 6F

Figure 4-10 (a) and (b) show the process of porosity formation on surface 6F. The concrete surface subjected to F-T cycles often produces pits and craters, due to mergence and enlargement of invisible bugholes. As the number of cycles increases, the concrete surface gradually becomes more porous, increasing the superficial area. The pits and craters on the concrete surface, together with visible holes, were detected with the image analysis.

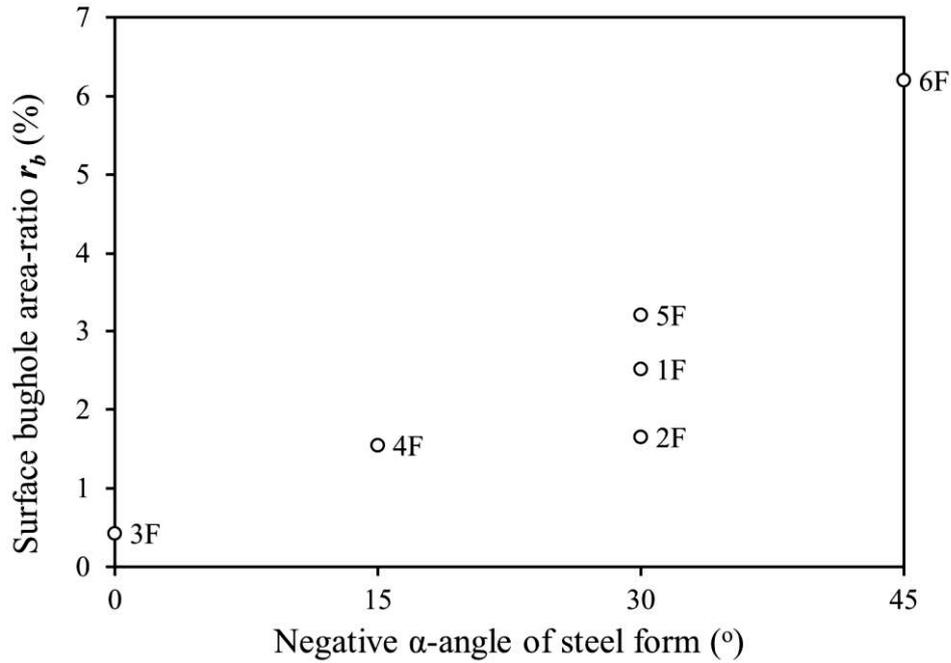
Figure 4-11 Bughole area-ratio r_b of front surface and negative α -angle of steel form

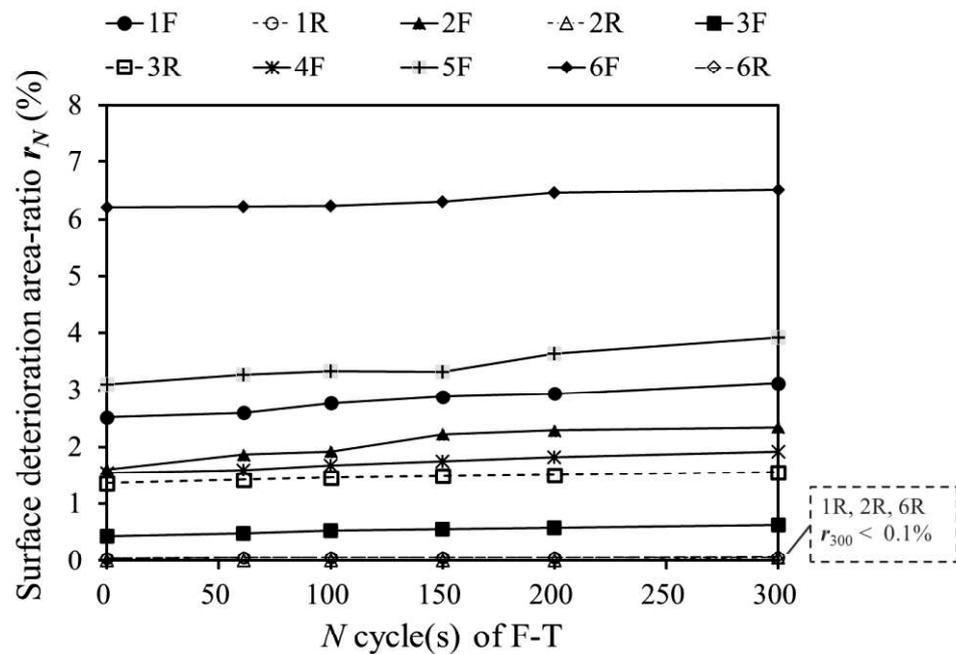
Figure 4-12 Variation of surface deterioration area-ratio during F-T cycles

where r_{sN} is the scaling area-ratio on the concrete surface. **Figure 4-12** shows that the deterioration area-ratios of the concrete surface slightly increased with F-T cycles.

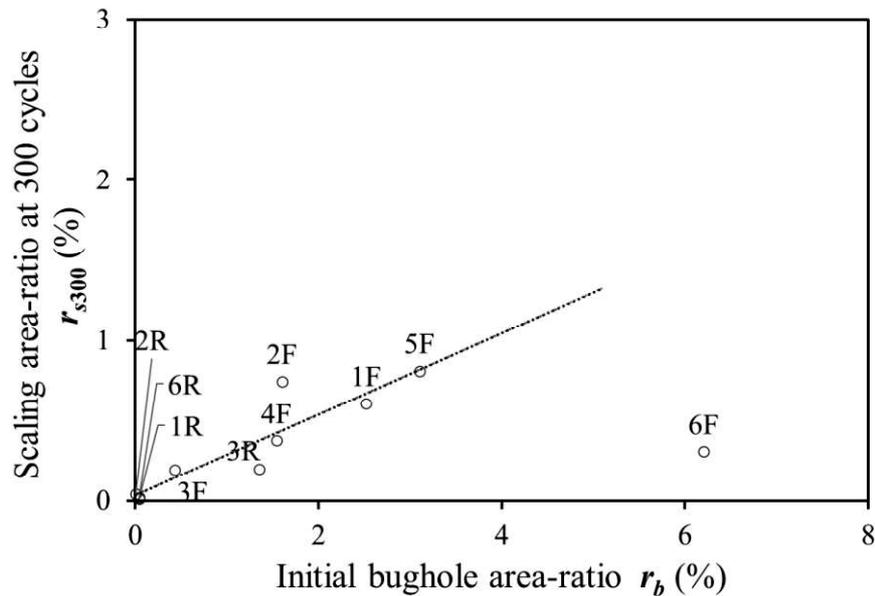
Figure 4-13 Scaling area-ratio at 300 cycles r_{s300} and initial bughole area-ratio r_b

the local scaling area-ratio is lower than 1%, and therefore not a significant influence. Consequently, a tunnel lining concrete with surface bugholes, with area-ratio lower than 5%, can be regarded as continuous and isotropic.

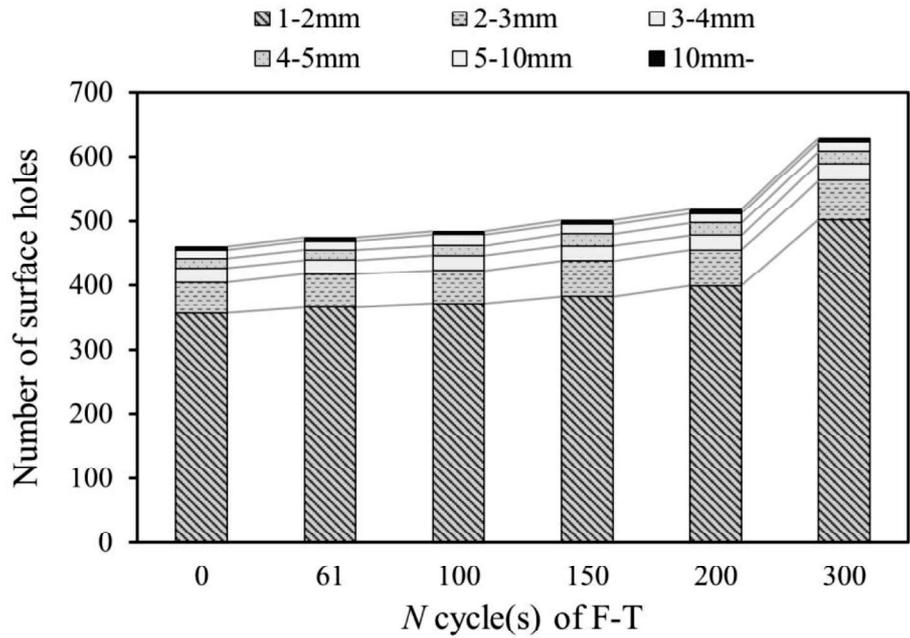
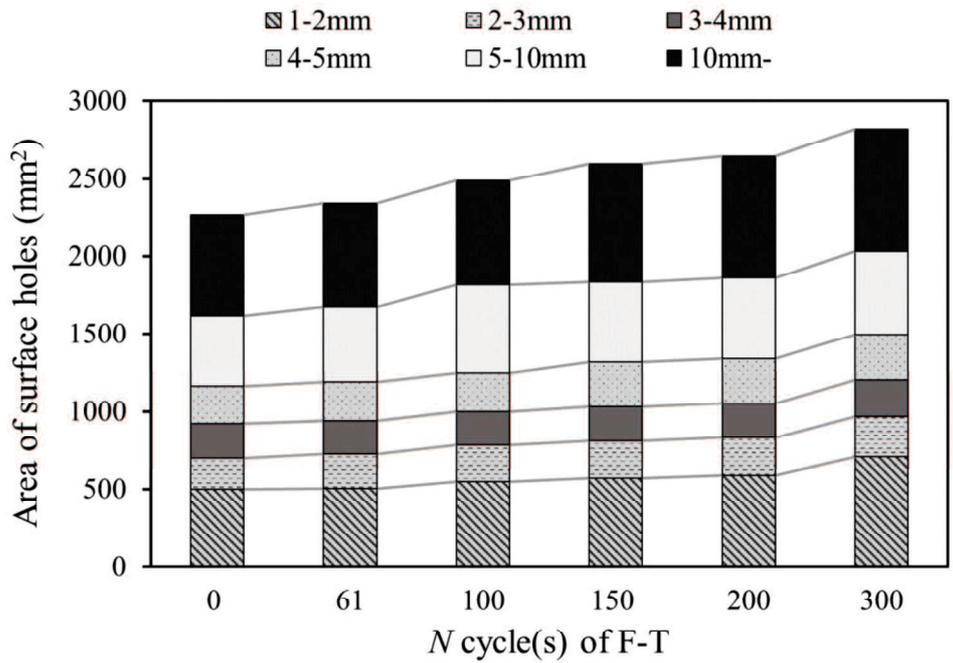
(a) number of surface holes during 300 F-T cycles

(b) hole area on surface 1F during 300 F-T cycles

Figure 4-14 Surface deterioration on surface 1F

Figure 4-14 shows the variation of surface deterioration on surface 1F, where the surface holes are isolated based on nominal diameter. The graph illustrates that both the number and area values of holes show variance among different diameter groups. If a hole enlarges or merges with other holes, the area of the hole would increase. Also, the nominal diameter would exceed the threshold value of the diameter. In such a case, the enlarged or merged hole will shift to the next larger diameter group. The enlargement and merging of the invisible bugholes (diameter < 1 mm) to visible holes (diameter 1-2 mm) increase harmful holes and significant imperfections of the surface. Although the number of holes with a diameter of over 10 mm slightly increased, the increase in area is more significant because of their larger area and longer circumference. Local scaling of cover-concrete occurs along the circumference. This relation was also observed in other concrete surfaces. Further research on the deterioration around the bughole circumference can give us more information about concrete durability.

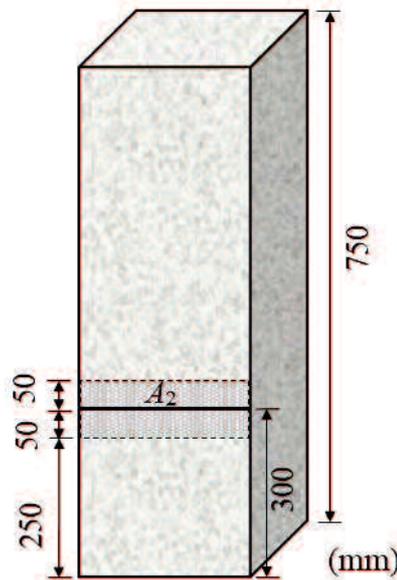
Figure 4-15 Chloride profile height and analyzed surface area A_2

Figure 4-15 shows the position of chloride profile determined at the height of 300 mm and an image analysis area of A_2 ($100 \text{ mm} \times 300 \text{ mm}$). Considering that the penetration depth of chloride is less than 50 mm, the area A_2 for the image analysis was selected as 50 mm offset from the chloride profile position. **Figure 4-16** shows the relation between penetration depth and surface bughole area ratio R_{A2} , which indicates that the chloride penetration depth increases sharply when the surface bughole area ratio is over 0.3%. The maximum penetration depth of all specimens was 40 mm. It should be noted that the chloride penetration may not be a serious concern as the thickness of concrete cover at the entrance of tunnel lining, which is constructed as RC structure, is greater than 40 mm.

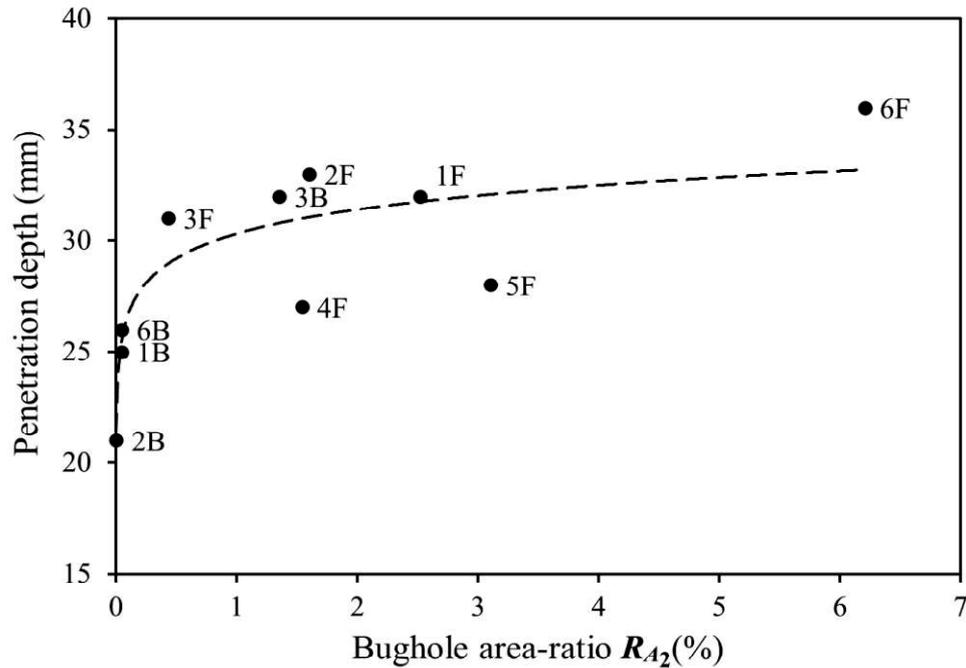
Figure 4-16 Chloride penetration depth - surface bughole area-ratio R_{A2}
