Influence of Surface Bugholes on Freeze-Thaw Degradation of Tunnel Lining Concrete

Dr. Eng. Thesis

**DEPARTMENT OF ENVIRONMENTAL ENGINEERING
YAMAGUCHI UNIVERSITY
UBE, JAPAN
September 2020**

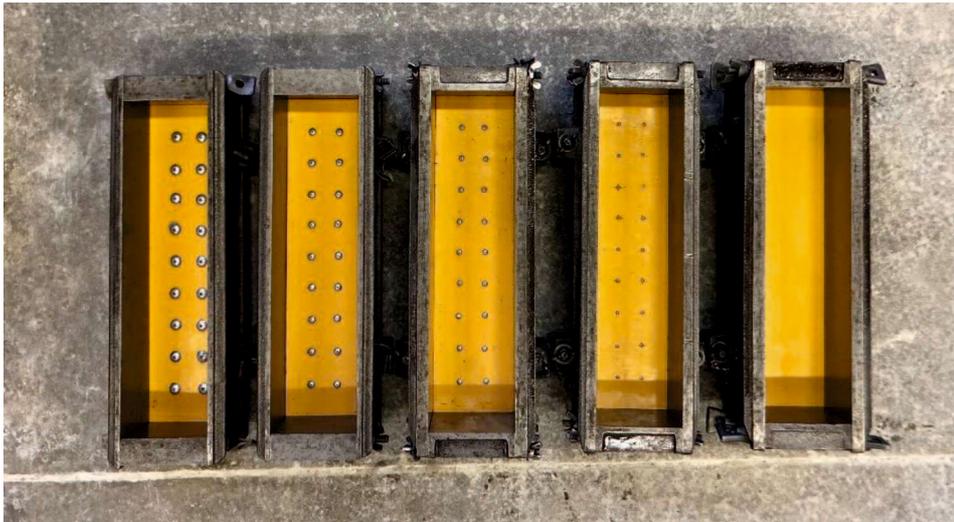
Figure 5-1 Steel forms with wood plates having round screws

To make concrete with surface holes, specimens were cast in the steel-wood forms. The wooden plate on the bottom side had the various size of round screws, as shown in **Figure 5-1**. The hole size and hole area-ratio of the specimens are given in **Table 5-3**. It was supposed that a bughole with a bigger diameter has a larger depth. In other words, small-diameter bugholes having large depth cannot appear. Therefore, to some extent, the effect of bughole size can also refer to the effect of bughole depth. Thirty-four specimens were used in the chloride immersion test. To examine the corrosion of steel reinforcement in situ, specimens No.26-34 in group P-S and N-S embedded with steel rebars, as shown in **Figure 5-2**. **Figure 5-3** shows the concrete specimens with surface holes after form removal.

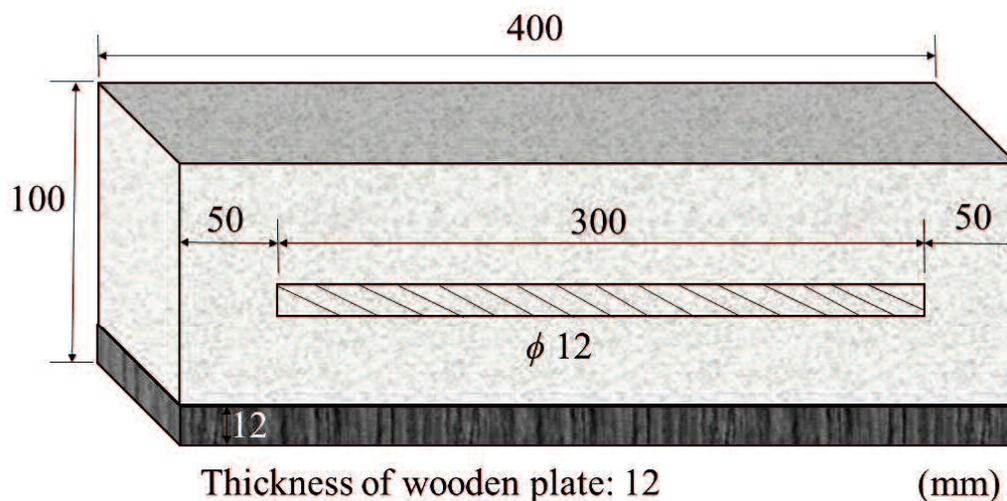
Figure 5-2 Specimen embedded with steel rebar

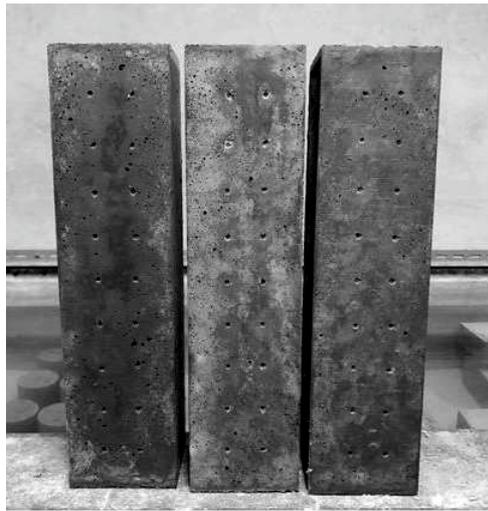
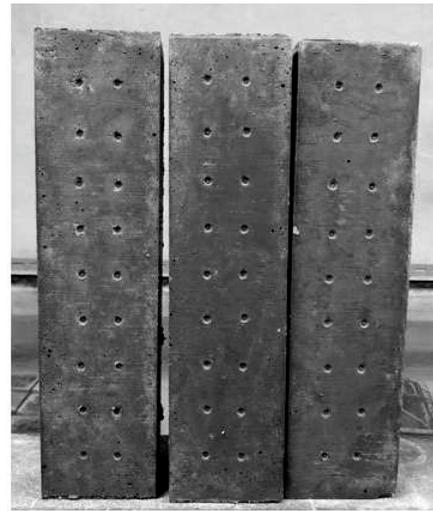
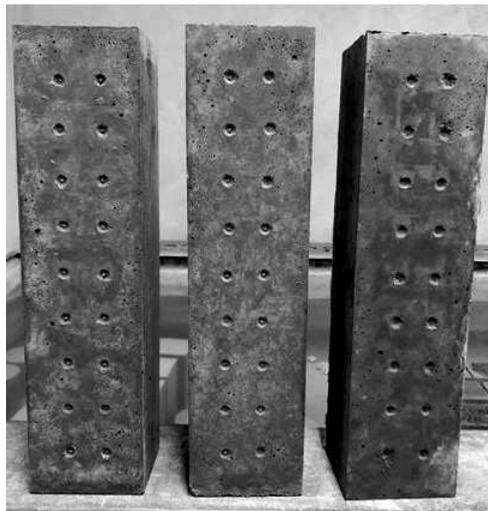
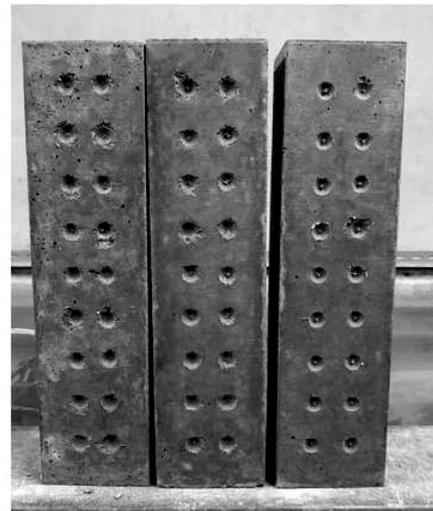
Figure 5-3 Concrete specimens after removal of forms

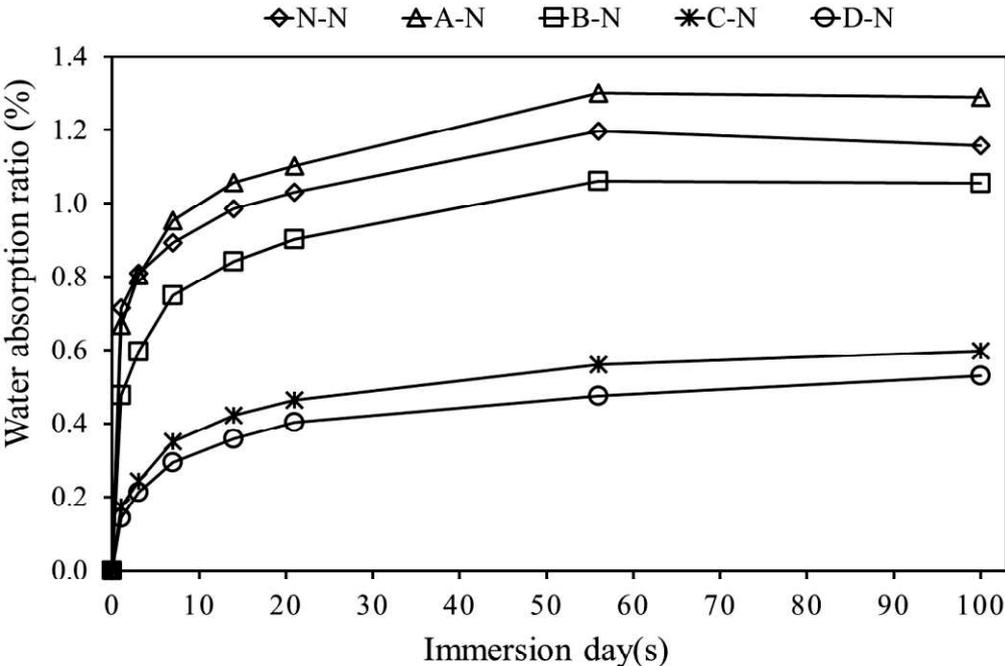
Figure 5-4 Water absorption ratio of concrete applied with different surface penetrants during immersion test

Figure 5-4 shows the water absorption ratio of concrete specimens during the immersion test. Group A-N has similar water absorption with uncoated group N-N, which indicates that surface penetrant LS has little resistance to water. Although specimens in group B-N displayed lower water absorption than group N-N, the water-repellent effect of siloxane-based penetrant SO-LS is questionable.

Penetrant SA-LS shows a high performance of water inhibition. This result indicates that silane is more effective than siloxane to penetrate concrete pores and make concrete resistant to water and ions. Li et al. (2012) reported that a silane-based penetrant could provide a hydrophobic surface in addition to the substrate surface tougher. The report showed that the silane was also effective to decrease cracking and to heal cracks of smaller than 0.2 mm. The interaction of silane and lithium silicate makes the concrete surface more water-repellent. Compared with a regular dosage in group C-N, double dosage of penetrant SA-LS in group D-N exhibited better water-repellent and reduced 6.7% water absorption at 100 days.

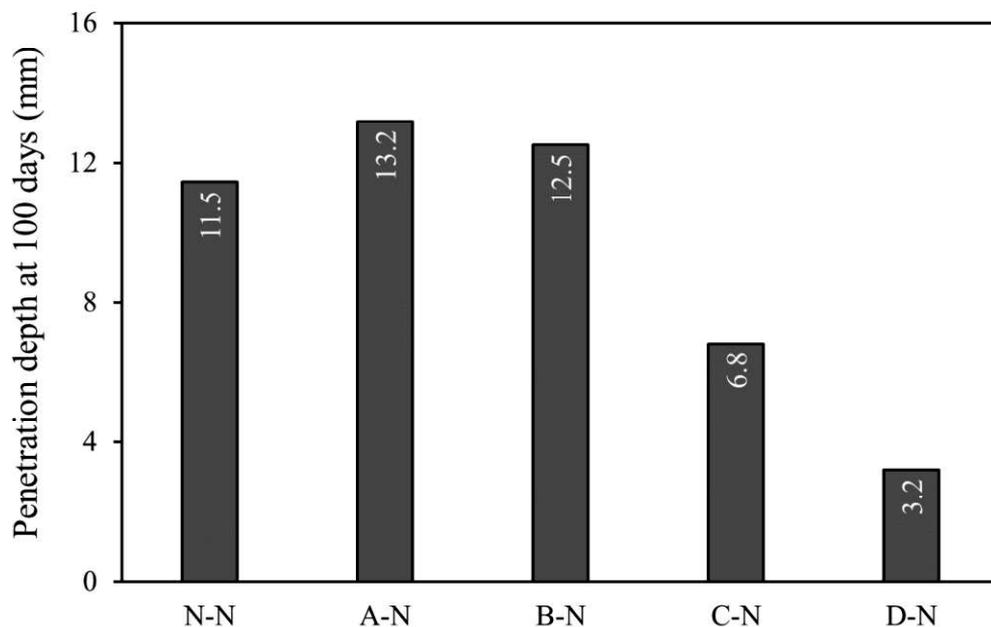
Figure 5-5 Chloride penetration depth after 100 days of immersion

Figure 5-5 shows the chloride penetration depth of each group after 100 days of immersion test. The results indicate that surface penetrants LS and SO-LS almost have no inhibition effect for chlorides compared with group N-N. Silane penetrant SA-LS shows an excellent inhibition effect for chloride. A double dosage (group D-N) brings a double effect against chloride intruding compared with group C-N.

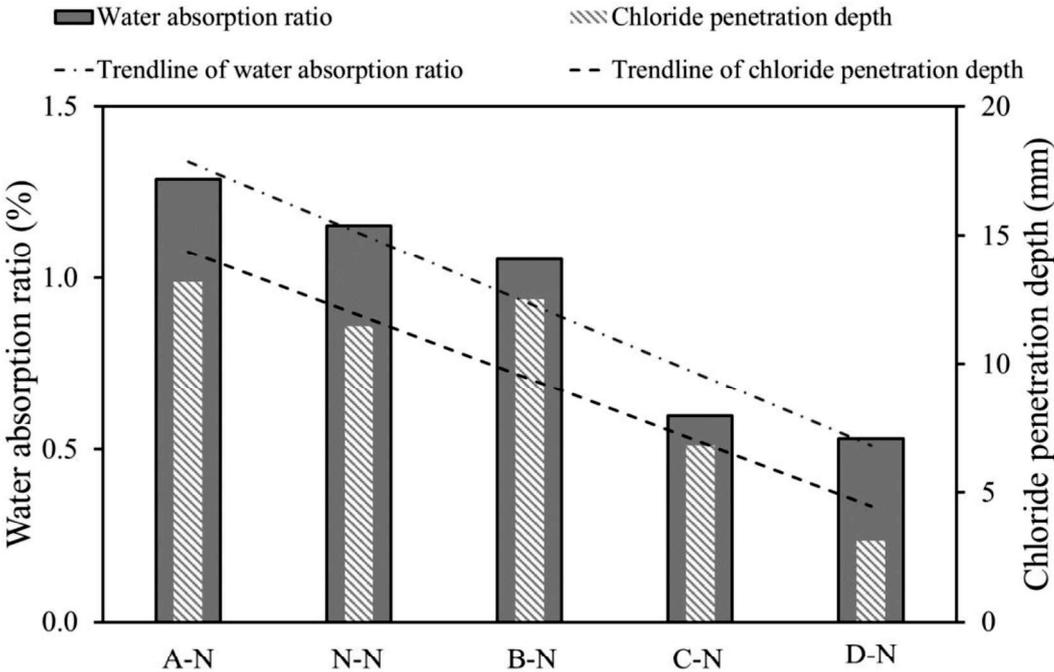
Figure 5-6 Water absorption and chloride penetration depth of concrete at 100 days

The water absorption and chloride penetration depth of concrete groups at 100 days are shown in **Figure 5-6**. It indicates that water absorption and chloride penetration depth are highly correlated. This is to say, the water-repellent effect of surface penetrants influences the chloride inhibition significantly.

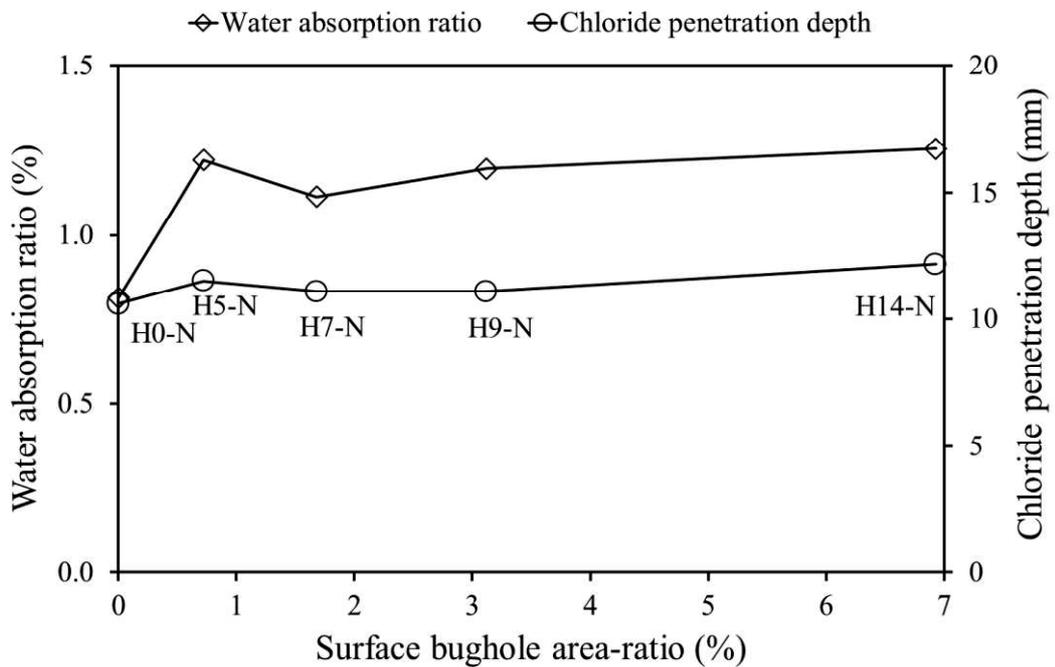
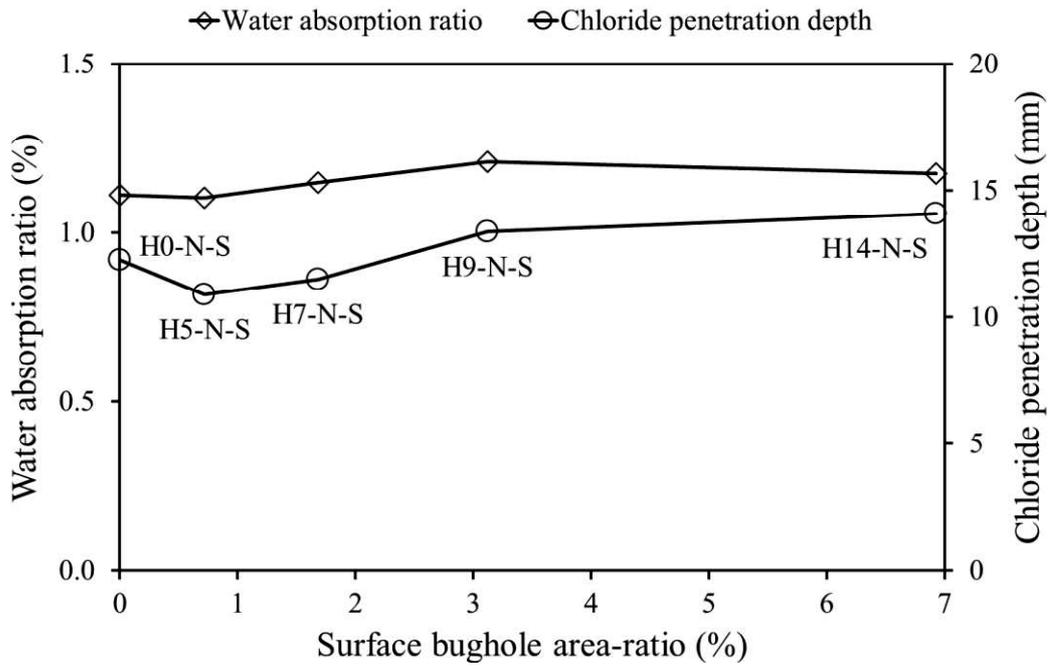
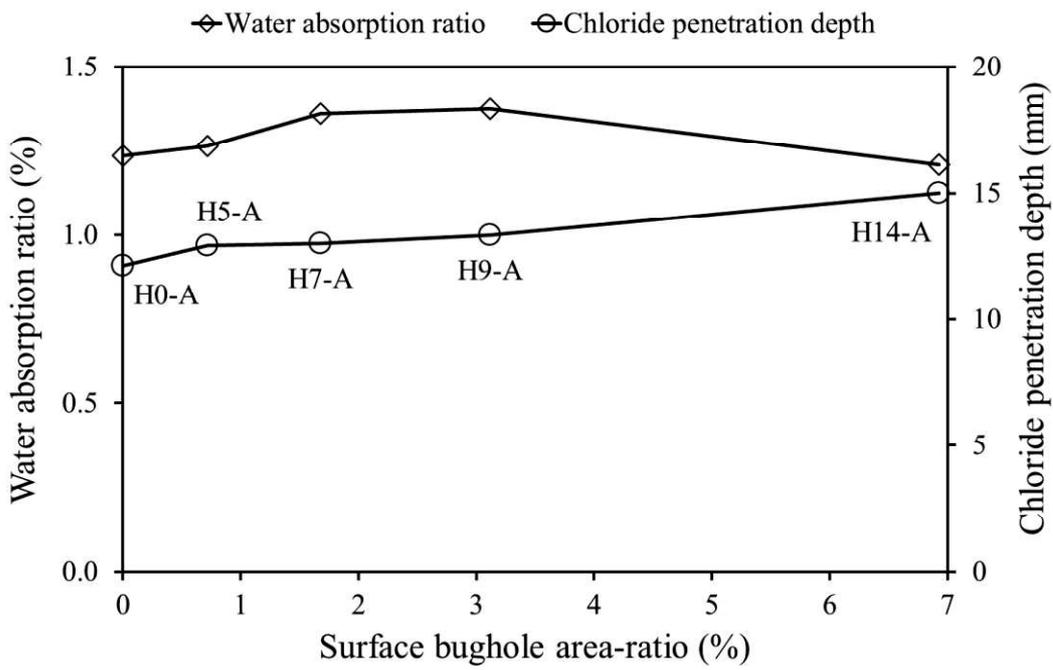
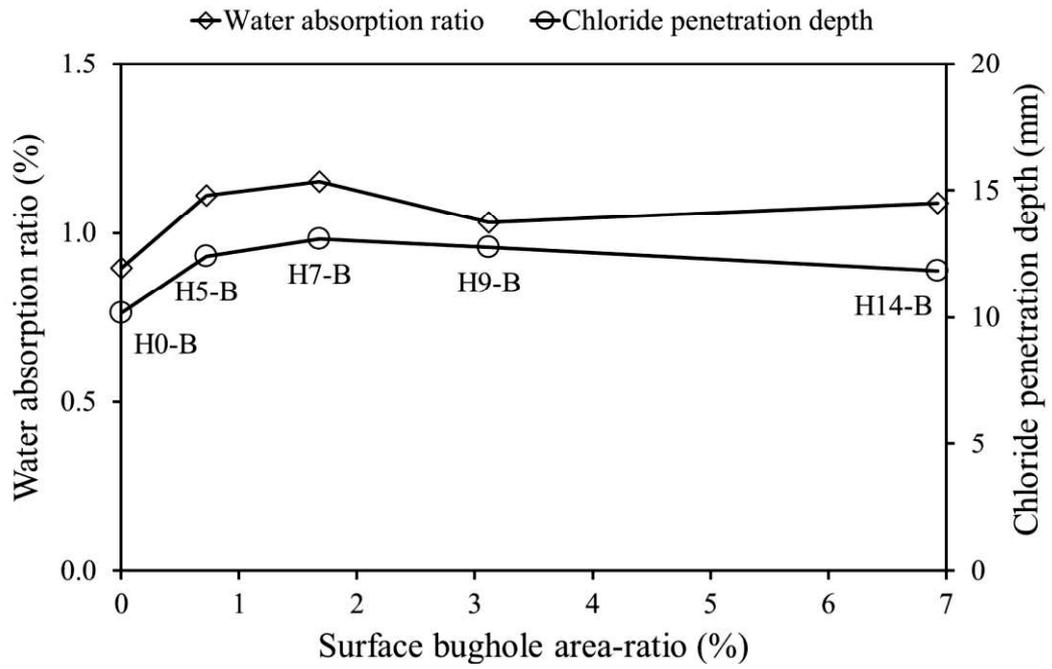
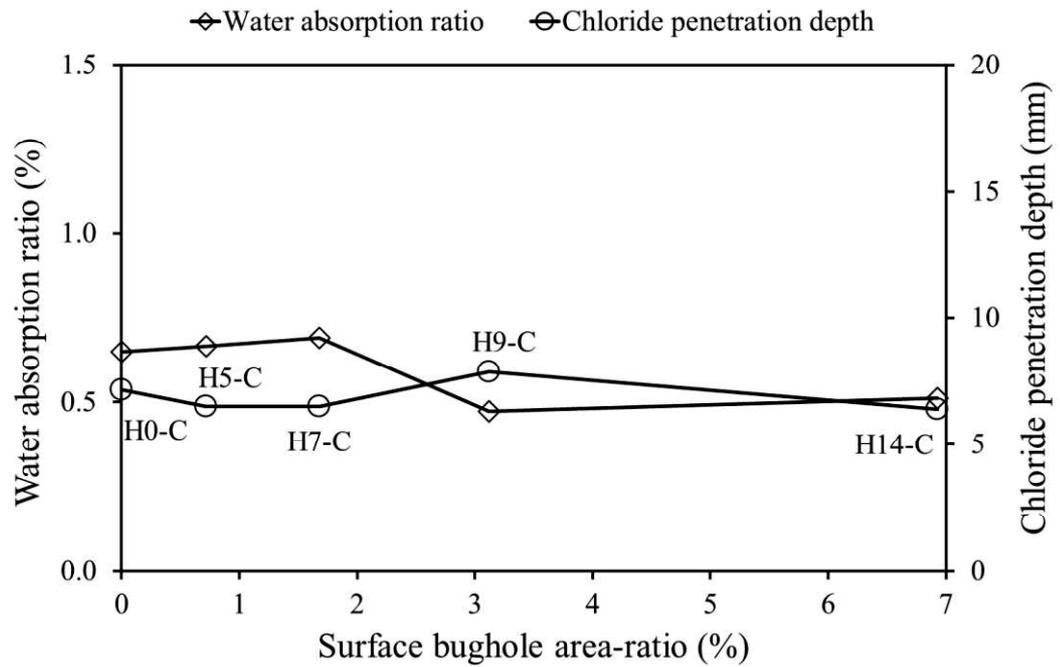
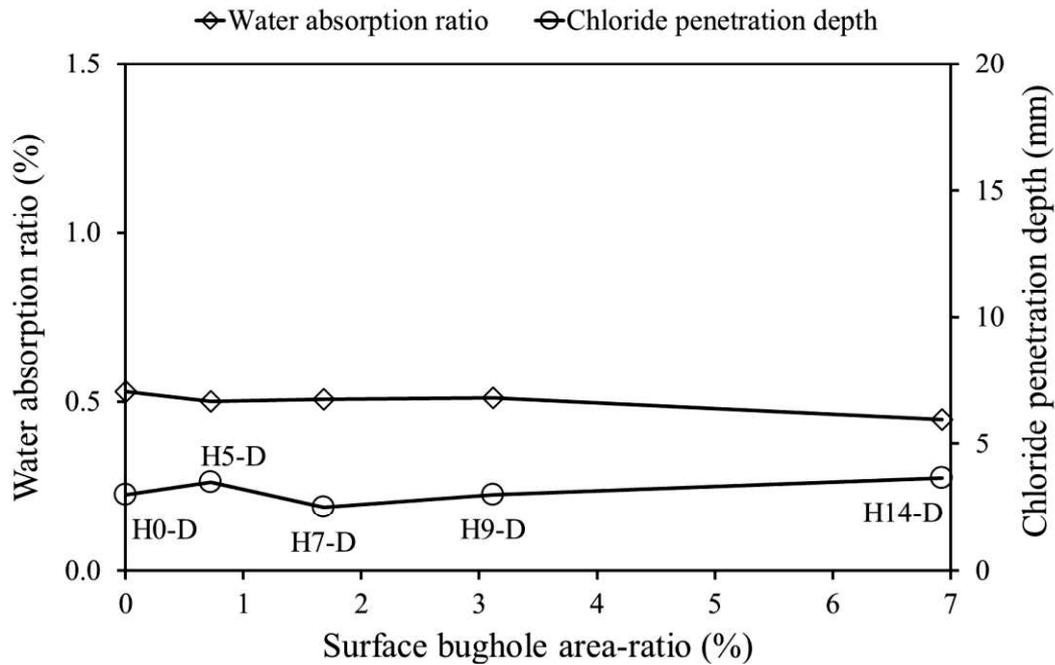
Figure 5-7 Relation of surface bughole area-ratio, water absorption, and chloride penetration depth

In contrast, group C-N and D-N show low water absorption as well as chloride penetration, as shown in **Figure 5-7** (e)-(f). However, chloride penetration depth or water absorption ratio is irregular with the surface bughole size or area-ratio. It demonstrates that silane-based penetrant SA-LS can improve water resistance effectively and against chloride intruding, even on a concrete surface with bugholes. Therefore, it can be concluded that bugholes on a concrete surface have a negligible effect on chloride intruding when the water-repellent effect of surface penetrants can be ensured. Thus, the process of surface finishing due to bugholes can be omitted before coating, which contributes to the reduction of construction cost and duration.
