Doctoral dissertation

Experimental study on cementitious mortars for  
repairing RC members

Graduate School of Sciences and Technology for Innovation  
Yamaguchi University  
Madeira Branco Leandro.

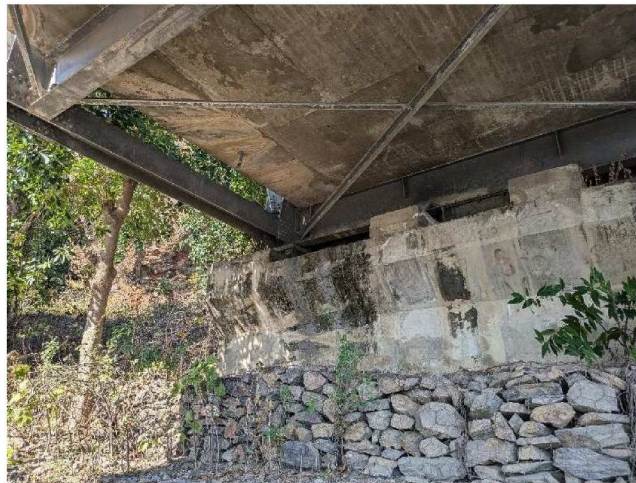
Figure 2.1. Initial damage and repair application to the concrete structure.

The development of modern concrete began with Joseph Aspdin's invention of Portland cement in 1824, later supplemented by Joseph Monier's RC in the mid-19th century, establishing concrete as the dominant global construction material throughout the 20th century [1]. Despite innovations such as prestressed and high-performance concrete and the current focus on low-carbon, self-healing, and geopolymers to promote sustainability, RC structures remain vulnerable to degradation.[2]. There are various damage mechanisms, including severe issues such as reinforcement corrosion, which is often caused by chloride or carbonation and results in cracking and spalling. Other mechanisms include chemical attacks, such as sulfate attack or alkali-silica reaction (ASR), as well as physical deterioration from freeze-thaw cycles and mechanical overloading.[3]. The impairment of the concrete is attributable to the installation method and the construction process, which are results of unprofessional behavior by the laborers. This issue will inevitably lead to long-term problems in the utilization of the concrete structure, as shown in Figure 2.1.

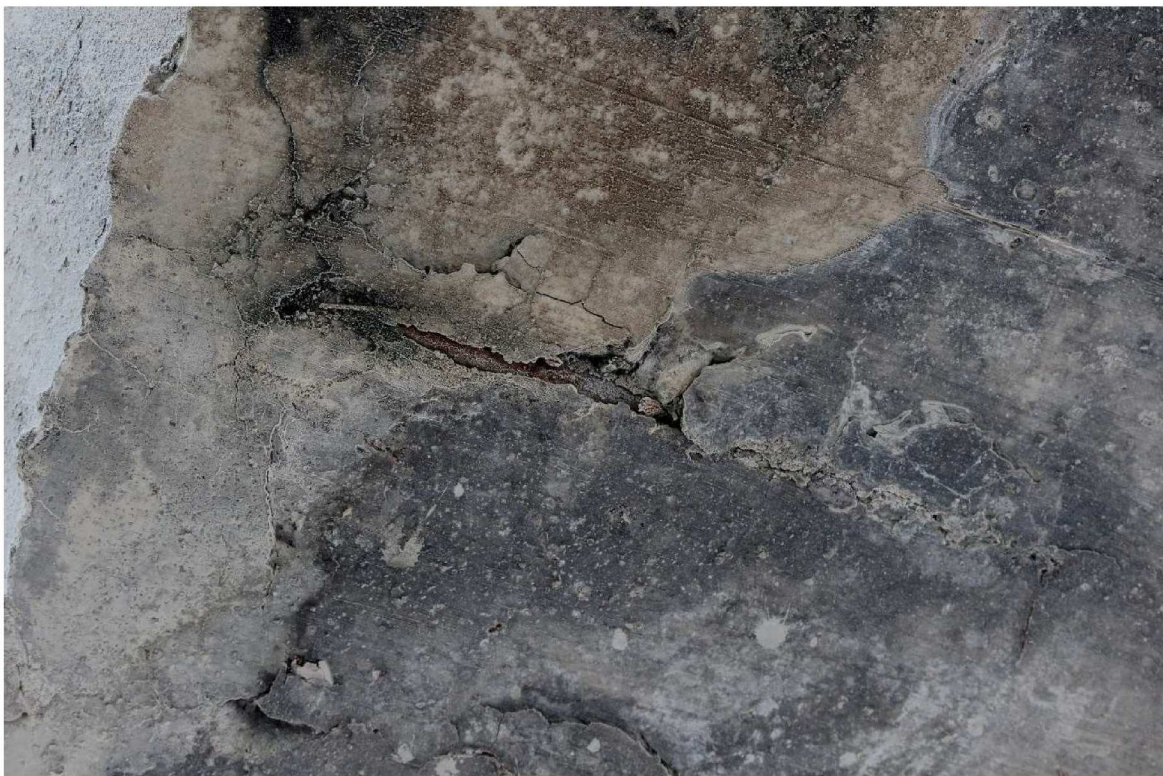
Figure 3.2. Poor concrete structure condition

This assessment begins with inspecting the structure's condition to determine the type, cause, and extent of damage (e.g., cracks, spalling, corrosion, honeycombing), as shown in Figure 3.2. The poor condition of the concrete structure requires immediate attention for repair [6]. This research also involves investigating the availability and price of conventional and advanced repair materials within the country, factoring in the repair budget and long-term planning. The main materials being evaluated are Ordinary Portland Cement (OPC), Polymer Modified Cement (PMC), polypropylene fibers (PF), and epoxy resin (ER) bonding agents [7].

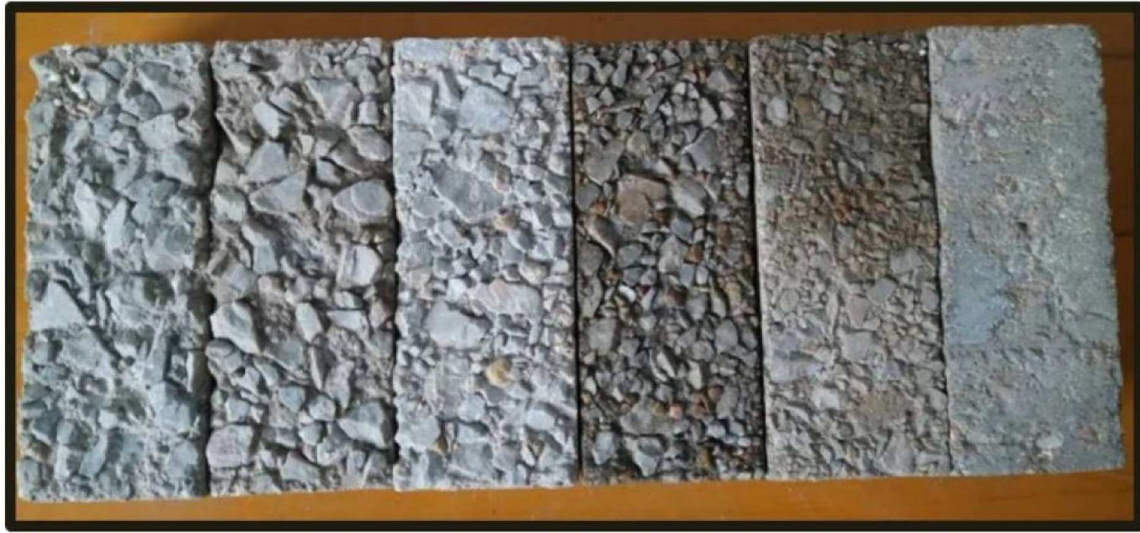
Figure 3.3. concrete surfaces with different roughness [9]

The roughness of the concrete substrate is considered a key factor in the bonding performance between the concrete substrate and the cement-based repair mortar. A rough surface provides a larger surface area and mechanical interlocking for the repair mortar to adhere, resulting in a more durable and enduring connection [8].

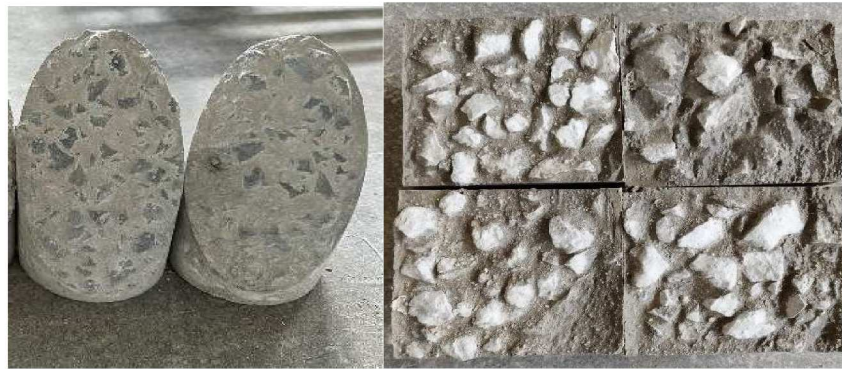
Figure 3.4. Surface roughness preparation in this research

The rough surface in this experiment for the concrete substrate was acquired by spraying water over the concrete surface after casting the concrete to delay the hardening of the concrete and removing the soft concrete surface by brushing until coarse aggregates were exposed, as shown in Figure 3.4.

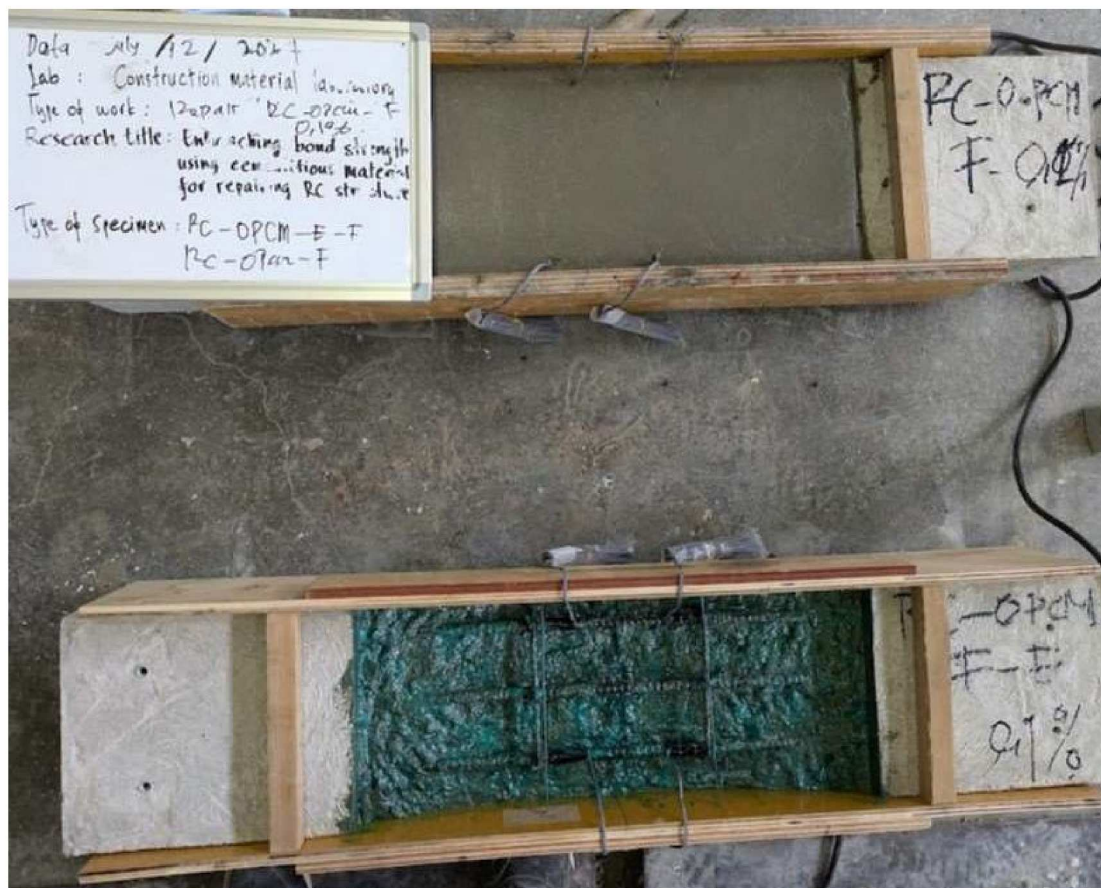
Figure 3.5. Application repair material

The application method depends heavily on the repair material selected and the size and orientation of the damaged area. First, the material, whether mortar, grout, or concrete, must be mixed precisely according to the manufacturer's instructions. Typically, a mechanical mixer is used to achieve a homogeneous, lump-free consistency. For placement (patching/troweling), standard patch repairs require applying the mortar with a hand trowel or spatula. Press it firmly against the primed substrate and into the cavity to eliminate air pockets. For overhead or vertical repairs, it is crucial to use thixotropic (non-sagging) materials to prevent slumping. When grouting or pouring is necessary, such as for larger voids or structural jacketing, secure formwork must first be installed. Flowable materials are then typically poured or pumped, starting from the lowest access point and moving upward, to ensure proper consolidation and prevent air entrapment within the repair zone, as shown in Figure 3.5.

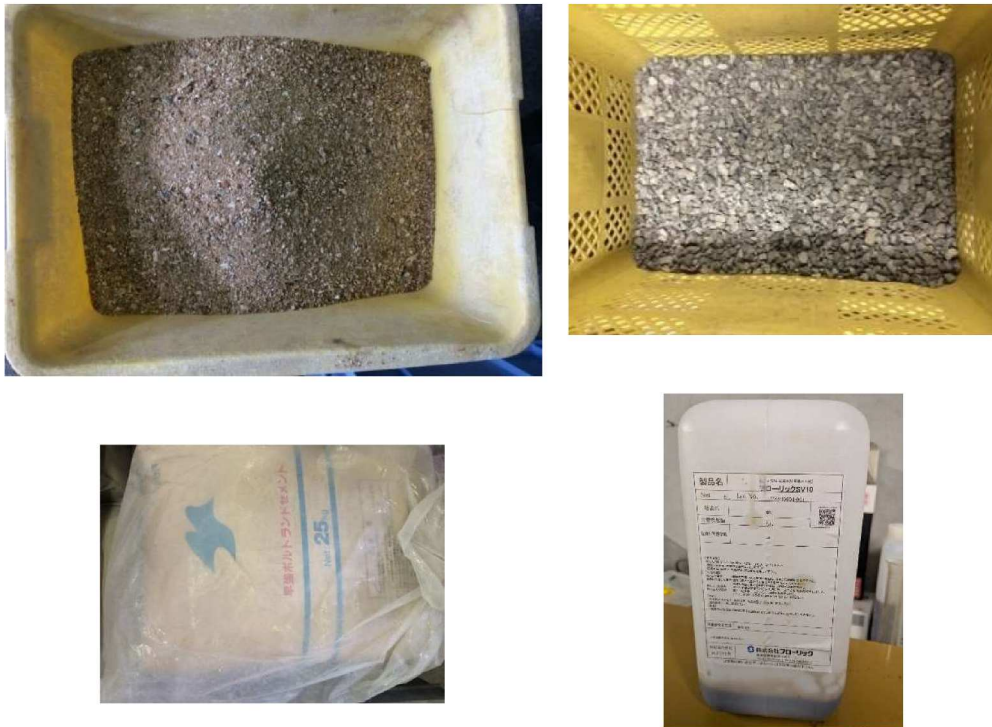
Figure 3.6. Material for conventional substrate concrete

A substrate concrete structure is an original concrete layer that has been modified or added to with materials like coatings or repair mortars; it acts as the necessary base for these subsequent additions. The substrate concrete used a conventional mix design as its foundational material. It was composed primarily of OPC, which acted as the main binder. The cement was mixed with water to initiate the chemical reaction (hydration) necessary for hardening. Void spaces were filled with fine aggregates (sea sand) and coarse aggregates (crushed gravel ranging from 5–20 mm), which provided structural mass. The material was used as shown in Figure 3.6. A crucial addition was a water reducer admixture, a chemical agent that allows for a lower water-to-cement ratio while maintaining sufficient workability, or ease of placement. This ultimately leads to denser, stronger, and more durable finished concrete.

The substrate concrete composition was determined using the ACI method for mix design. The ACI mix design method is generally used in Timor-Leste. The concrete was cast, and the fine aggregate and cement were combined in the mixer. Then, add an admixture (water reducer) to the water. Next, add half of the water mixture to the mixer. Followed by the coarse aggregate and the remaining water mixture. The mixing process was allowed for three minutes before being discharged from the mixer for placement in the form. The mixer was continuously operated throughout the mixing procedure. The molds were formed in different shapes depending on the purpose of testing: a rectangular form with dimensions (100 mm × 100 mm × 70 mm) for double shear and a cylindrical prismatic form with an angle of 30° for slant shear, including cylinder specimens for the compressive strength (diameter 100 and height 200 mm). Additionally, RC beam samples were prepared. The samples were cured for 28 days before the experiment.

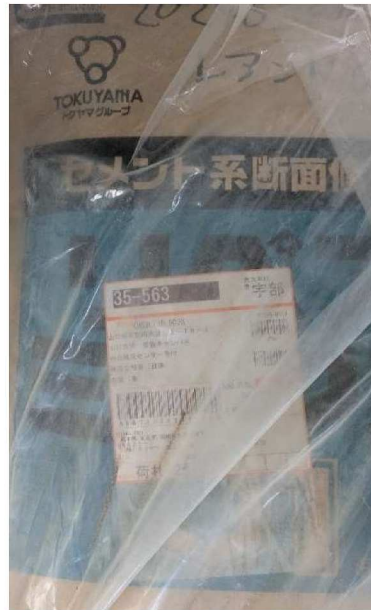
Figure 3.7. Polymer-modified cement

The typical repair cement mortar used in this study for polymer-modified cement is a commercial PMC (RepairmixJ1 produced by Tokuyama Company, Japan), which is a form of repair material for concrete structures, as shown in Figure 3.7.

PMC is composed of a combination of Portland cement (which contains crystalline silica), silica sand (which contains silica, aluminum oxide, and iron oxide), admixtures (which contain calcium oxide), and fibers. The PMC mortar mix proportions were based on the manufacturing guidelines. The mixing process was allowed for three minutes before being discharged. Prepare samples for compressive strength and flexural test for RC beams after repairing.

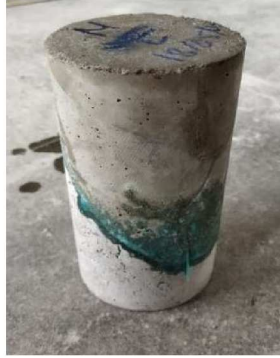
Figure 4.3. Slant shear sample

specimens were obtained by applying OPCM with and without epoxy, as well as PMC mortar, as shown in Figure 4.3. The samples were cured 28 days before the experiment.

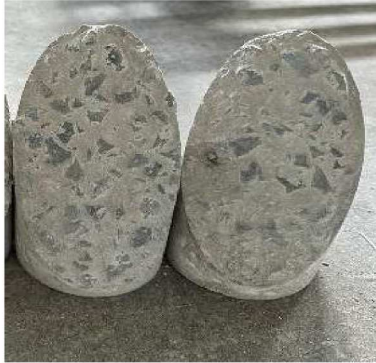
Figure 4.5. Surface roughness preparation for the slant shear test

concrete to delay the hardening of the concrete and removing the soft concrete surface by brushing until coarse aggregates were exposed, as shown in the figures. 4.5 and 4.6 for double shear specimens and slant shear specimens, respectively. The samples were cured 28 days before the experiment.

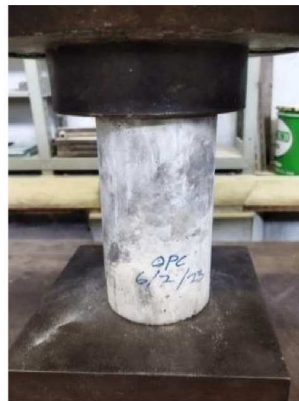
Figure 4.8. Slant Shear experiment

performance of all the other materials tested. The PMC mortar also demonstrated high bond strength; however, introducing epoxy resin in combination with the PMC mortar at the interface caused a significant decrease in bond strength (by approximately 30%), resulting in a lower average strength for this specific composite. Notably, combining the OPCM with epoxy resin caused a dramatic decrease in its slant shear strength, reducing it to the lowest value recorded across all material combinations and representing a substantial reduction from the OPCM's bond strength. Normal stress calculations performed on the repair materials used at the concrete substrate interfaces revealed that the OPCM once again exhibited the highest normal stress, as obtained by Eq. (3). The PMC mortar also exhibited high normal stress strength. However, when epoxy resin and PMC mortar were used together, the normal stress strength decreased by over 30% compared to PMC mortar alone. The OPCM combined with ER had the lowest normal stress strength in the group, with a decrease of approximately 50%.

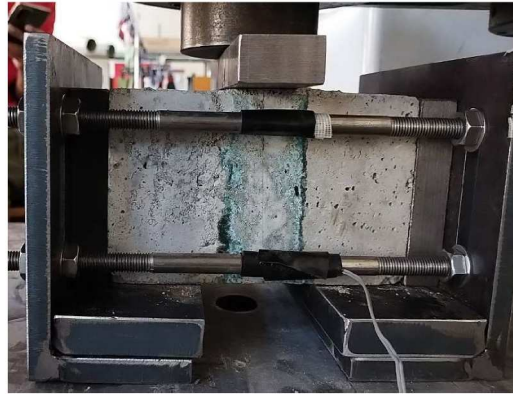
Figure 4.9. Double-strength test

The specimens produced at the vertical interface were tested against a single axial load. The bonding properties between the concrete substrate and repair materials are shown in Figure 4.9, and the experimental results as shown in Table 4.4.

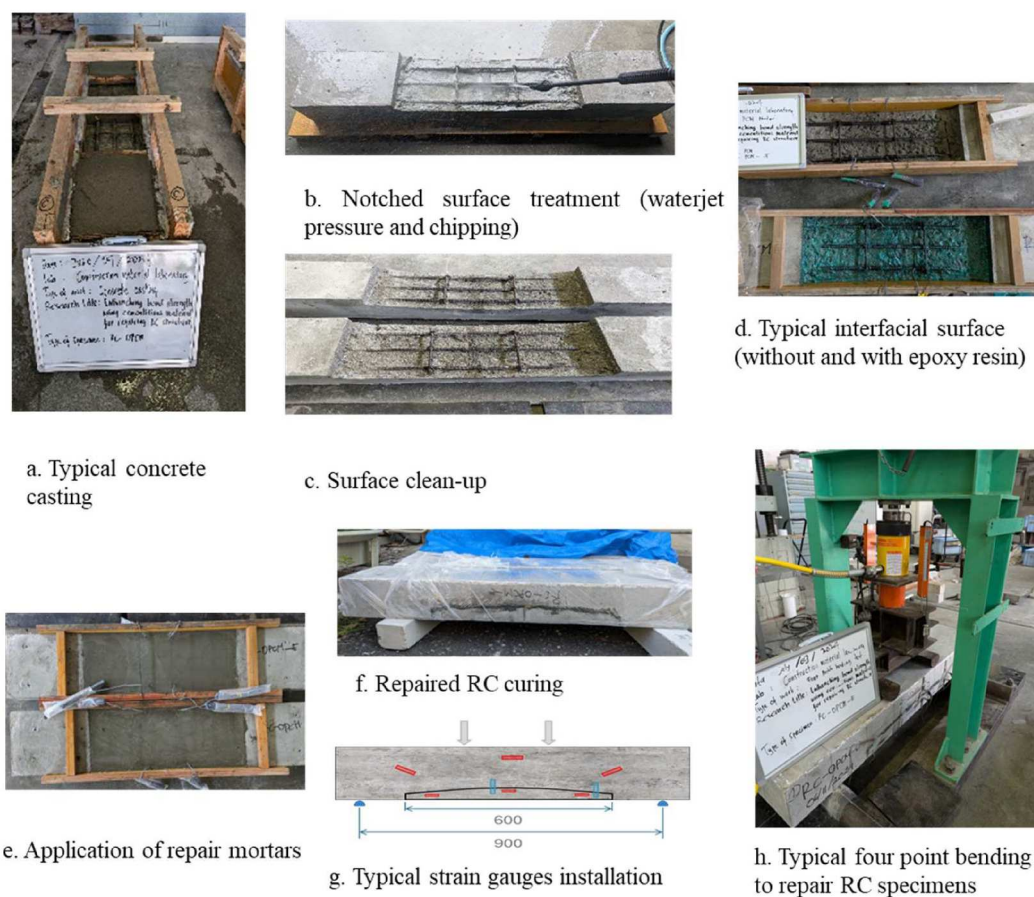
Figure 6.6. Typical repaired RC specimen preparation and testing
